October 2021
SF613A

Subject: ConMet Front Hub to Rotor Fasteners

Models Affected: Specific model year 2021 Freightliner 108SD, 114SD, 122SD, Business Class M2, Cascadia, Columbia, Coronado; and Western Star 4700, 4900, and 5700 model vehicles manufactured May 27, 2020, through September 1, 2020.

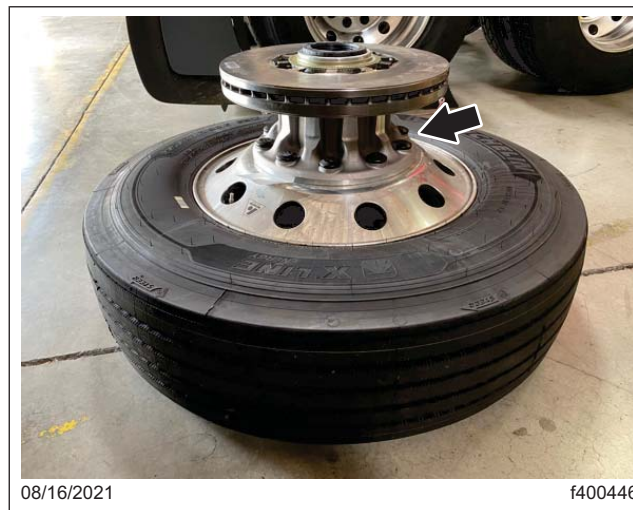
Fig. 1, Hub Held in Place on Front Wheel

3. Raise the vehicle and support it with jack stands.
4. Remove both front wheel assemblies.
5. Working on one side of the front axle, fully back off the adjusters.
6. Remove and discard the caliper bolts.
7. Remove the caliper and support it on the frame rail.
8. Remove the hub. If instructions are needed, see **Group 33** of the appropriate Workshop Manual.
9. Set the hub in the front wheel to hold it in place. See **Fig. 1**.

10. Repeat steps 5-9 on the other wheel end so both hubs are removed and held in place using the front wheels as shown in step [Fig. 1](#).
11. Using a thin-wall socket to clear the ABS ring, tighten all the rotor nuts on both hubs to 40 lbf·ft (54 N·m). Did any of the rotor nuts move at all?
 - 11.1 If **YES**: Replace the complete hub and rotor assemblies on both sides of the front axle. For instructions, see **Group 33** of the appropriate Workshop Manual.
 - 11.2 If **NO** on both front hubs: Replace the hub seals and install both removed hubs. For instructions, see **Group 33** of the appropriate Workshop Manual.

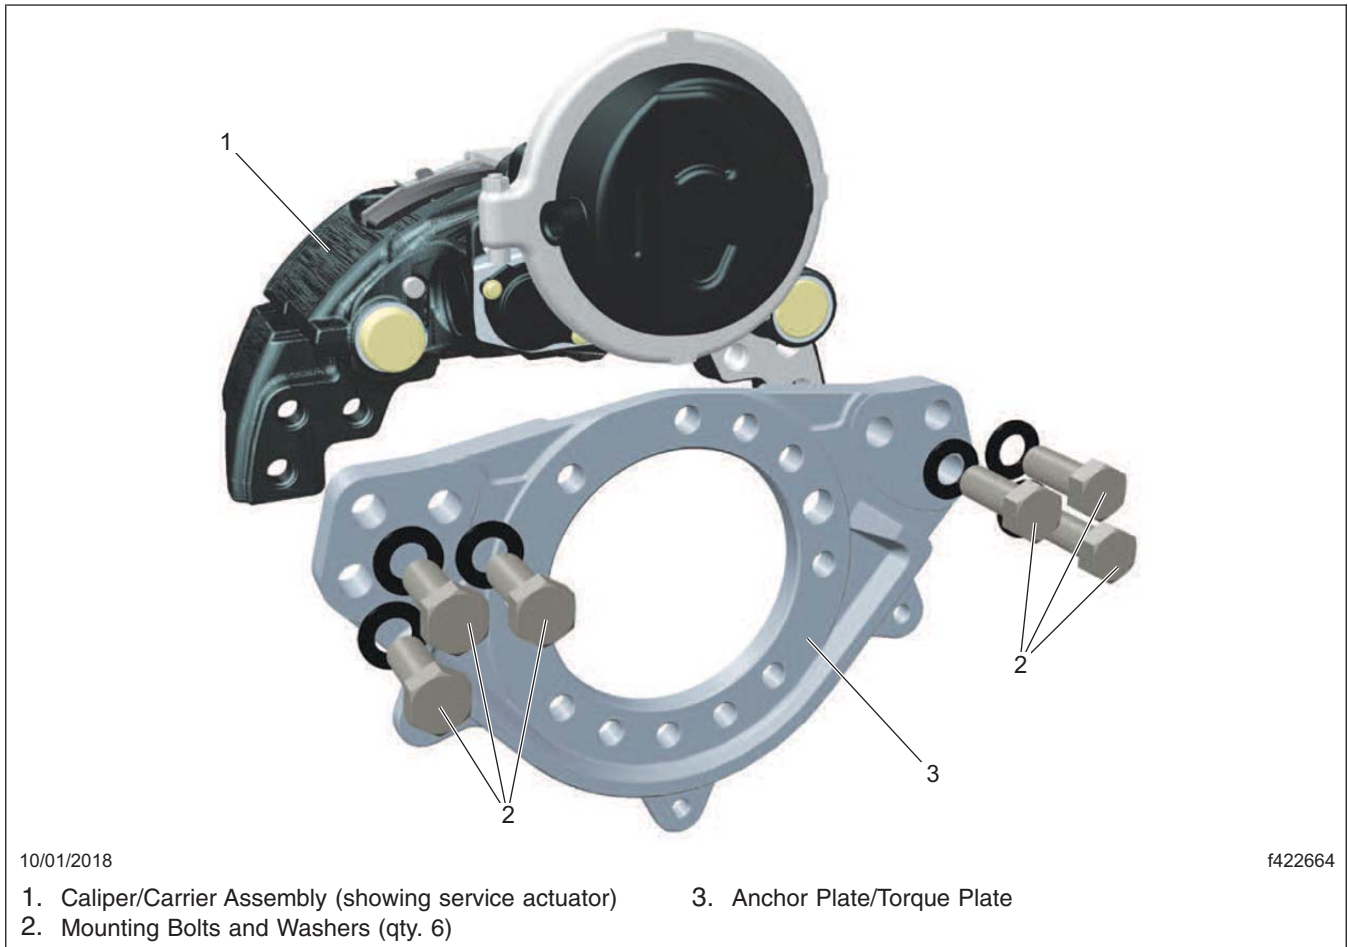
Fig. 2, Axial Mounted Caliper

12. Align the caliper/carrier assembly with the rotor by pushing the caliper against the shelf on the torque plate, then install the caliper/carrier assembly using new caliper mounting bolts. See [Fig. 2](#).

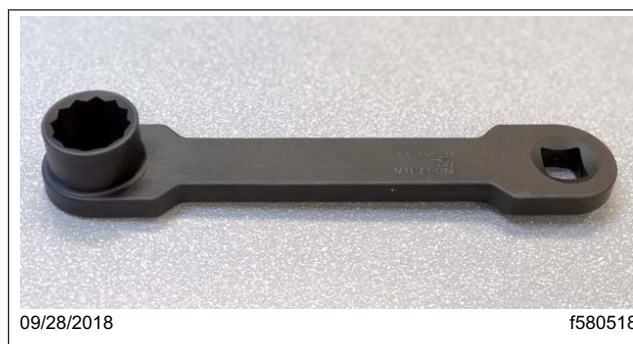
Fig. 3, DDC DSNCHA018005 30 mm Air Disc Brake Caliper Brake Bolt Torque Adaptor

NOTE: Due to limited caliper bolt access, it may be necessary to use tool DDC DSNCHA018005 referenced in tool letter 18TL18. See [Fig. 3](#). If the tool is needed, use tool DDC DSNCHA018005 only and no other tools.

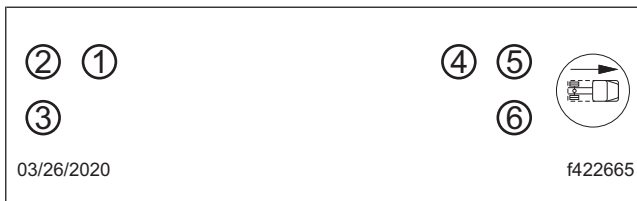
Fig. 4, Tightening Pattern, Left-Front Axial Caliper

Then tighten the three bolts on the other side of the caliper 40 ± 20 lbf·ft (54 ± 27 N·m), beginning with the inner-most bolt and moving to the outer-most bolt.

See [Fig. 4](#) for an illustration of the tightening pattern for the left-front caliper and [Fig. 5](#) for an illustration of the tightening pattern for the right-front caliper.

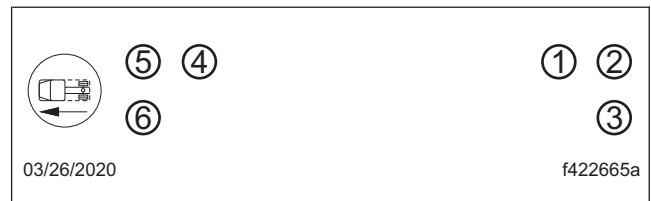
Fig. 5, Tightening Pattern, Right-Front Axial Caliper
