| Release Date | 10/29/2021 | Technical Service Bulletin | |
| 91CQ UPDATE | | | Audi |
| ConBox Software Update – (NVLW) | | | |

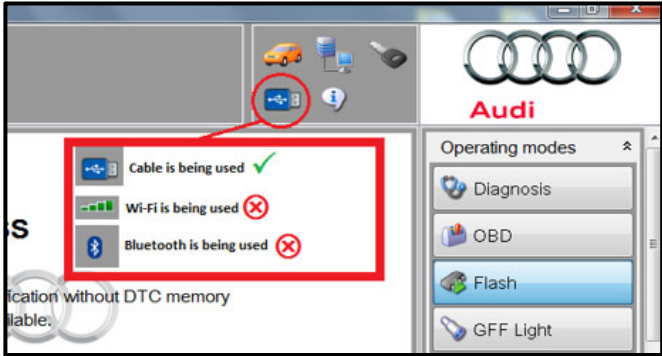
- Confirm that scan tool is communicating with the diagnostic head by USB cable.
 - If the Bluetooth or WiFi symbol is shown, then disconnect the diagnostic head from the vehicle and reconnect the USB cable to the diagnostic head and then reattach to the vehicle.

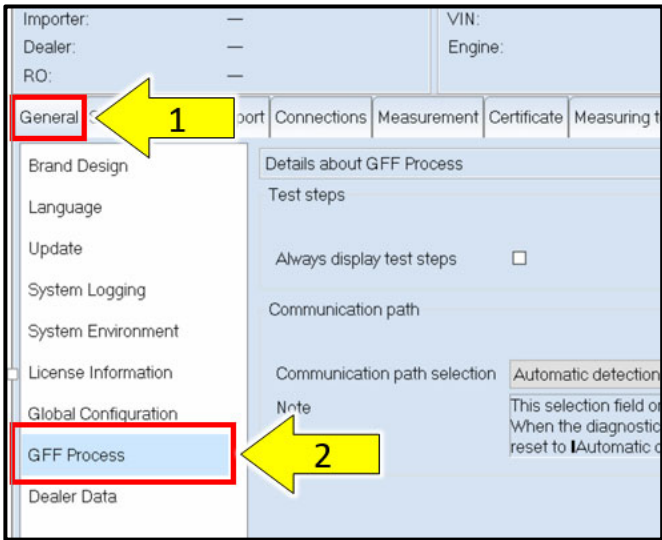
- From the “General” tab <arrow 1>, select “GFF Process” <arrow 2>.

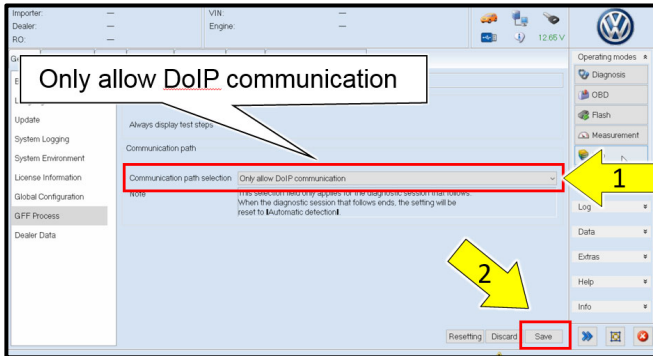
- From the “Communication path selection,” select “Only allow DoIP communication” <arrow 1>.
- Select “Save” <arrow 2>.

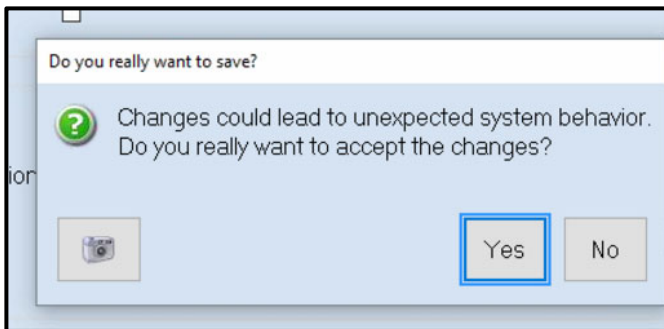
- Select “Yes” when prompted, “Do you really want to save?”
- Return to the home screen of the scan tool.

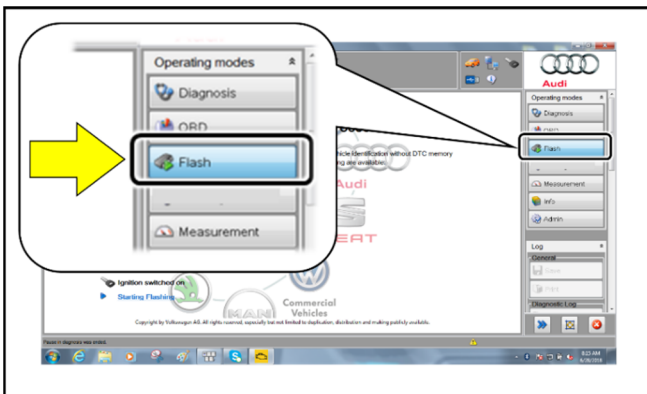
- From the home screen of the scan tool highlight “Flash” <1>.
- Follow the on-screen prompts.

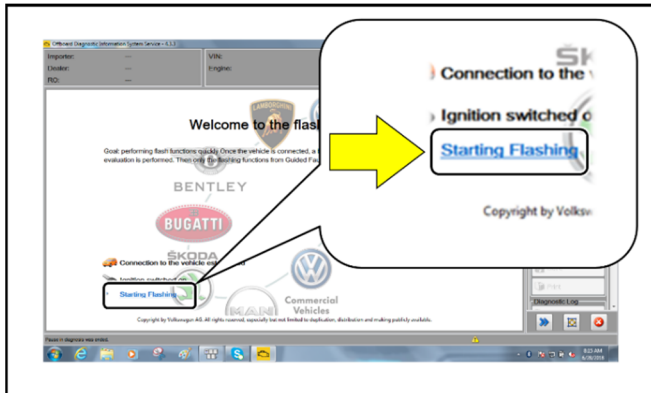
- Select “Starting Flashing” and follow the on-screen prompts.

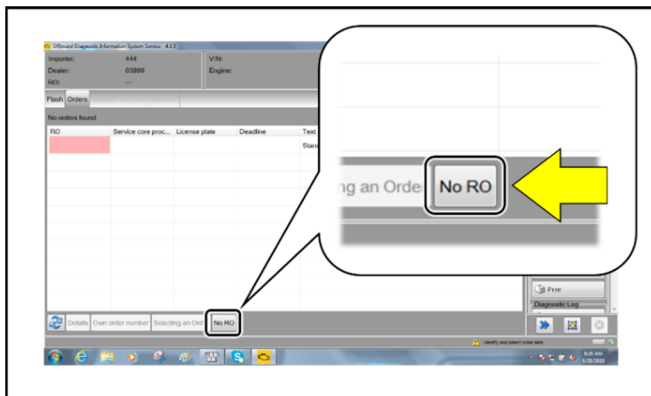
- Select “No RO”.

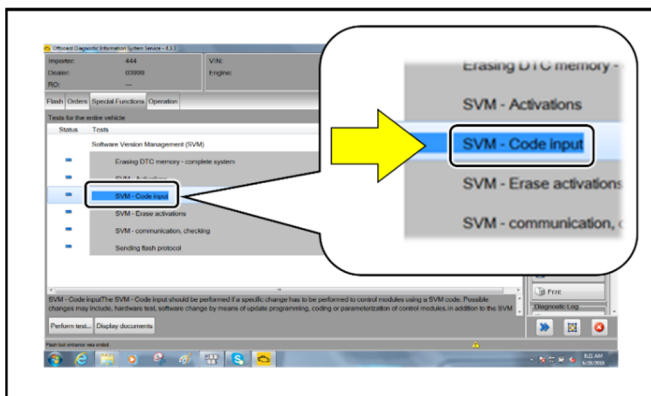
- Highlight “SVM – Code Input”.

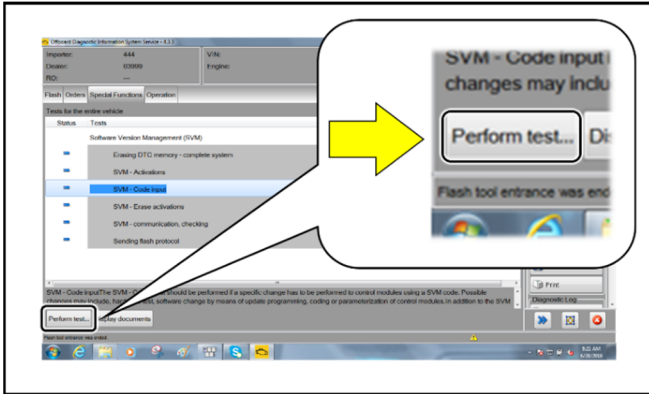
- Select “Perform test”.

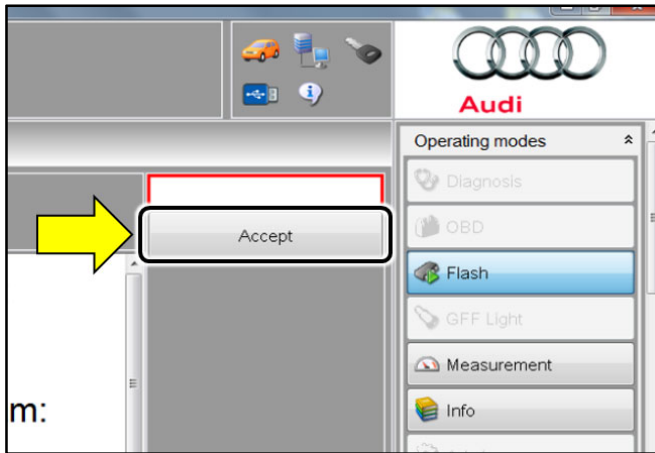
- Enter the corrective action code (SVM code) as listed below.

- Select “Accept” <arrow>.
- Follow the on-screen prompts.

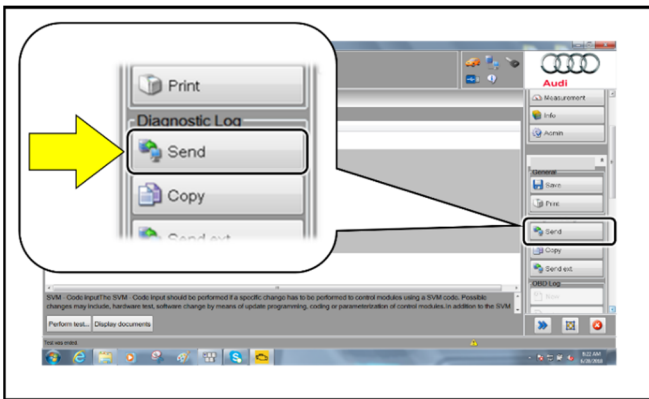
- After receiving confirmation that the flash completed successfully, select “Send” <arrow> to send the diagnostic protocol online.
- Follow the on-screen prompts.

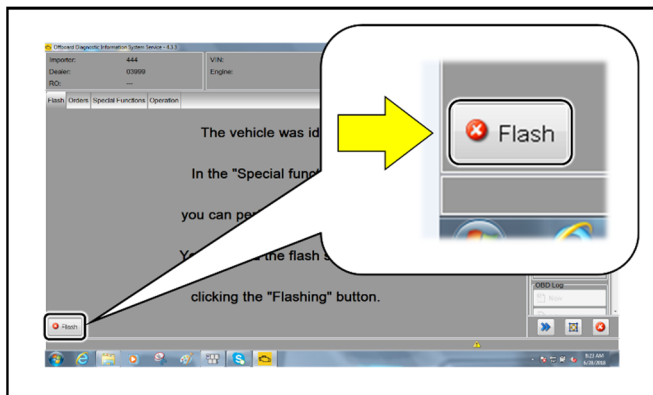
- Click “Flash” <arrow> to exit the flash session.
