Service Action

Code: 96G2

Subject	Gateway Control Module Software																			
Release Date	November 2, 2021																			
Affected Vehicles

Repair Instruction

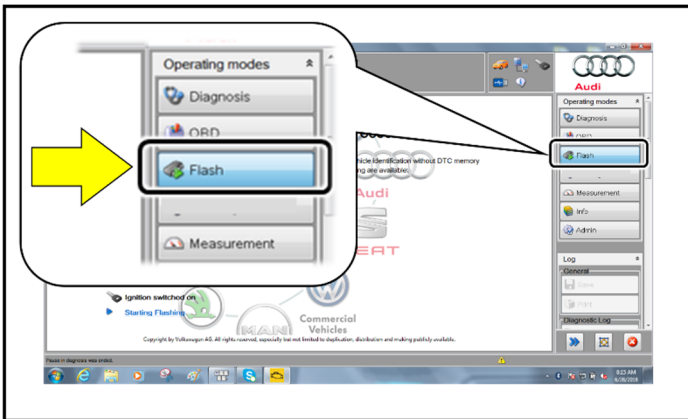
- From the home screen of the scan tool highlight “Flash” <1>.
- Follow the on-screen prompts.

Operating mode “Flash” must be used. Performing this update using “Diagnosis” (Guided Fault Finding) could result in non-payment of the claim.

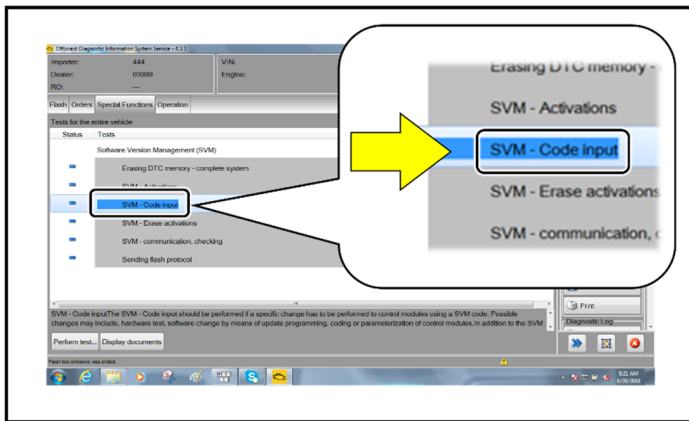
- Highlight "SVM - Code Input".
