# Service Action

## Code: 96G5

<b>Subject</b>	<b>Gateway Control Module Software</b>															
<b>Release Date</b>	November 2, 2021															
<b>Affected Vehicles</b>

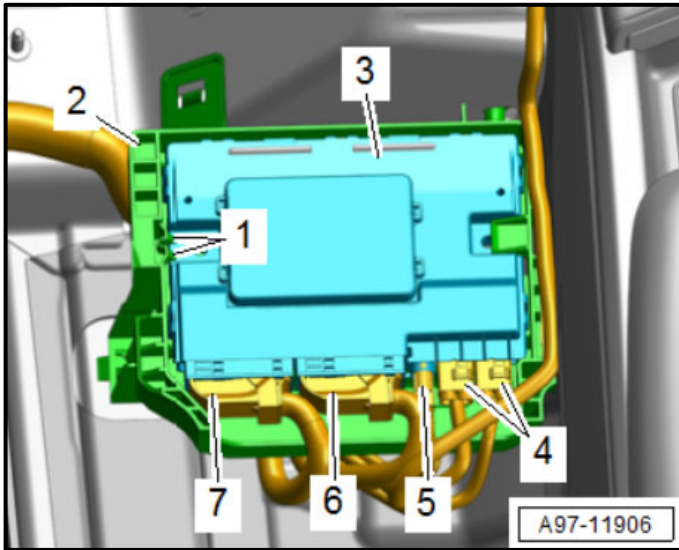
### Access gateway control module (Q7 – Criteria 02,03):

- Remove driver front seat:
  - See ELSA Repair Manual: *Repair manual > Body > Body Interior > 72 Seat Frames > Front Seats > Front Seat, Removing and Installing*
- Lift the front carpet at the transition to the rear carpet to gain access to the gateway control module.
- DO NOT disconnect gateway at this time.

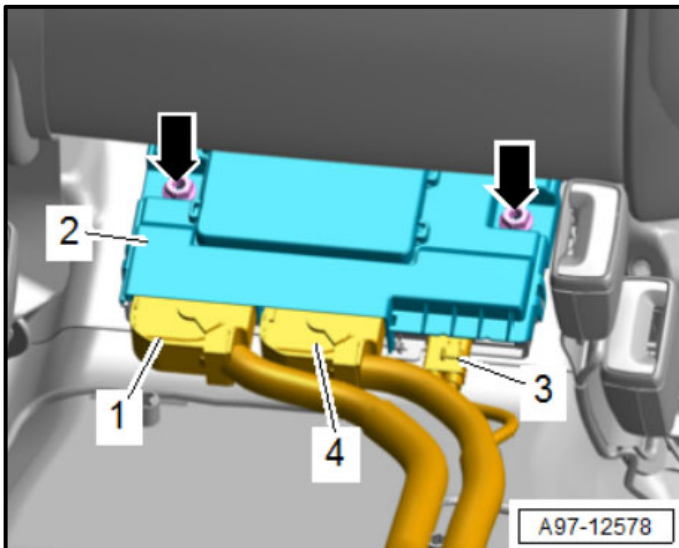
### Access gateway control module (A4 Variants – Criteria 01,03):

- Remove rear seat bench:
  - See ELSA Repair Manual: *Repair manual > Body > Body Interior > 72 Seat Frames > Rear Seats > Bench Seat/Single Seat, Removing and Installing*
- DO NOT disconnect gateway at this time.

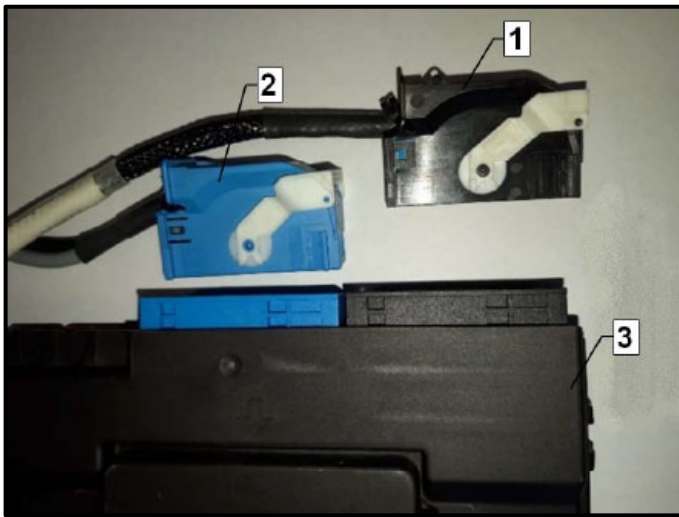
- Turn off the ignition.
- Unplug black supply connector <1> and blue communication connector <2> from control unit <3>.

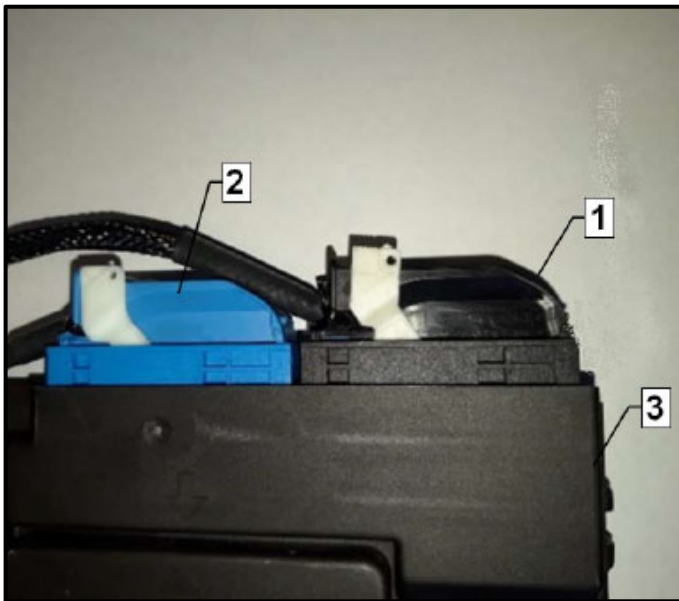
- Connect the blue communication connector <2> from the -VAS601013- kit to the control unit <3> and the USB connector at the other end to the diagnostic tester.
- Connect the black supply connector <1> to the control unit <3>.
- Switch on ignition.

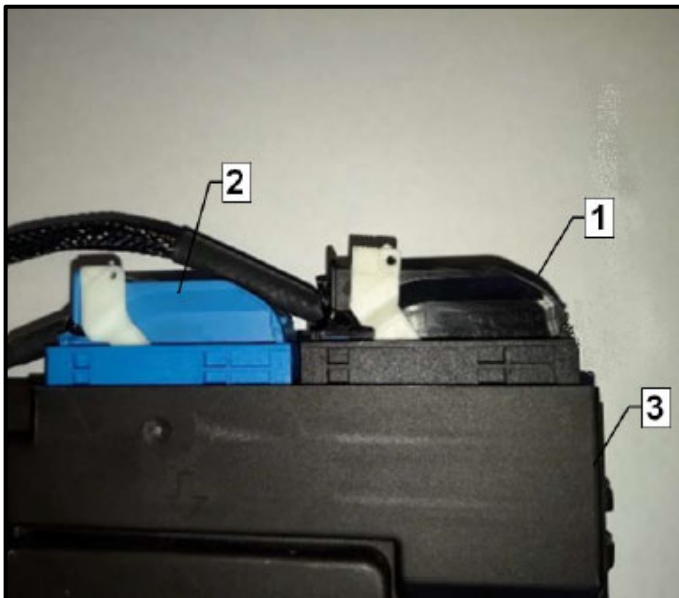
- Remove the -VAS601013- adapter cable.
- Reconnect the gateway to the vehicle.
- Switch the ignition on.
