GROUP	MODEL
ELE	2019MY Stinger (CK) 2020MY Soul (SK3), Sportage (QL)
NUMBER	DATE
239 (Rev 1, 11/08/2021)	June 2021

SUBJECT: **SERVICE ACTION: ECM OBD CODE DISPLAY
LOGIC IMPROVEMENT (SA474)**

This bulletin provides the procedure to update the software logic of the Engine Control Module (ECM) system on some 2019MY Stinger (CK) vehicles equipped with the 2.0L T-GDI engine and 8AT transmission, 2020MY Soul (SK3) vehicles with 2.0L MPI engine and 6MT transmission, and 2020MY Sportage (QL) vehicles with 2.4L GDI engine and 6AT transmission, in order to improve OBD authentication code display logic. Apply the improved logic to the ECM system using the KDS ECU Upgrade function as described in this bulletin. For confirmation that the latest reflash has been applied to a vehicle you are working on, verify the ROM ID using the table on page 3 of this bulletin. Before conducting the procedure, verify that the vehicle is included in the list of affected VINs.

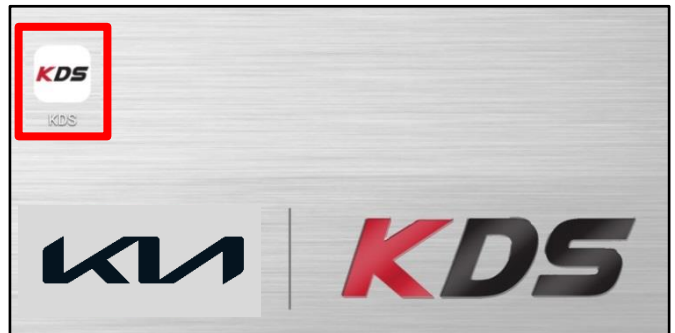
2. With the ignition ON, turn ON the KDS tablet. Select 'KDS' from the home screen.

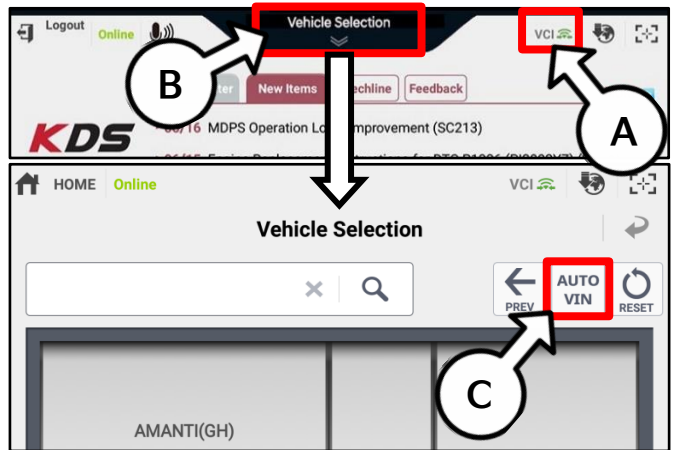
3. Confirm communication with VCI (A) and then configure the vehicle (B) using the 'AUTO VIN' (C) feature.

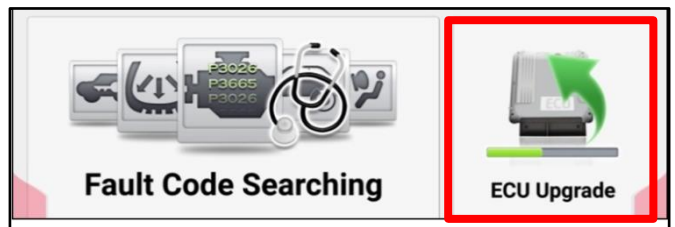
4. Select 'ECU Upgrade'.

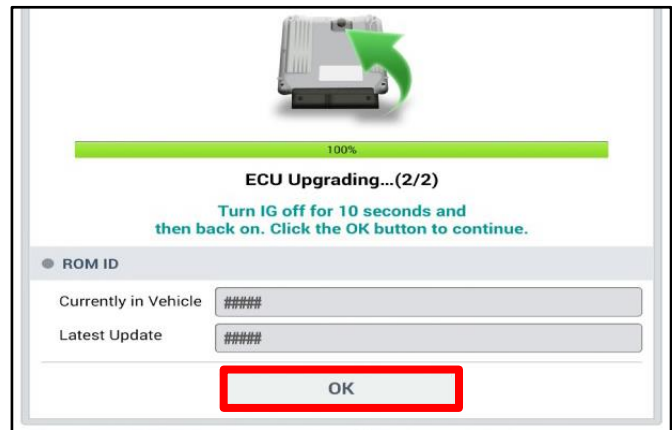
- When instructed on the KDS, turn the ignition OFF for ten (10) seconds then back on. Select 'OK' to continue.

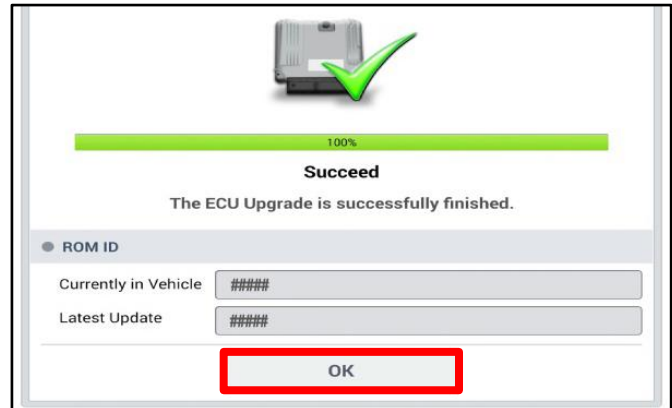
- Once the upgrade is complete, select 'OK' to finalize the procedure.

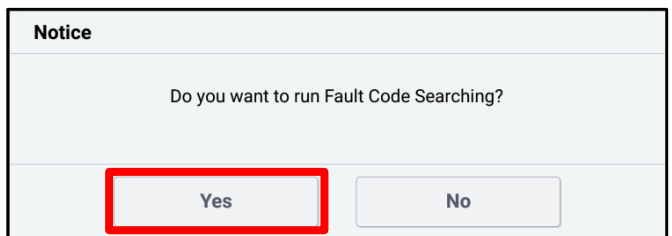
- When prompted, select 'YES' to check for Diagnostic Trouble Codes (DTC) and erase any DTCs stored such as EPS, ESC, and TPMS that may have been set during the upgrade.
