## Product Improvement: Multi-Model 3G OTA TCU Software Update

In February of 2022, the 3G network will no longer support the in-vehicle services that the vehicle has previously supported. The Telematics Control Unit (TCU) using the Over the Air (OTA) update is required to connect to the VoLTE network to continue communications.

Update the TCU software using the OTA update method.

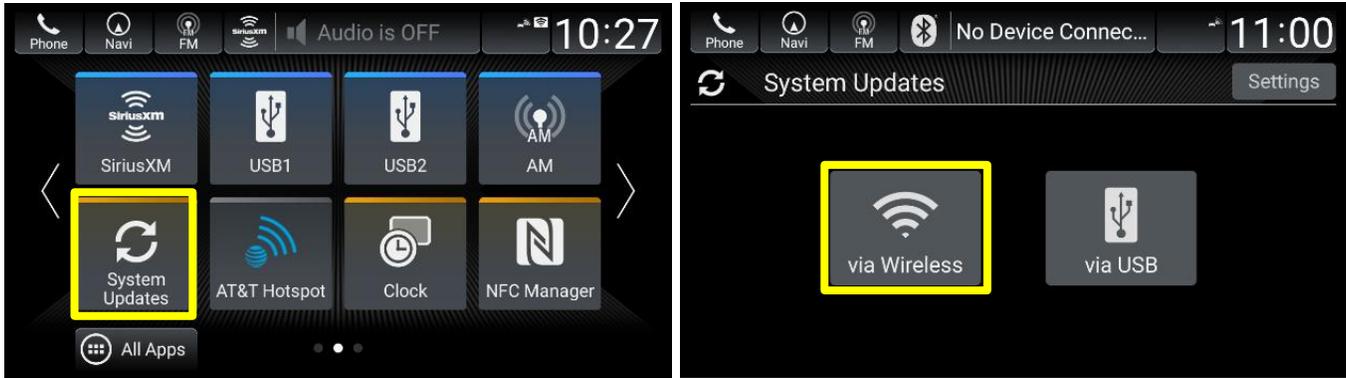
1. To complete the update, go to the HOME screen, select **System Updates**, and when the download is complete, select **via Wireless**.

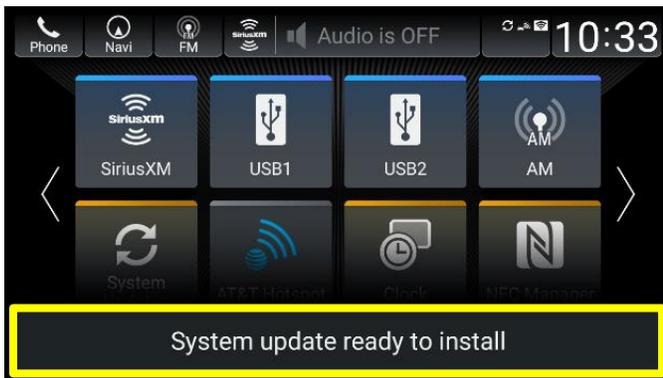
2. When the download is complete, **System update ready to install** will appear.

NOTE: In some instances, the download process may have already occurred. In this case, proceed to step 3.

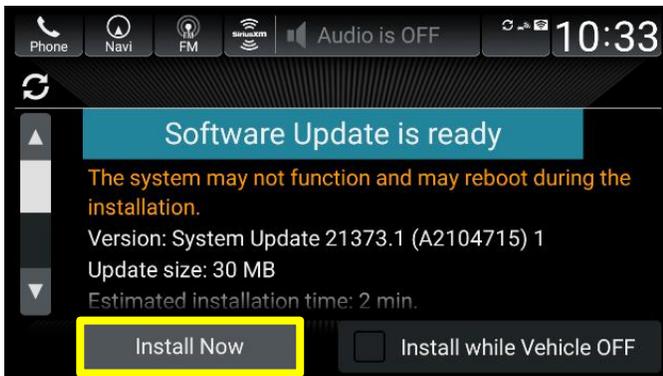
3. Select **Install Now**.

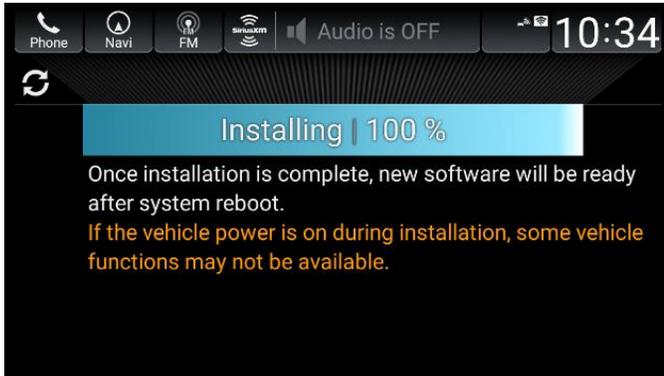
- The first part of the update will start. The Display Audio **Installing** update process will begin, this takes 2–5 minutes to complete.

NOTE: The system will reboot once the progress bar reaches 100 percent.

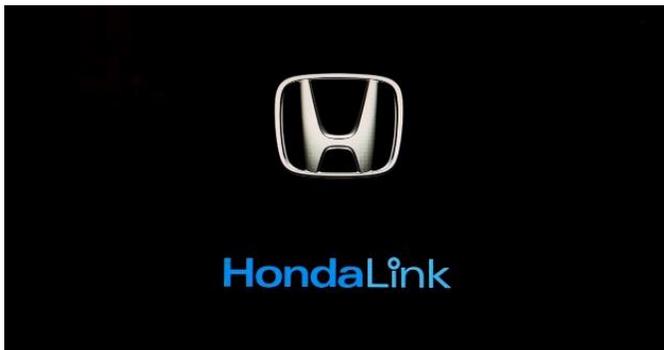
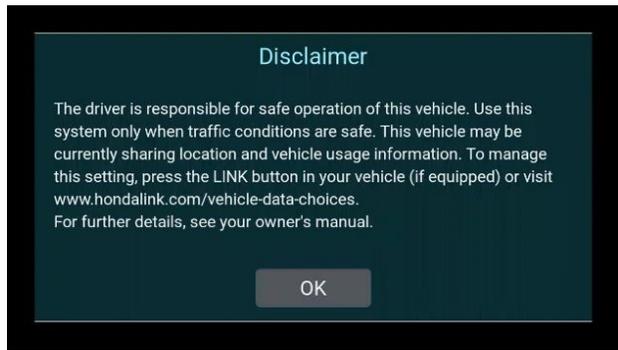
- Wait for the HondaLink and Disclaimer screens to appear and select **OK**.

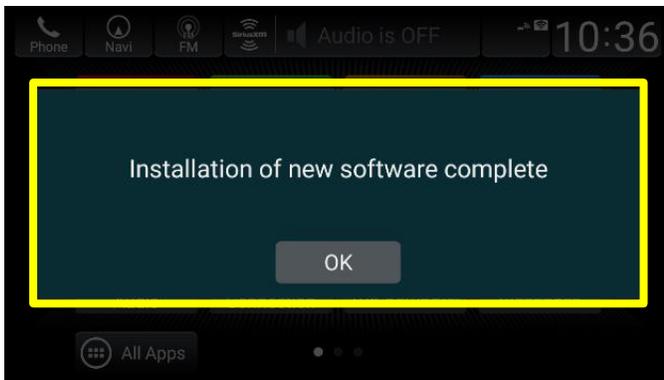
- Once the update completes, you will see **Installation of new software complete**, then select **OK**.

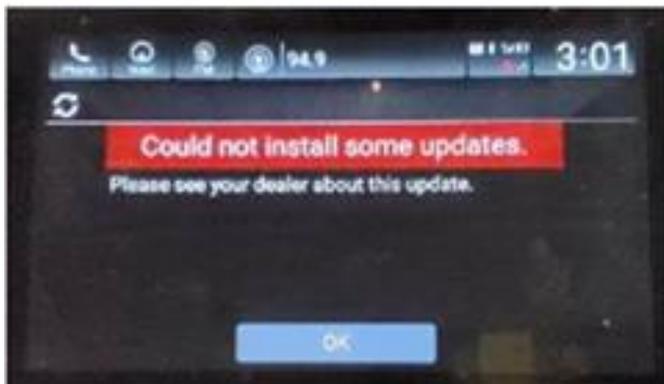
NOTE: If you see **(Could not install some updates.)** during the update, start from Step 1 to repeat the process.

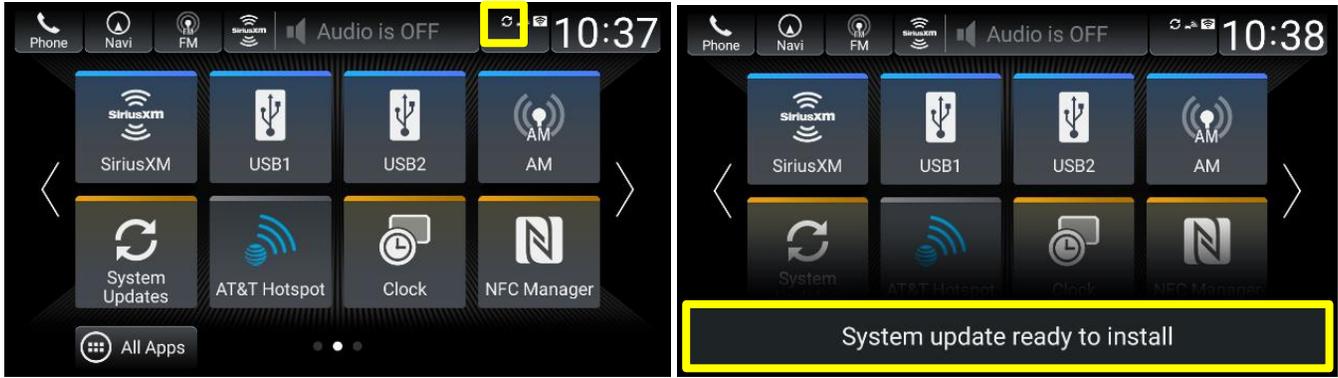
- After selecting **OK**, the system will start the second part of the update. Wait for **System update ready to install**. This does not immediately occur, this may take about 5–10 minutes.

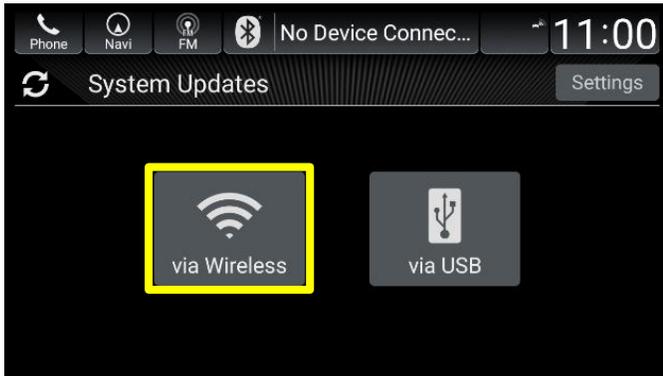
NOTE: If **System update ready to install** does not appear, manually check for the second update by selecting **System Updates**, via **Wireless**. The download process will begin.

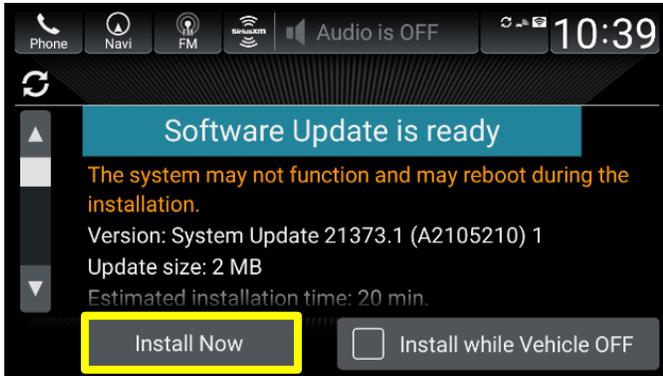
- From the HOME screen select **System Updates**, to verify software update is ready. Select **Install Now**.

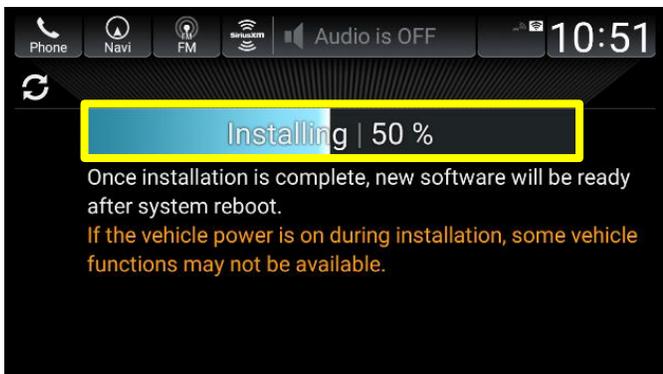
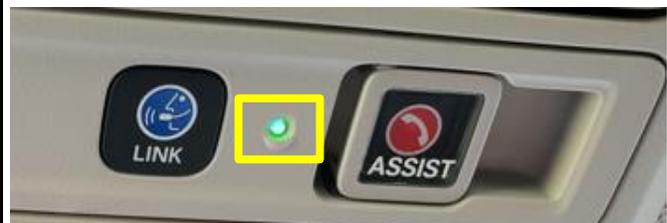
- The second part of the update will start. The TCU update process takes 15–25 minutes to complete depending on cellular signal strength.

NOTE: The installing progress bar will count to 100% and the LED indicator located in the dome light console will blink.

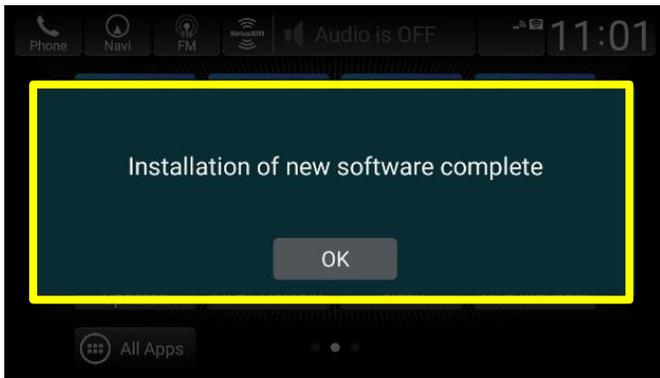
10. Once the update completes, you will see **Installation of new software complete**, then select **OK**.

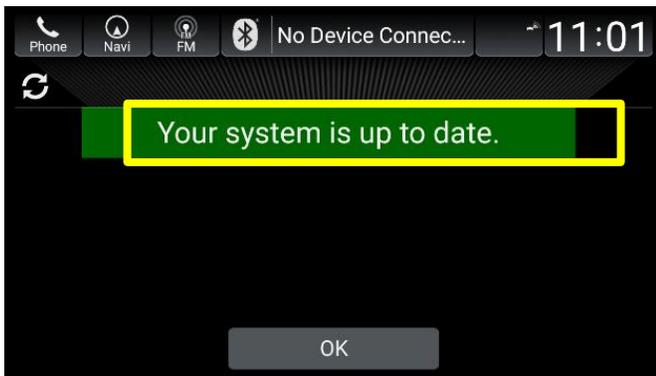
NOTE: If you noticed only one update occurred following the reprogramming, select **System Updates, via Wireless** and check if the system returns with **Your system is up to date**. One of the two components may have previously been updated, refer to the **SOFTWARE VERSION VERIFICATION – Display Audio and TCU** section to confirm software versions.

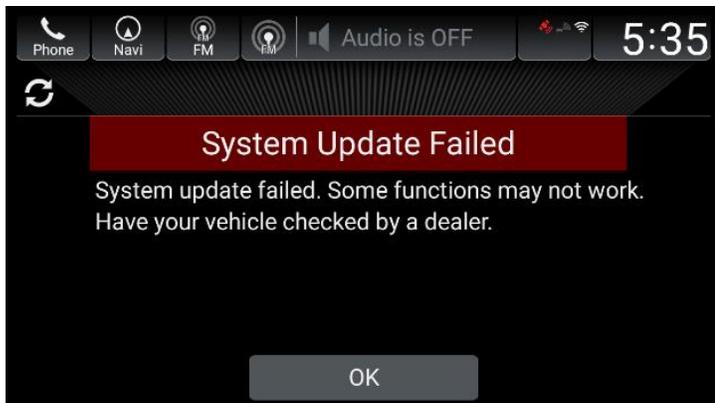
NOTE: If you see **System Update Failed** during the update process, the software update may have failed due to poor cellular signal.

Make sure the vehicle is in an open-air area to get optimal cellular signal strength.

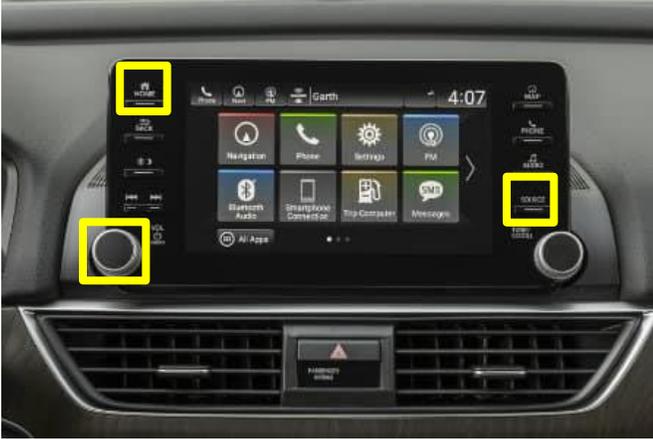
1. For Accord models press **HOME**, **POWER**, and **SOURCE** at the same time.

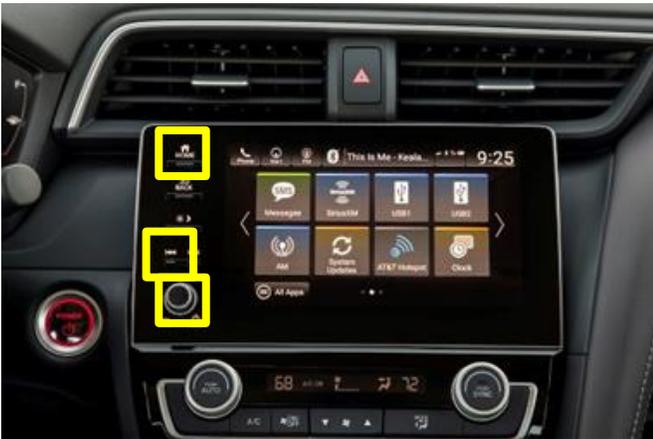
For Insight models press **HOME**, **REWIND**, and **Power** at the same time.

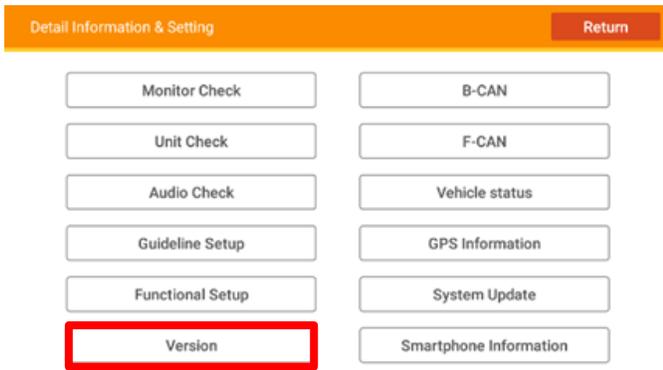
3. Select **Version**.

2. From Diagnostics Menu screen, select **DETAIL INFORMATION & SETTING**.

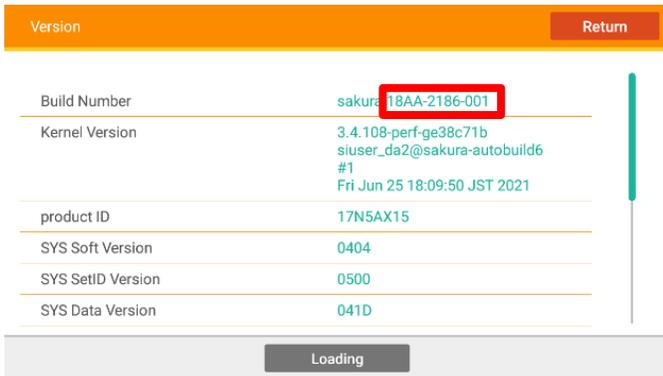
4. In the Version screen note the **Build Number**.

Model	Part Number	Software Version
Accord	39540-TVA-A57	18AA-2186-001
Insight	39540-TXM-A83	18AE-2186-001

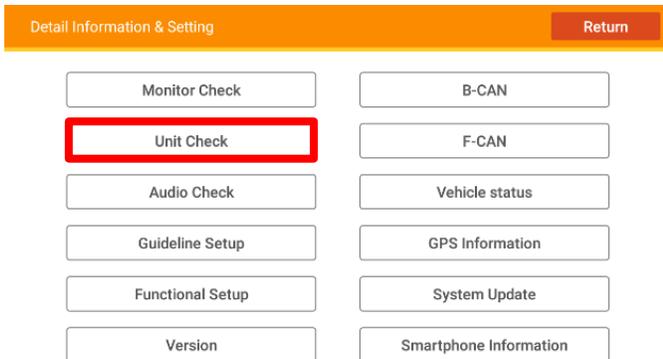
5. Select **Return** to be brought back to the Detail Information & Setting screen, then select **Unit Check**.

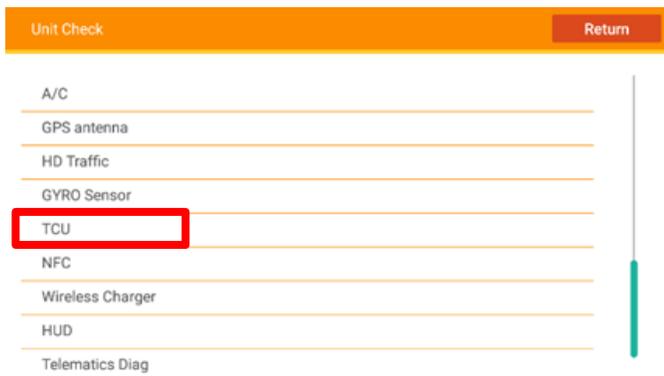
6. Scroll down to Select **TCU**.

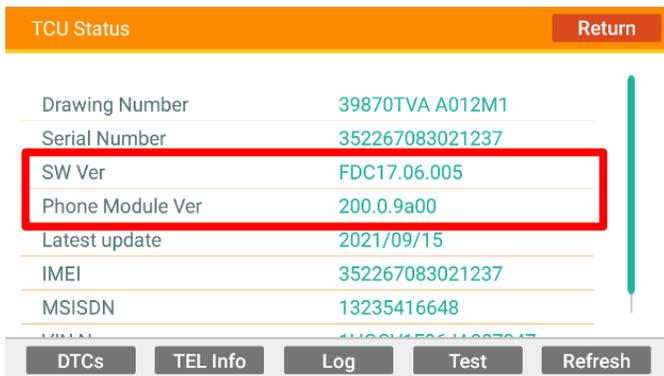
7. Confirm the TCU SW as Follows:

TCU Software Version:

Model	Part Number	Software Version	Phone Module Version
Accord	39870-TVA-A01	FDC17.06.005	200.0.9a00
Insight	39870-TXM-A01	FDC17.09-004	200.0.9a00

NOTE: If software versions do not match, it is recommend to replace TCU. Follow the **REPAIR PROCEDURE - TCU REPLACEMENT**
