DCM Reset and Firmware Update (LG)

YEAR(S)	MODEL(S)	ADDITIONAL INFORMATION
2021	Avalon, Avalon HV, Corolla, Corolla HV, Sienna HV, Venza HV	
2020 - 2021	Camry, Camry HV, Corolla Hatchback, RAV4, RAV4 HV

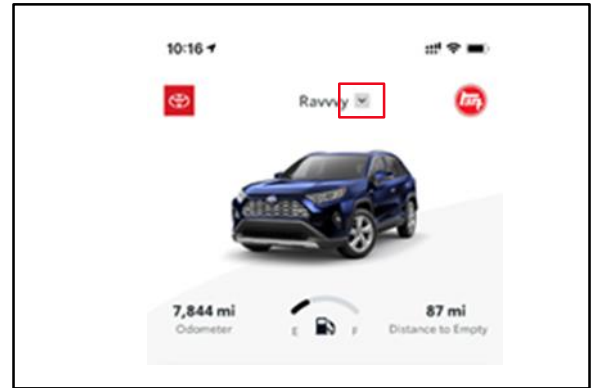
Figure 9.

- Click on the arrow by the vehicle name/nickname.

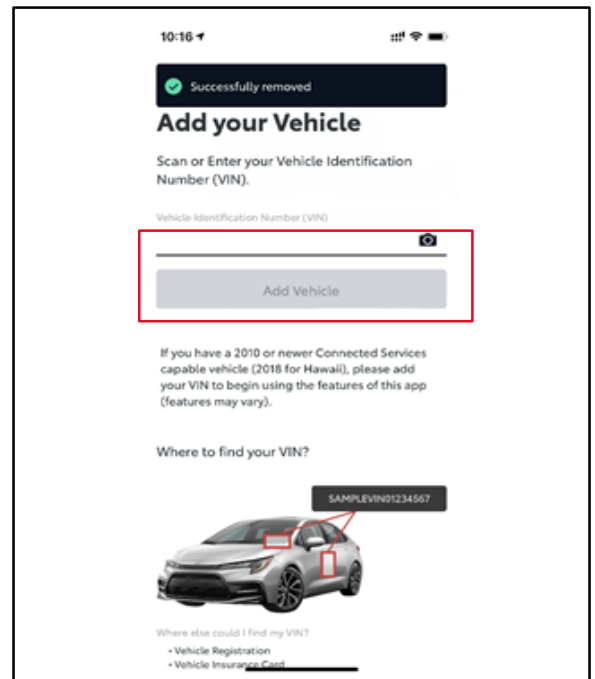
Figure 11.

- Click on Add Vehicle to perform the enrollment again.
