Service Action

Code: 93M3

Subject Drivetrain Software

About this Service Action A software update to improve range is being carried out on Audi e-tron vehicles.

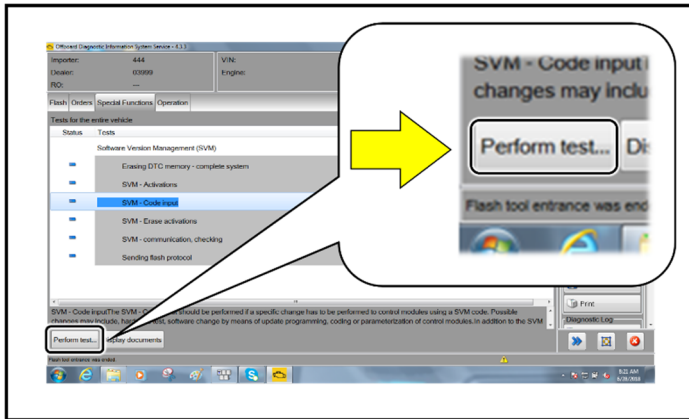
- Select “Perform test”.
