Service Action

Code: 93M3

Subject	Drivetrain Software																			
Release Date	November 16, 2021																			
Affected Vehicles

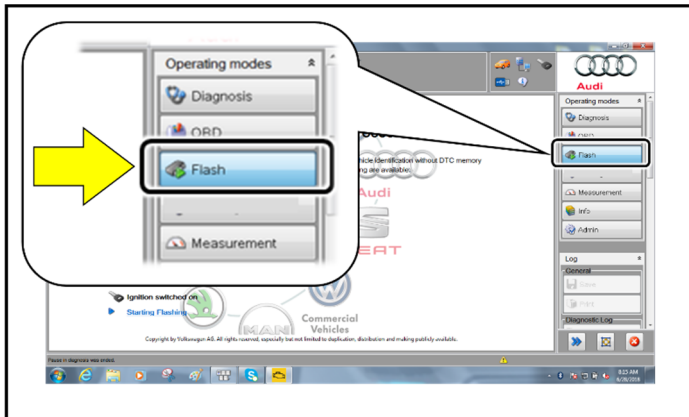
- From the home screen of the scan tool highlight “Flash” <1>.
- Follow the on-screen prompts.

Operating mode “Flash” must be used. Performing this update using “Diagnosis” (Guided Fault Finding) could result in non-payment of the claim.

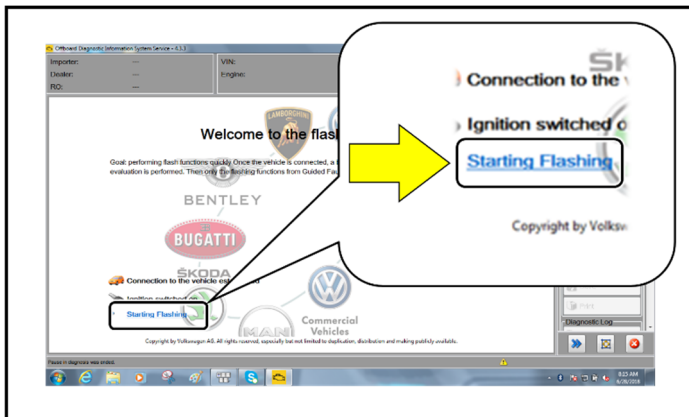
- Select “Starting Flashing” and follow the on-screen prompts.

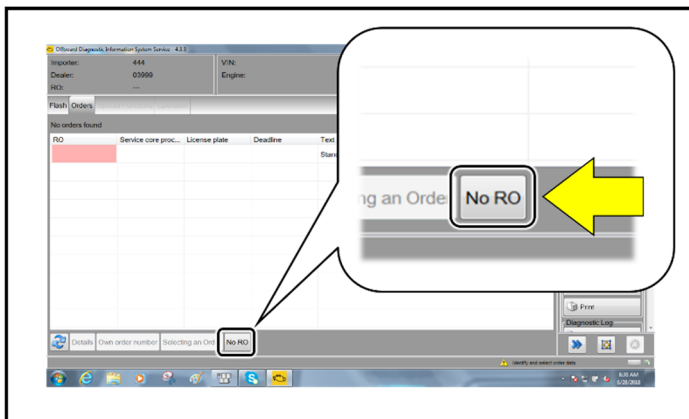
- Select “No RO”.

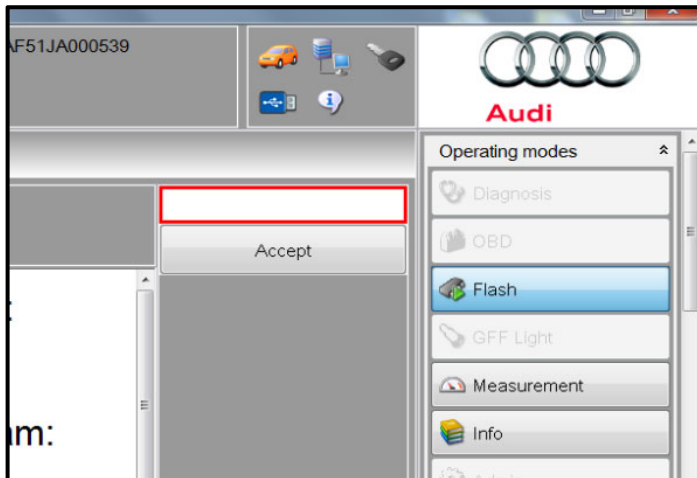
- Enter the corrective action code (SVM code) as listed below.

93M3A053

- Select “Accept”.
- Follow the on-screen prompts.

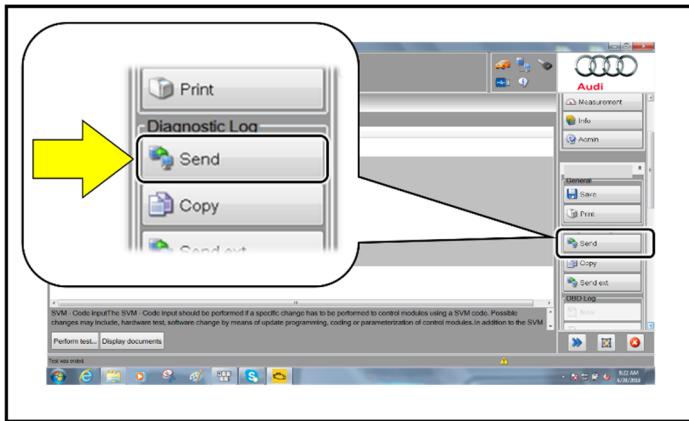
- After receiving confirmation that the flash completed successfully, select "Send" to send the diagnostic protocol online.
- Follow the on-screen prompts.

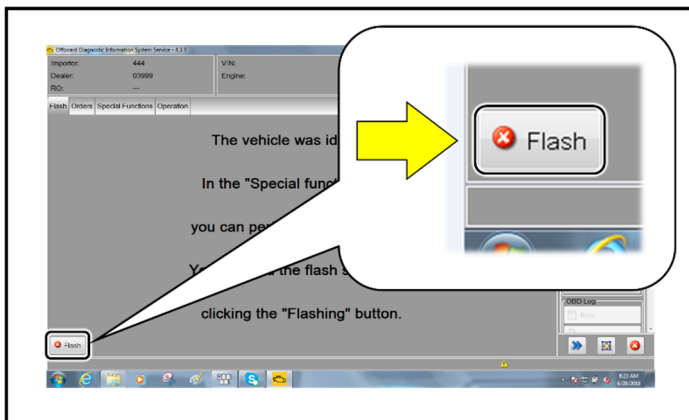
- Click "Flash" to exit the flash session.
- Proceed to Section C.**
