GROUP
Product Improvement

NUMBER
PI1803Y/Z (Rev 5, 11/04/2021)

PRODUCT IMPROVEMENT CAMPAIGN

**ENGINE REPLACEMENT INSTRUCTIONS
FOR DTC P1326 (PI1803Y/Z)**

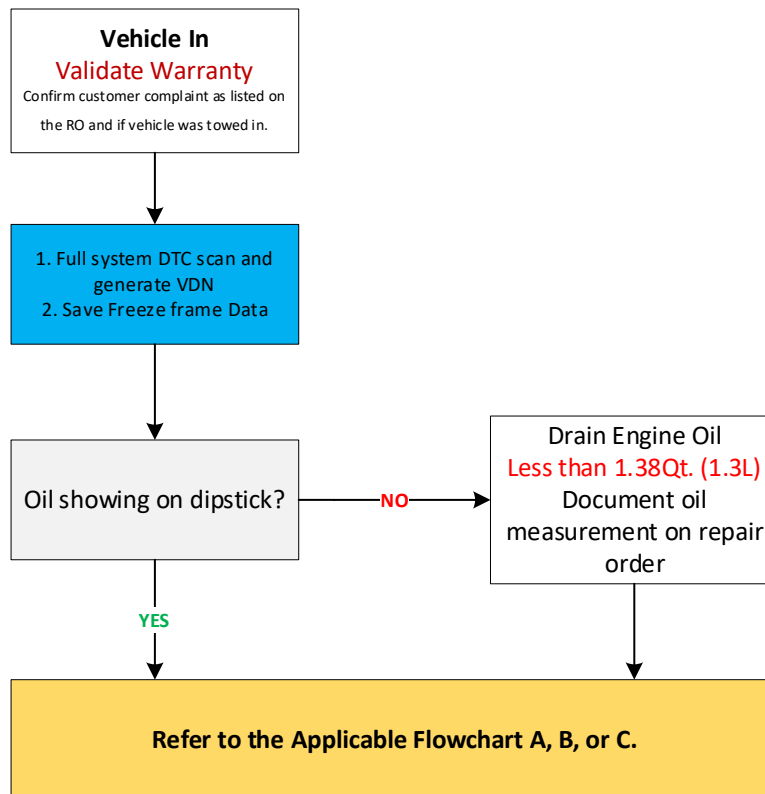
Main Flowchart:

Follow the applicable Main Flowchart below upon documenting customer complaint. Then follow the corresponding flowchart for one (1) of the three (3) following concerns:

- A. DTC P1326 Stored... (Page 3) - NO Engine Noise
- B. ENGINE NOISE... (Page 4)
- C. ENGINE, NO CRANK... (Page 5)

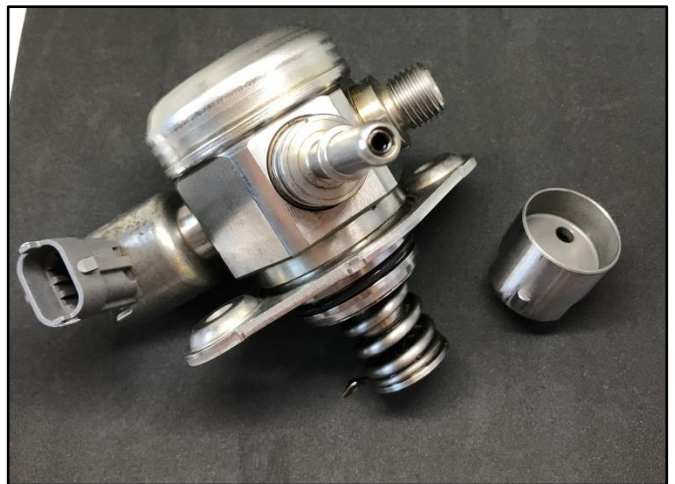
High Pressure Pump & Roller Tappet:

- Refer to [TSB ENG083](#) for special attention and handling procedures of GDI-specific components.
- When installing the high pressure pump and roller tappet onto the new engine, apply engine oil to the roller tappet, and O-rings of the high pressure pump.

**Tightening torques of pump bolts:
9.4 – 10.9 lb.ft (12.8 – 14.7 N.m,
1.3 – 1.5 kgf.m)**

**Tightening torques of pipe flare nut:
19.5 – 23.9 lb.ft (26.5 – 32.4 N.m,
2.7 – 3.3 kgf.m)**

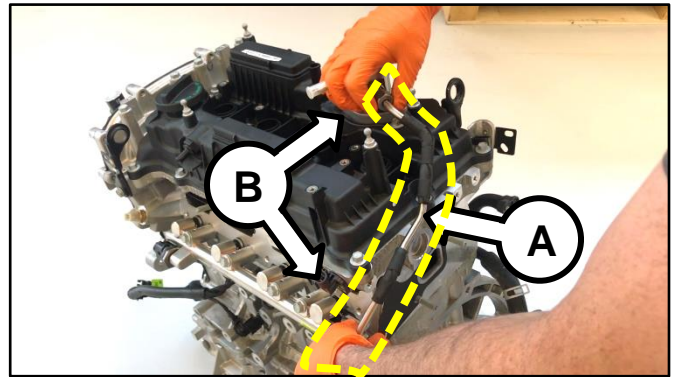
1. Properly position the new fuel pipe (A) and then hand-tighten both flare nuts (B).

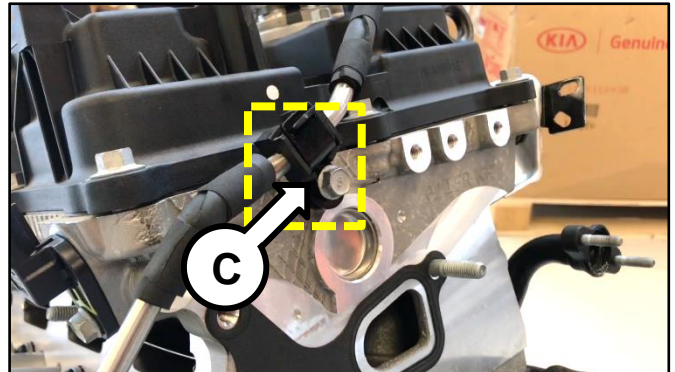
2. Install the pipe retaining bracket and bolt (C) and torque to specifications.

Tightening torque (bracket bolt):
 5.8 – 8.7 lb.ft (7.8 – 11.8 N.m,
 0.8 – 1.2 kgf.m)

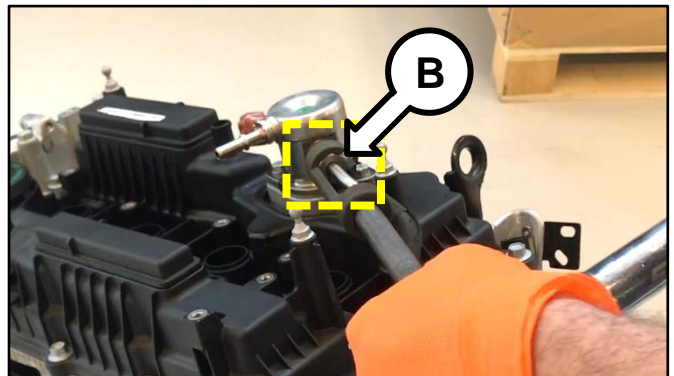
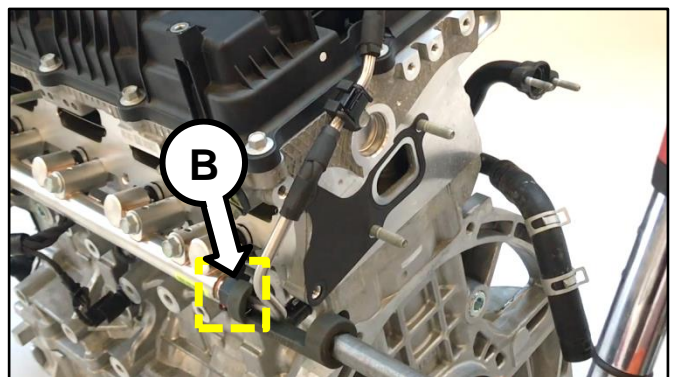
3. Using a click-type/electronic torque wrench and SST 09314-3Q100, torque both flare nuts (B) to specifications.

Tightening torque (flare nuts):
 19.5 – 23.9 lb.ft (26.5 – 32.4 N.m,
 2.7 – 3.3 kgf.m)

The high pressure fuel pipe bracket and bolt must be installed **AND** properly torqued prior to torquing the high pressure fuel pipe flare nuts.

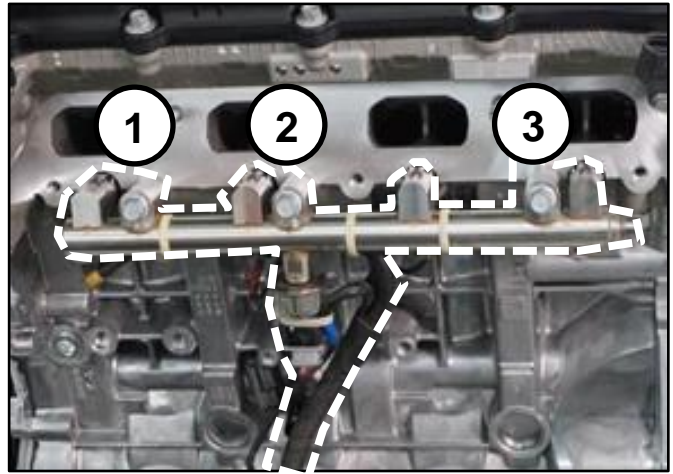
Delivery Pipe:

- Refer to [TSB ENG083](#) for special attention and handling procedures of GDI-specific components.
- Prior to installing the delivery pipe, be sure to replace all of the injector O-rings and injector retainers.
- Prior to installing the delivery pipe, apply engine oil to the injector O-rings.
- When installing the delivery pipe, use caution not to damage the tip of the injector.
- Be sure to replace the delivery pipe retaining bolts and torque them in the sequence shown.

**Tightening torque of bolts:**

**13.7 – 17.4 lb.ft (18.6 – 23.5 N.m,
1.9 – 2.4 kgf.m)**

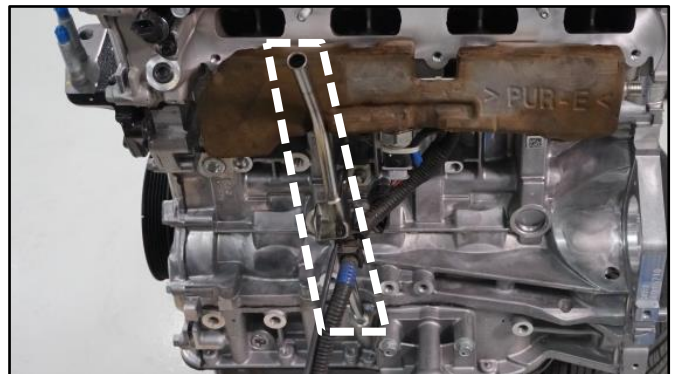
Dipstick Tube & Dipstick:

- Prior to installing the new tube, lubricate the o-ring located at the bottom of the tube with engine oil.
- Install the red dipstick included in Service Kit I.

Tightening torque of bolt:

**5.8 – 8.7 lb.ft (7.8 – 11.8 N.m,
0.8 - 1.2 kgf.m)**

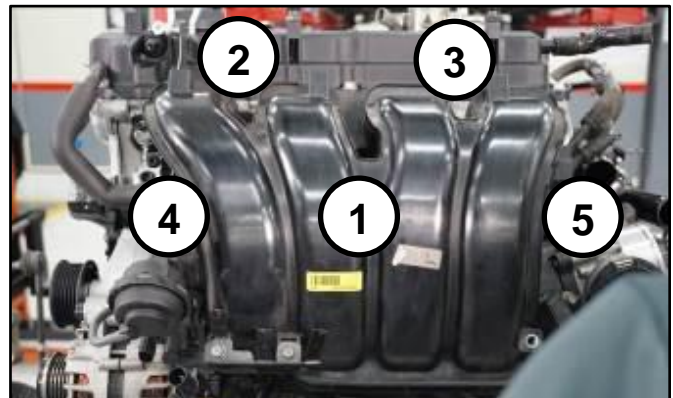
**Intake Manifold:**

- Prior to installation, replace the intake manifold gaskets.
- Torque bolts in the sequence shown.

Tightening torque of bolts:

**13.7 – 17.4 lb.ft (18.6 – 23.5 N.m,
1.9 – 2.4 kgf.m)**

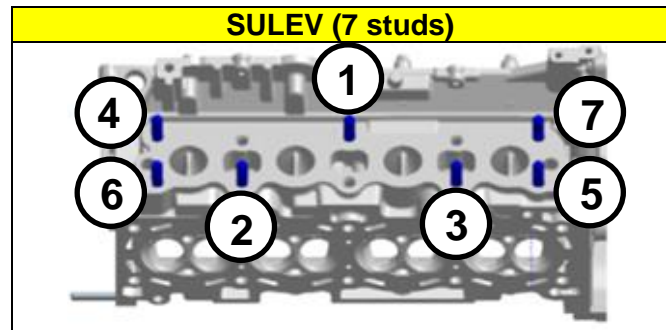
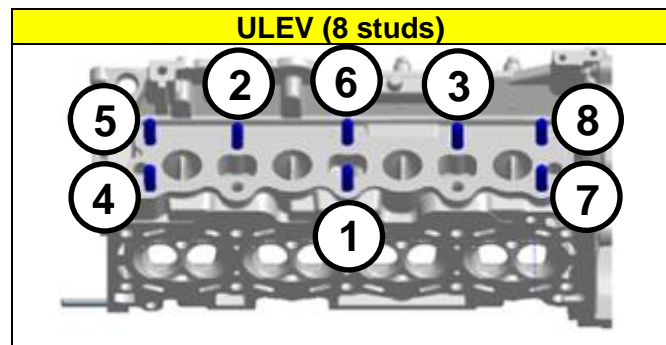
- All engines supplied under this Product Improvement Campaign have the exhaust manifold studs configured for SULEV engines.
- Using the pictures to the right, check the exhaust manifold stud location and quantity. Relocate as required for ULEV engines and obtain one (1) extra from the removed engine.
- Prior to installation, replace the exhaust manifold gasket and front muffler gasket.
- Torque nuts in the sequence shown.

Tightening torque of nuts:

36.2 – 39.7 lb.ft (49.0 – 53.9 N.m,
5.0 – 5.5 kgf.m)

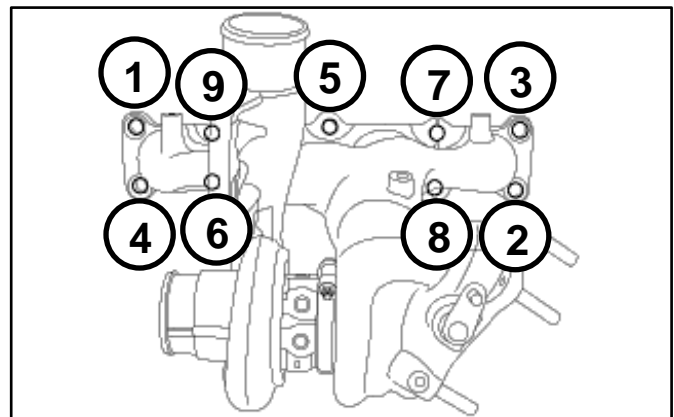
- On Turbo engines, replace the turbocharger oil feed line and gaskets.

Tightening torque of oil feed line bolt:
8.7 – 13.0 lb.ft (11.8 – 17.7 N.m,
1.2 – 1.8 kgf.m)

Tightening torque of oil feed line nuts:
5.8 – 8.7 lb.ft (7.8 – 11.8 N.m,
0.8 – 1.2 kgf.m)

Tightening torque of oil drain line nuts and bolts:
5.8 – 8.7 lb.ft (7.8 – 11.8 N.m,
0.8 – 1.2 kgf.m)

- Torque exhaust manifold nuts in the sequence shown.

Tightening torque of nuts:

36.2 – 39.7 lb.ft (49.0 – 53.9 N.m,
5.0 – 5.5 kgf.m)

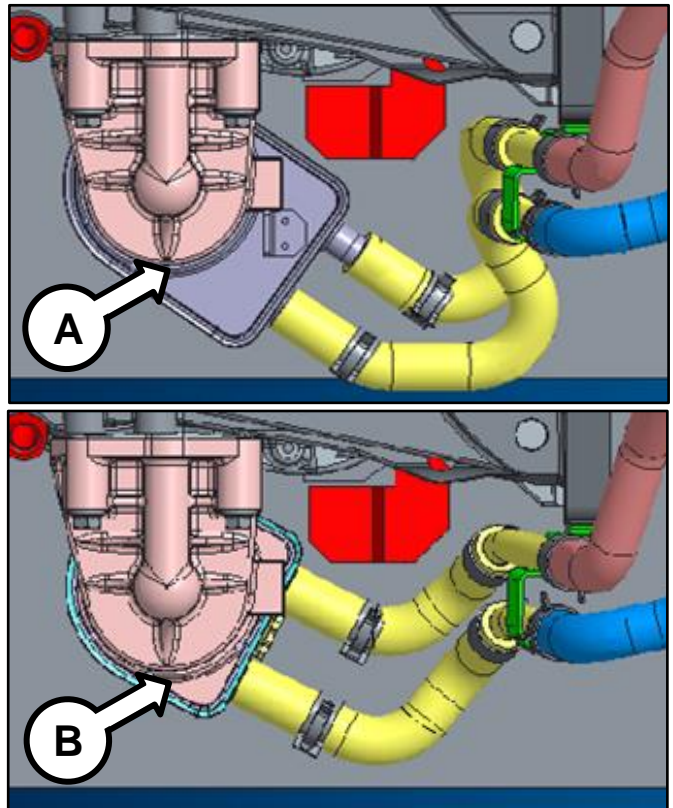
Oil Cooler Tube Assembly:

New engines may be supplied with a different oil cooler. Use steps below to determine the need for a replacement oil cooler tube assembly.

- If the new engine's (bigger) oil cooler (A) does not match the old engine's (smaller) oil cooler (B), replace the oil cooler tube assembly with the improved part. See parts table on page 23.
- If the new engine's (bigger) oil cooler (A) matches the old engine's (bigger) oil cooler (A), reuse the old engine's oil cooler tube assembly.
- If the new engine's (smaller) oil cooler (B) matches the old engine's (smaller) oil cooler (B), reuse the old engine's oil cooler tube assembly.

***Oil Cooler Tube assembly replacement is conditional, refer to page 10.**

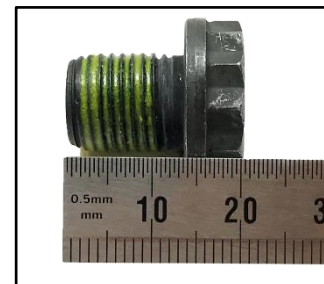
Drive Plate Bolt (A/T)

Drive Plate Bolts:

- Replace all seven (7) drive plate (AT) bolts.

Tightening torque of nuts:

**86.8 – 93.9 lb.ft (117.7 – 125.5 N.m,
12.0 – 13.0 kgf.m)**

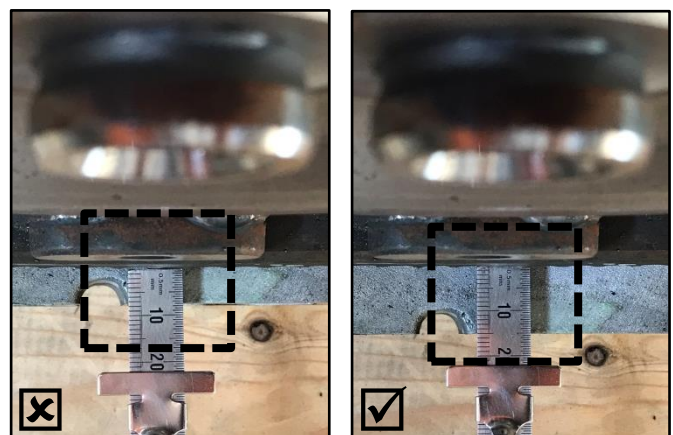
- If the torque converter has moved from the fully inserted position, carefully push inward while rotating the torque converter until it is recessed approximately 9/16 – 5/8" (14 – 16mm) (☑) into the transaxle case when reinstalling the automatic transaxle.

Not Fully Inserted

Fully Inserted

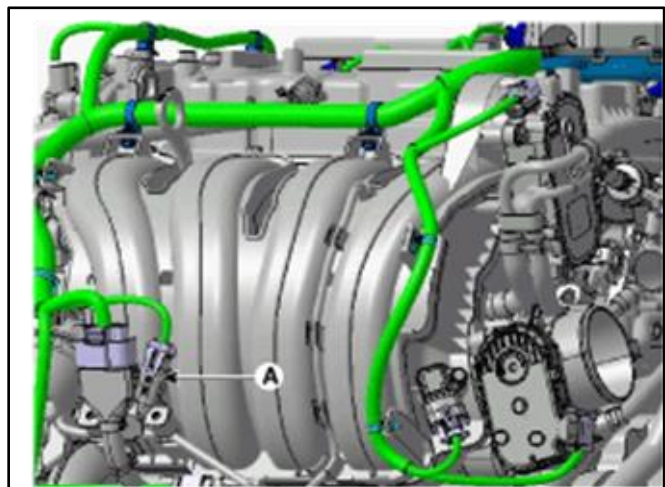
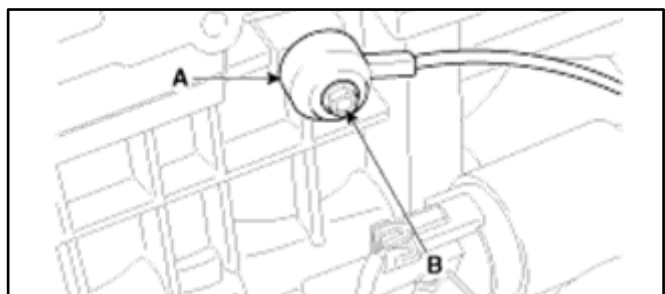
Knock Sensor Replacement:

Disconnect the knock sensor (A) connector.

Loosen the knock sensor (A) retaining bolt (B) and replace the knock sensor.

Torque Specification for bolt (B):

13.7 – 17.4 lb. ft. (18.6 - 23.5 N.m,
1.9 - 2.4 kgf.m)

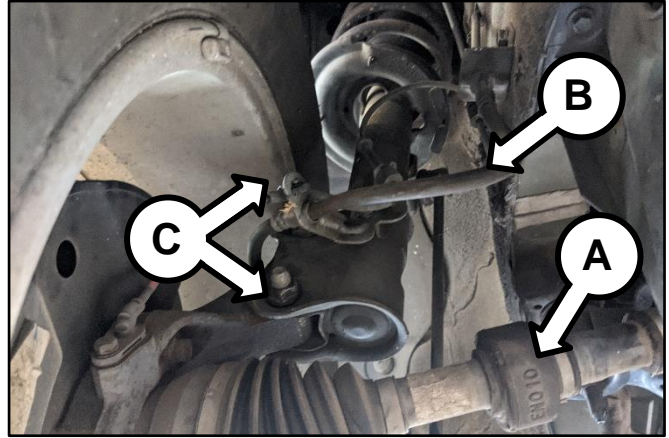
Additional Instructions for AWD (XM) 2.4L models:

1. Remove the right front drive axle (A) by detaching the brake line (B) and removing the bottom knuckle/strut retaining bolts (C).

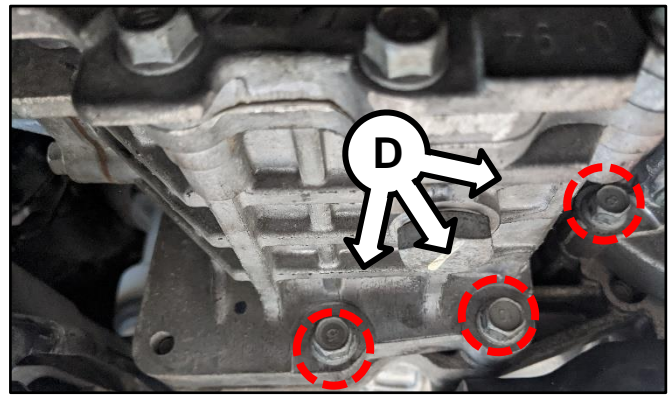
2. Remove the five (5) transfer case retaining bolts (D).

Note: Three (3) located on the bottom.

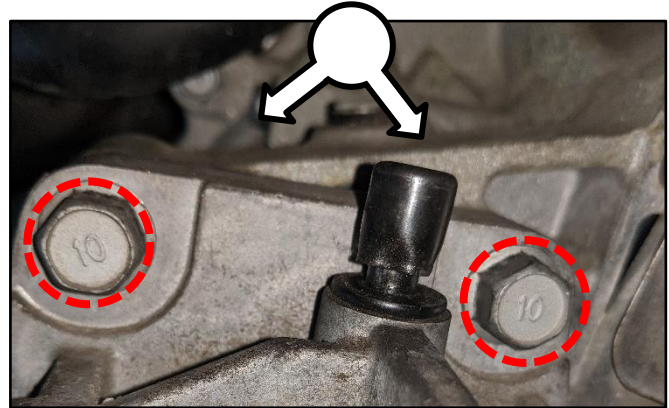
Note: Two (2) located on the top.

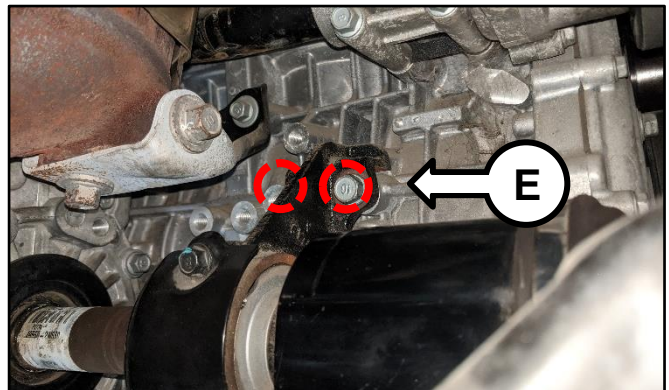
3. Remove the two (2) drive axle bracket retaining bolts (E).

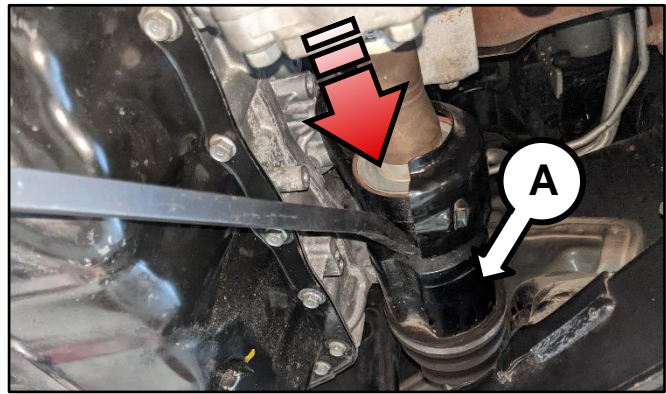
- Using a pry bar and rubber hammer, strike the axle where shown to release the right front drive axle (A).

Remove the right front drive axle (A) and set aside.

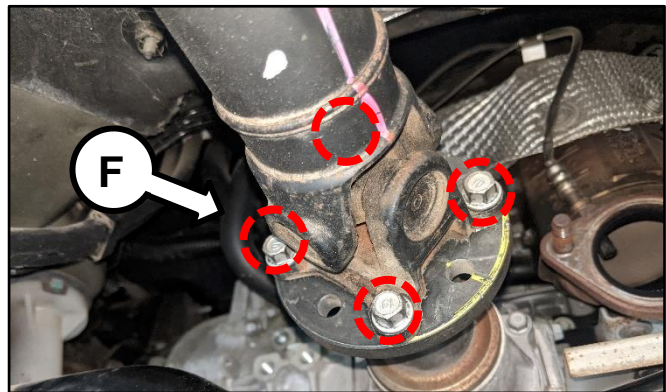
- Remove the four (4) rear driveshaft retaining bolts (F).

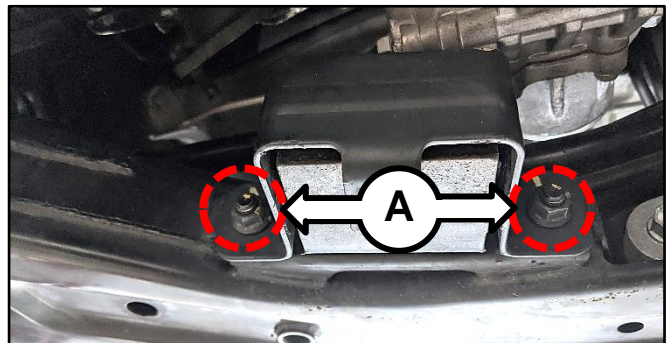
Additional Instructions for AWD (SL) 2.0L-T models:

- Remove the two (2) bottom damper retaining bolts (A).

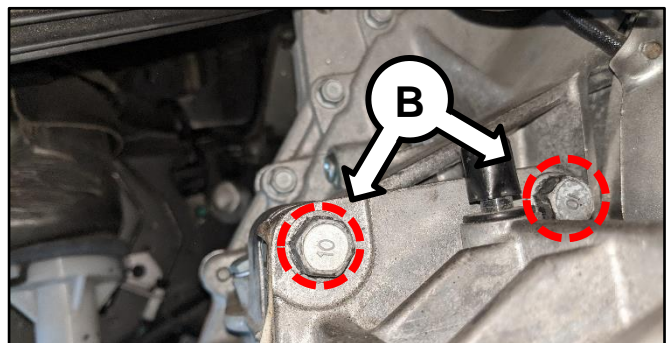
- Remove the five (5) transfer case retaining bolts (B).

Note: Two (2) located on the top.

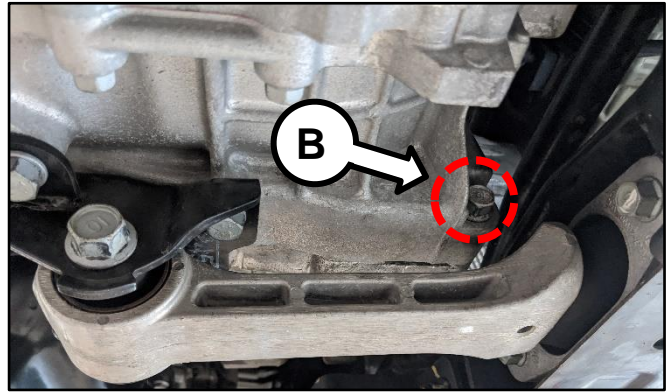
Note: One (1) located on the bottom left.

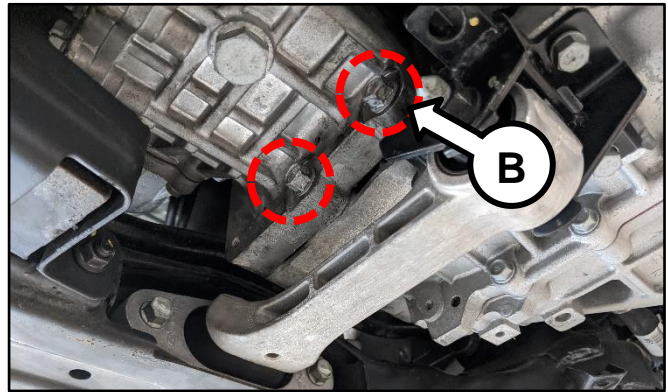
Note: Two (2) located on the bottom right.

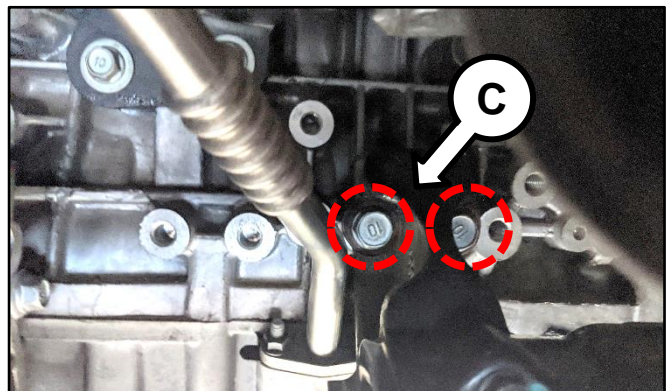
3. Remove the two (2) drive axle bracket retaining bolts (C).

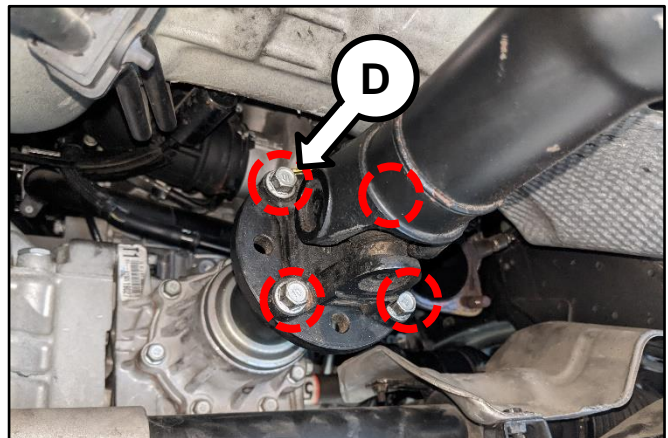
4. Remove the four (4) rear driveshaft retaining bolts (D).

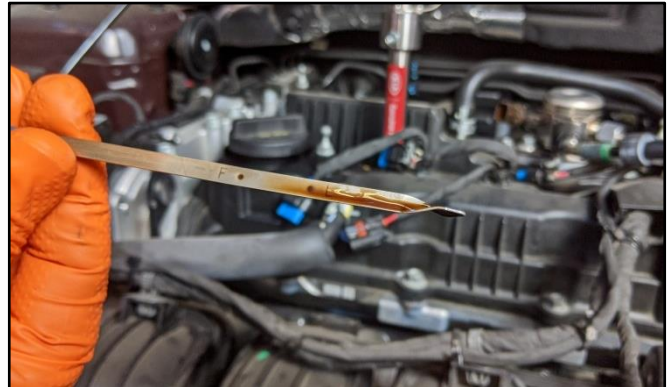
Oil Level Check: (Applies to all Flowcharts)

1. Measure and record oil dip stick level.
2. Note oil dip stick reading on the RO.
3. If no oil is showing on dipstick, proceed to Oil Level Measurement.

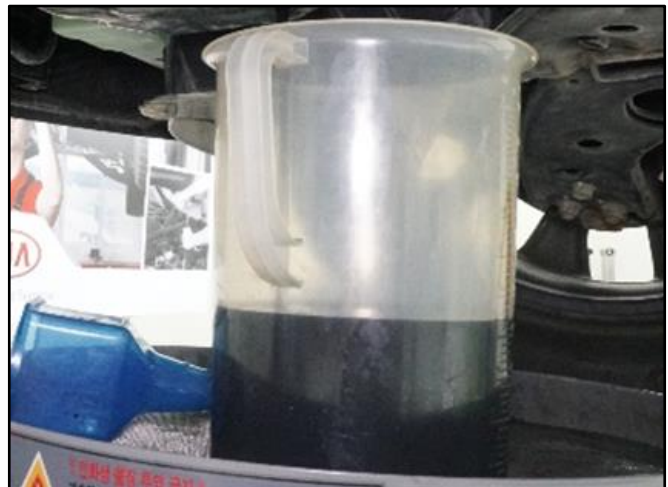
Oil Level Measurement: (Applies to all Flowcharts)

1. Remove oil filler cap, remove oil drain plug and drain oil into the supplied measuring container SST067BUCK and check oil level.
2. Record oil level reading.
3. Take photo of the oil level using KDS.

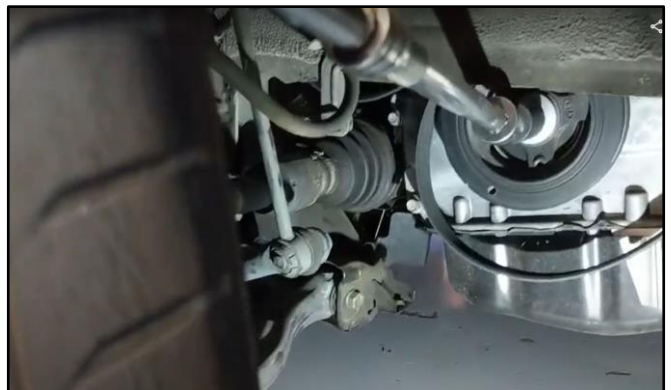
Prepare the vehicle prior to the video by removing the spark plugs and drive belt as well as setting the torque wrench to 94 lb.ft.

4. Show the removed drive belt and attached torque wrench to crank bolt.

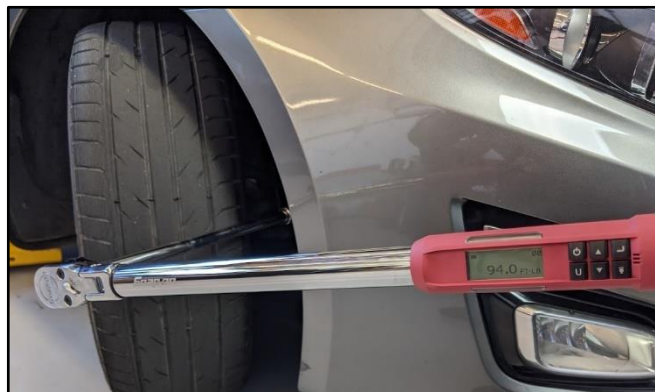
5. Show the engine being cranked and torque specification exceeding 94 lb.ft. torque.
