October 2021
SF630A
REVISED NOTICE

Subject: Cascadia Lane Assist Software

Models Affected: Specific model year 2019-2021 Freightliner Cascadia model vehicles manufactured June 18, 2019 , through June 15, 2021.

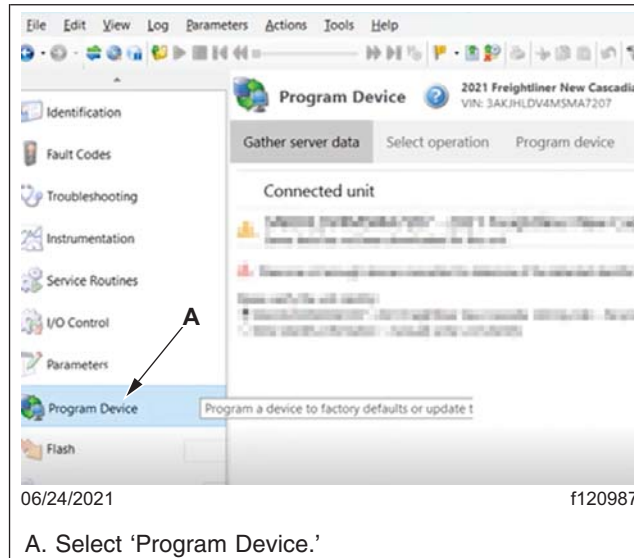
Fig. 1, Selecting Program Device

- Go to 'Program Device,' then select 'Gather Server Data.' Verify and select the vehicle identification number (VIN), then select 'Download Data from Server.' See [Fig. 1](#) and [Fig. 2](#).

- Select 'Program Device' on the left-hand side of the window. See [Fig. 1](#).
- Select the ECU to program, then select the VIN. Select either 'Newest' or 'Latest,' then select 'Next.'
- Verify the VIN and hardware part number, then select 'Start' to program the selected ECU.
- Repeat substep 12.2 for all incompatible ECUs, that require programming.

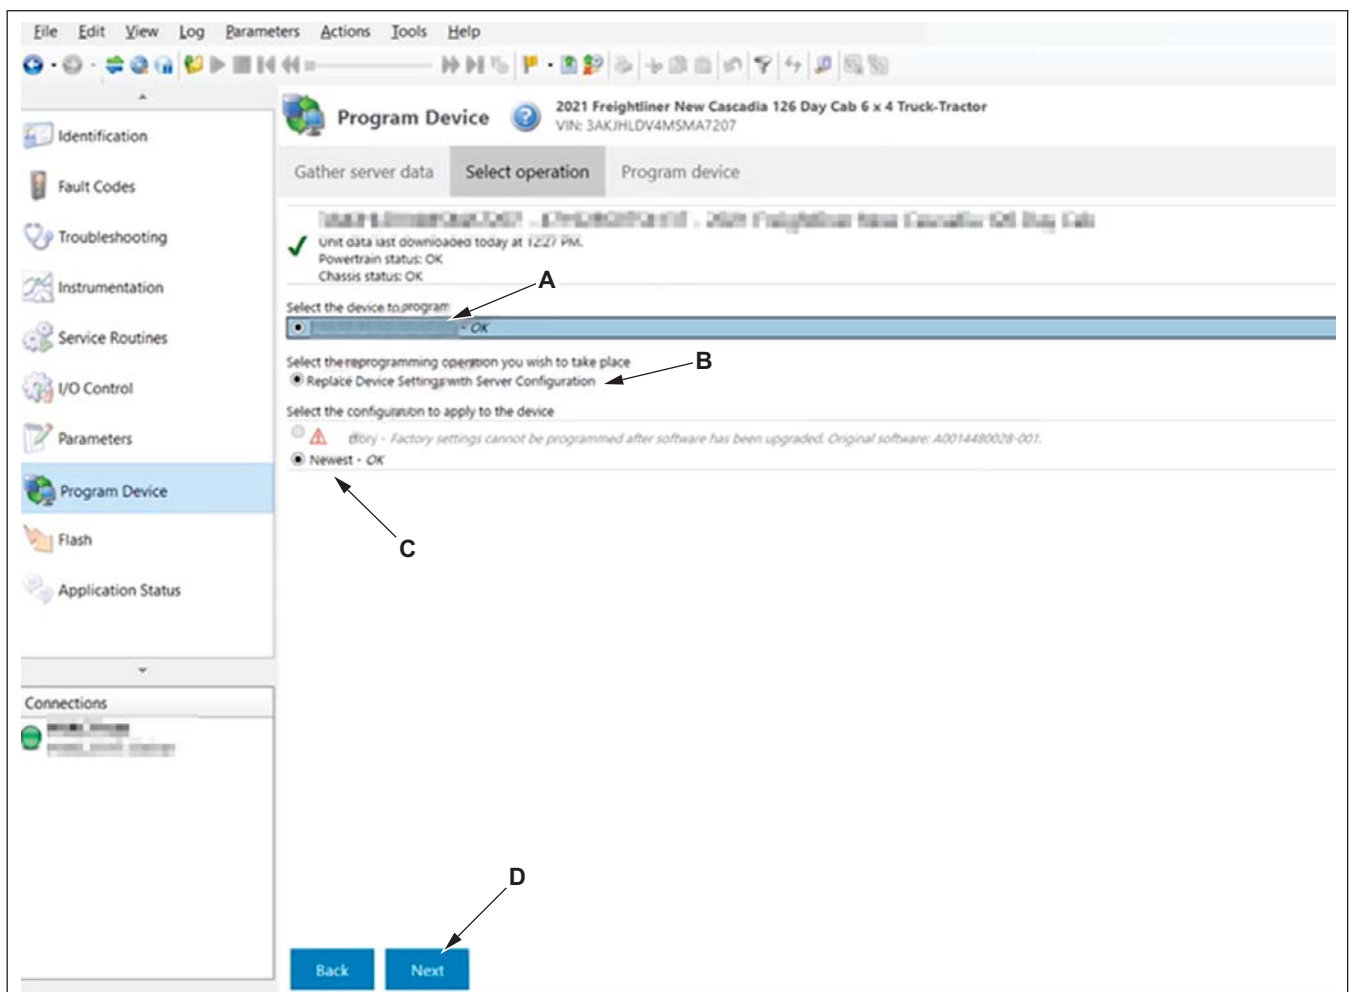
Fig. 4, Programming an ECU

8. Select the APS3 ECU to program. See [Fig. 4](#).
9. Select 'Replace Device Setting with Server Configuration' as shown in [Fig. 4](#).

10. Select 'Newest' under 'Select the configuration to apply to the device,' as shown in [Fig. 4](#). and proceed to next step.

| A. Select the ECU to program. | C. Select the configuration to apply to the device. |
| B. Select the programming operation to take place. | D. Select 'Next.' |

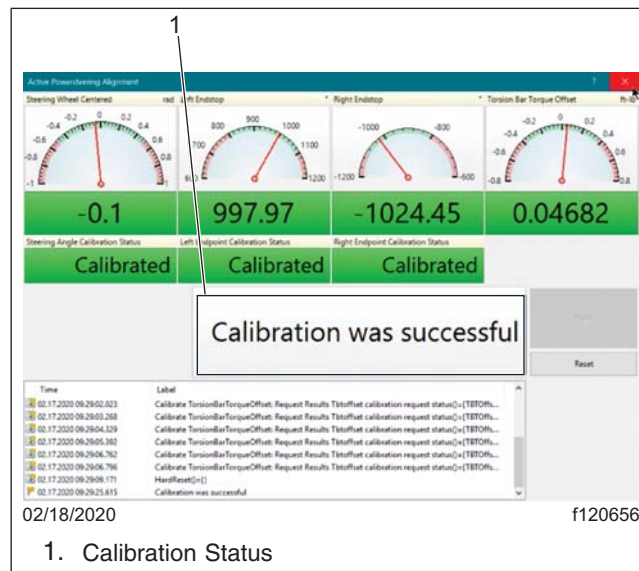
Fig. 7, Calibration Status

17. In the Actions menu, select the 'Active Powersteering Alignment' routine. Check the panel to determine if calibration is required. See **Fig. 7**.

YES → Calibration is not required. Go to the next step.

NO → Perform active power steering (APS) calibration. For instructions, refer to **Section 46.09** of the *New Cascadia Workshop Manual*.
