# Mack Chassis - Diagnostic Trouble Code ( DTC ) P0422 Lighting The Malfunction Indicator Light ( MIL ) - US14+OBD15 And US14+OBD16 Emissions, Common Model Years 2016 And 2017

## Verify the chassis emissions level

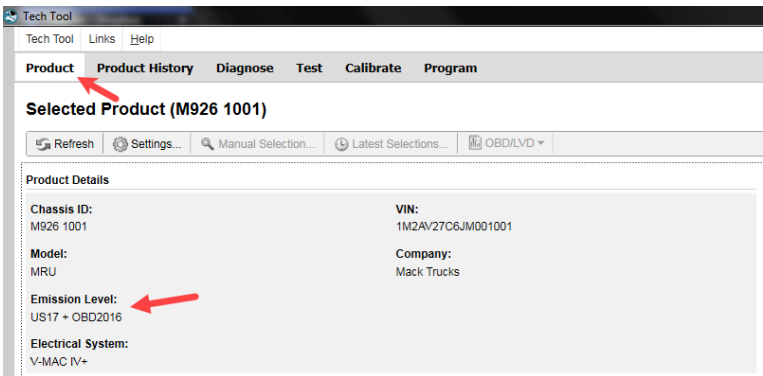
- Details can be found in the Product Details box on the Product tab in PTT as seen below:

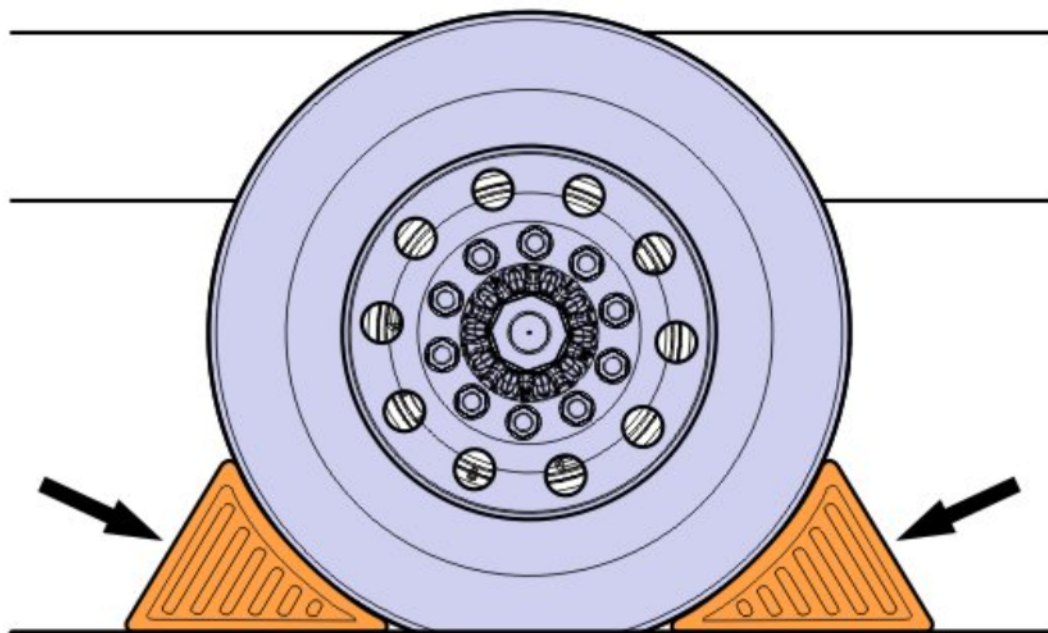
1. Park the vehicle on a level surface.
2. Apply the parking brake.
3. Place the transmission in neutral or park.
4. Install the wheel chocks.

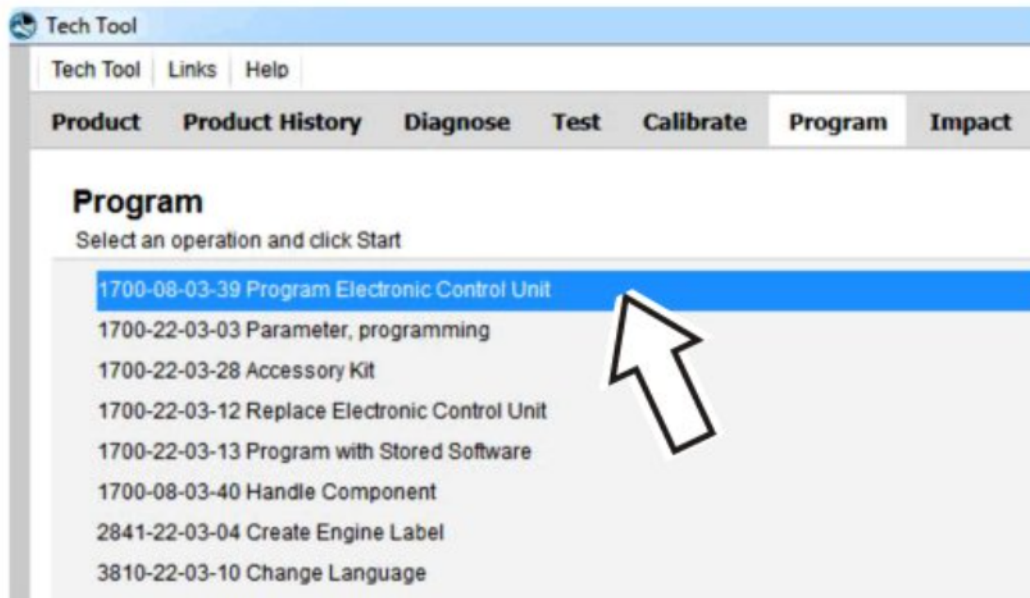
9. From the Main Menu select Program and then Program Electronic Control Unit 1700-08-03-39. Then click Start.

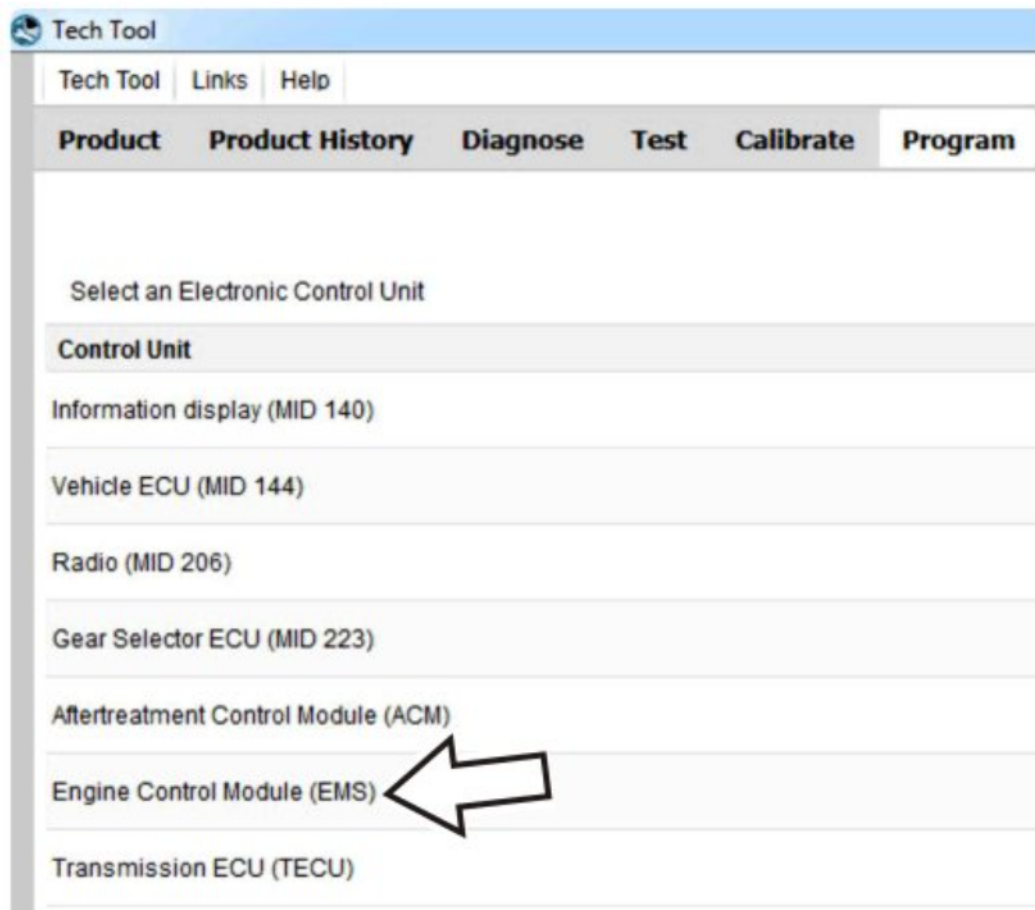
10. Select Engine Control Module (EMS).

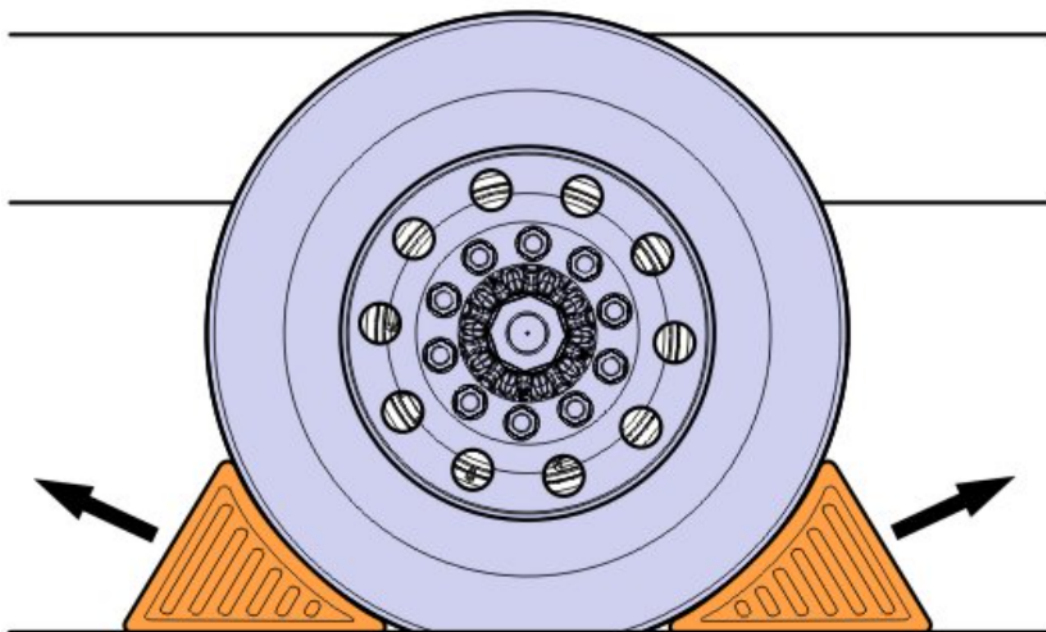
14. When programming is complete, click Exit to return to Main Menu to program the ACM.
15. When all programing is complete, clear any diagnostic trouble codes (DTC) and Finish Work.
16. Remove the wheel chocks.

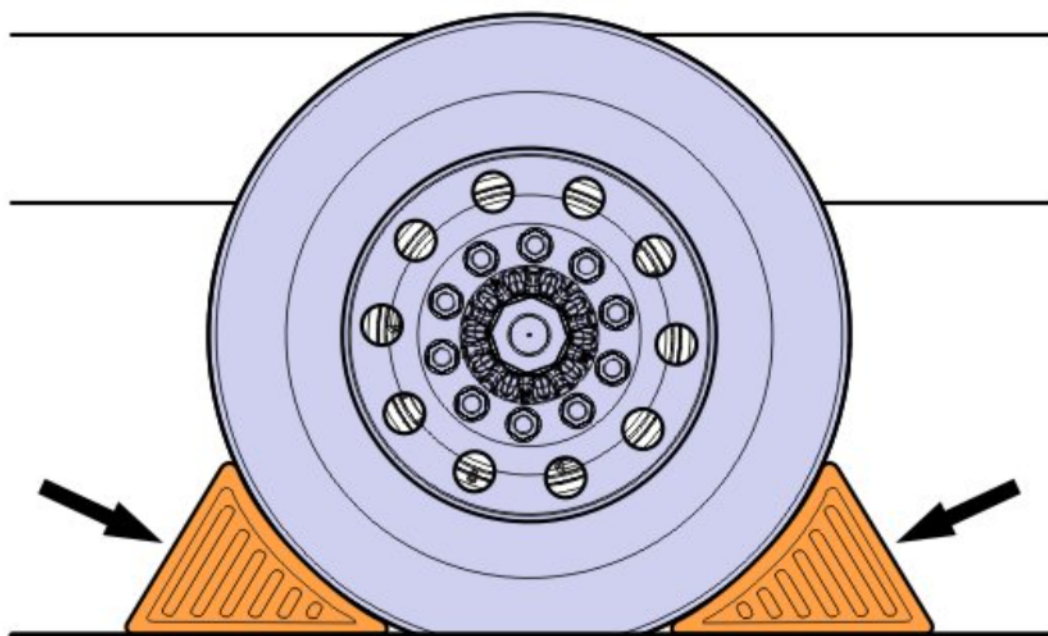
1. Park the vehicle on a level surface.
2. Apply the parking brake.
3. Place the transmission in neutral or park.
4. Install the wheel chocks.

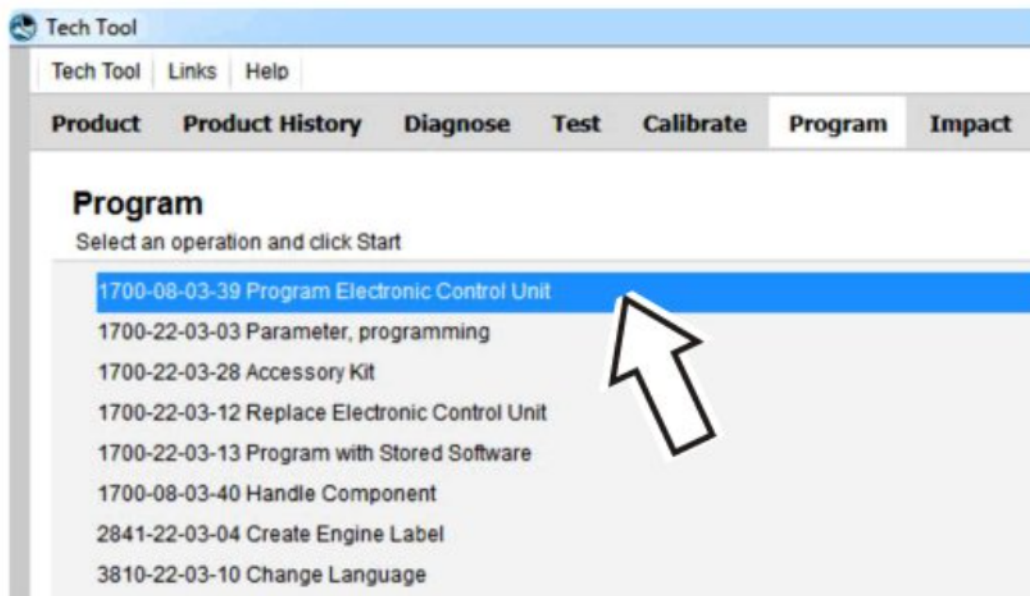
9. From the Main Menu select Program and then Program Electronic Control Unit 1700-08-03-39. Then click Start.

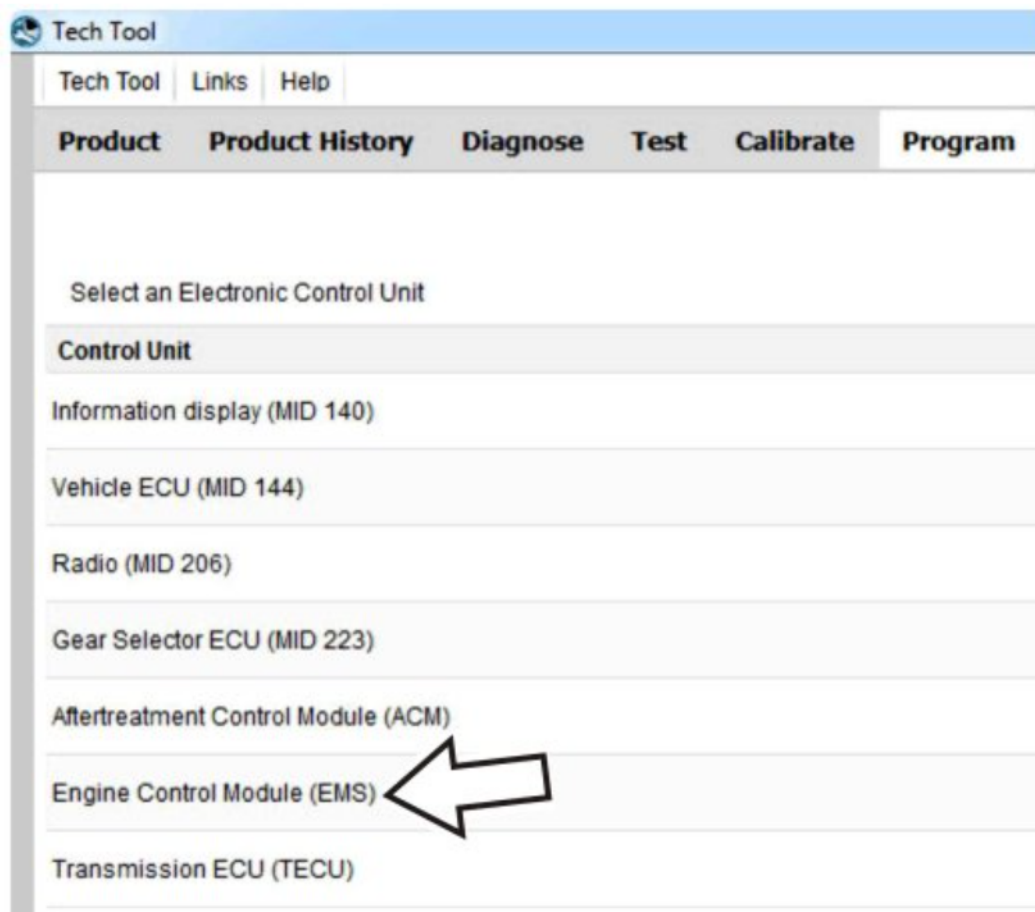
10. Select Engine Control Module (EMS).

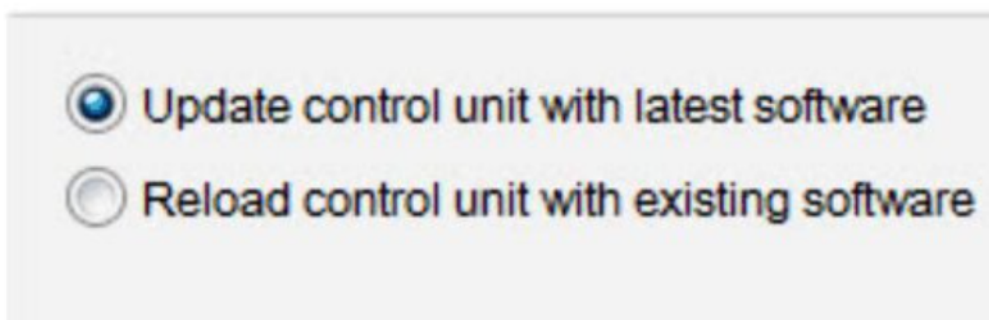
## Programming options

11. Select Program to update the ECM with the latest software.

12. Certain conditions must be met to continue with programming: battery voltage above 10v, parking brake applied, and ignition key in ON position with engine not running. When all conditions have been met, click Continue to proceed with programming.

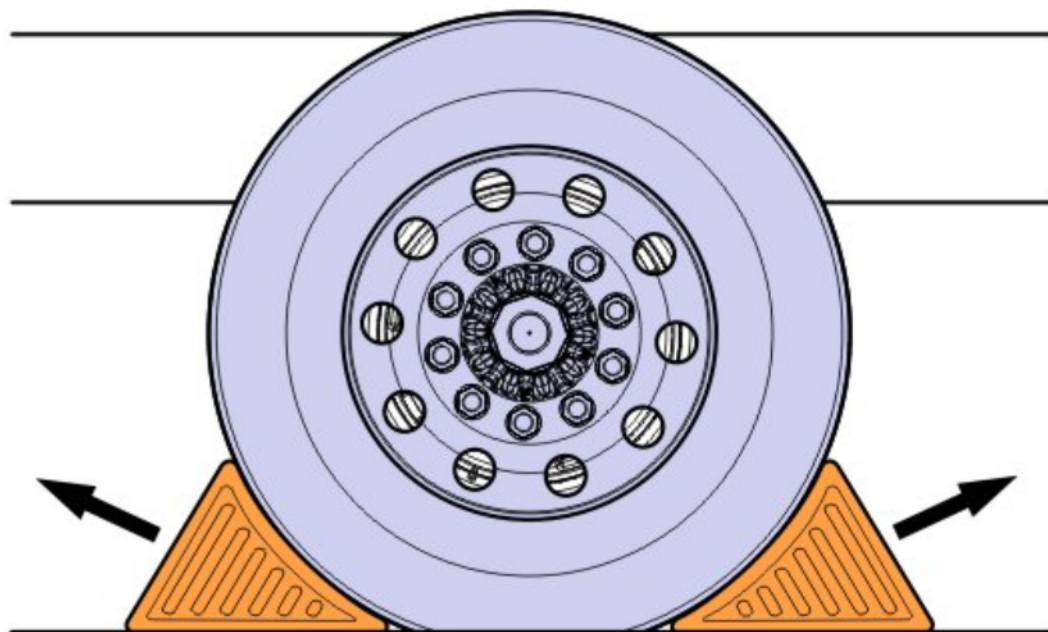
14. When programming is complete, click Exit to return to Main Menu to program the ACM.
15. When all programing is complete, clear any diagnostic trouble codes (DTC) and Finish Work.
16. Remove the wheel chocks.
