Complaint – Warning Message "PowerAssist Failure – Greater Force Needed" / Fault Memory Entry "B200046 – Function Restriction" in Power Steering Control Unit (65/21)

Model Line: **911 (992)**

Model Year: **As of 2020 up to 2021**

Concerns: **Power-steering gear**

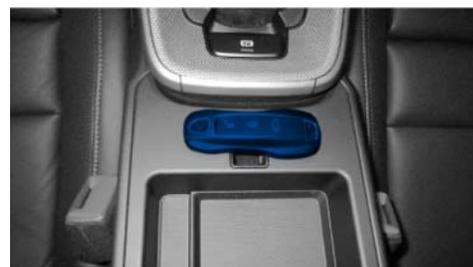
Emergency start tray

- 2 Place the driver's key with the back facing down in the area in front of the storage compartment under the armrest (emergency start tray) in order to guarantee a permanent radio link between the vehicle and driver's key ⇒ *Emergency start tray*.
- 3 Connect **9900 - PIWIS Tester 3** to the vehicle communication module (VCI) via the **USB cable**. Then connect the communication module to the vehicle and switch on the PIWIS Tester.
- 4 Switch on the ignition.
- 5 On the PIWIS Tester start screen, call up the '**Diagnostics**' application.
The vehicle type is then read out, the diagnostic application is started and the control unit selection screen is populated.
