**WML2 – Re-Programming 22 kW High-Voltage Charger (OBC) (Workshop Campaign)**

Vehicle Type: **Taycan (Y1A)**  
**Taycan Cross Turismo (Y1B)**

Concerns: **22 kW high-voltage charger (OBC)**

Action required: Re-program the 22 kW high-voltage charger using the PIWIS Tester with software version 40.550.050 (or higher) installed.

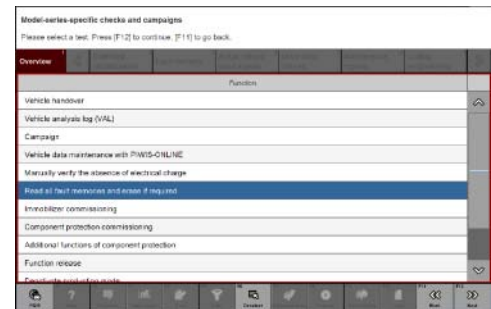
*Erasing fault memories*

If fault memory entries for individual control units cannot be deleted, proceed as follows:

- End operational readiness (switch off ignition).
- Disconnect the PIWIS Tester diagnostic connector from the diagnostic socket.
- Lock the vehicle using the driver's key and remove the **driver's key from the proximity of the vehicle** (approx. 10 metres).
- **Wait approx. 15 minutes** before unlocking the vehicle again.
- Restore operational readiness (switch on ignition).
- Plug the PIWIS Tester diagnostic connector into the diagnostic socket again and restore communication with the vehicle.
- Read out the fault memory again and delete any fault memory entries that are stored.

- 2.6 Once you have erased the fault memories, select the **'Overview'** menu to return to the control unit selection screen ⇒ *Control unit selection*.
