OTA Map Update Failed/Navigation Map View Black/Incomplete on PCM Screen (169/21)

Model Line: **Cayenne (9YA/9YB)**

Concerns: **Porsche Communication Management (PCM 5.0)**

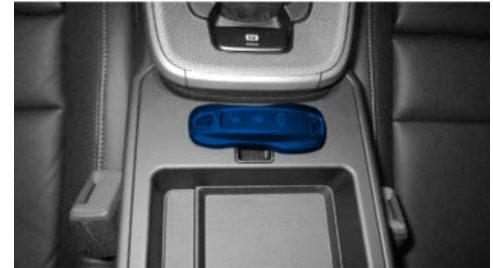
Emergency start tray

- 2 Place the driver's key with the back facing down in the area in front of the storage compartment under the armrest (emergency start tray) in order to guarantee a permanent radio link between the vehicle and driver's key ⇒ *Emergency start tray*.

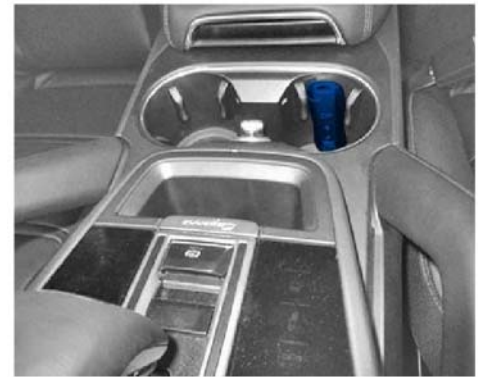
Emergency start tray

- 2 Place driver's key in emergency start tray.
- 3 Connect **9900 - PIWIS Tester 3** to the vehicle communication module (VCI) via the **USB cable**. Then connect the communication module to the vehicle and switch on the PIWIS Tester.
- 4 Switch on the ignition.
- 5 On the PIWIS Tester start screen, call up the '**Diagnos**tics' application.
