NUMBER: 08-114-21 REV. A

UBR UER and UFR Radio Enhancements

This bulletin involves updating the radio software level to 34.00.49.

2021 (WL) Jeep Grand Cherokee

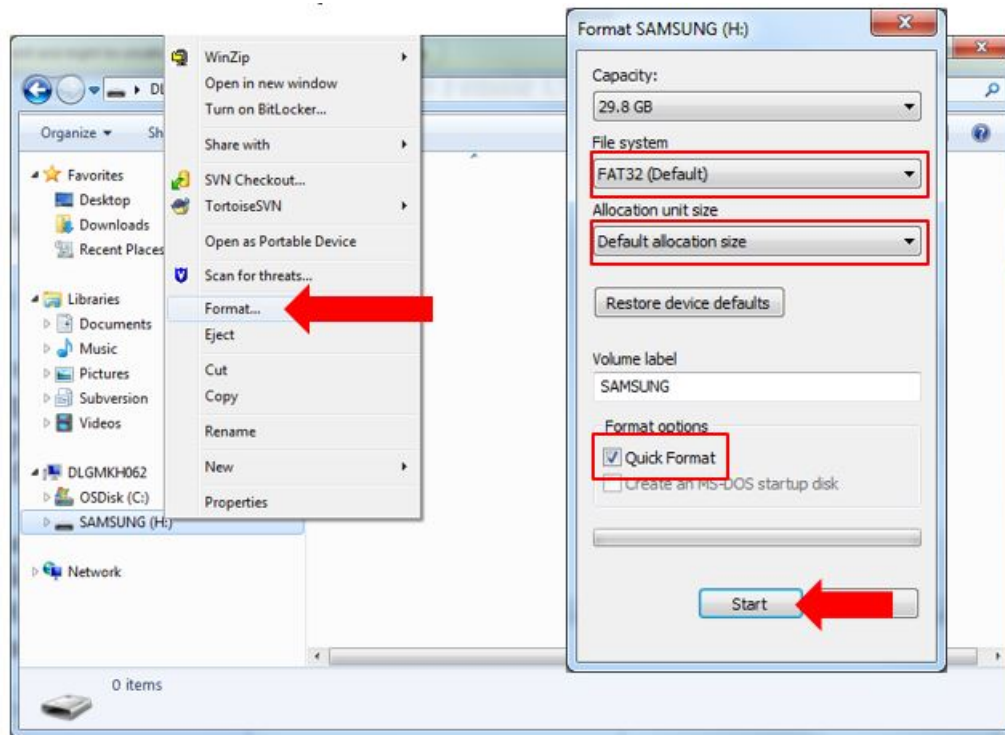
1. Has a **8 GB** USB flash drive been created?
 - YES >>> Proceed to [Step 13](#).
 - NO >>> Proceed to [Step 2](#).
2. Perform the following steps to format the USB flash drive ([Fig. 1](#)) .
 - a. Select “FAT32” format.
 - b. Select “Default allocation size” under Allocation Unit Size.
 - c. Select “Quick Format” under Format Options.
 - d. Click “Start”.

Fig. 1
Formatting The USB Flash Drive

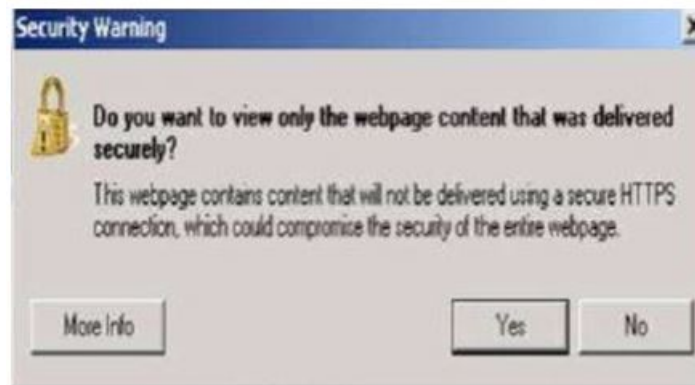
4. If a security message appears “Do you want to view only the web page content that was delivered securely?” (Fig. 2) . Press “No” to continue.

Fig. 2
Pop-Up Security Message

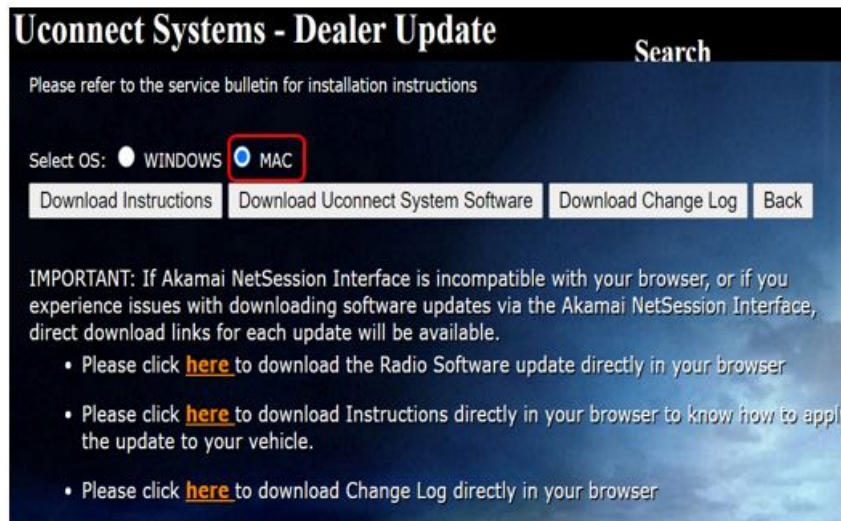
5. Use a blank USB flash drive with at least 8 GB of space. Follow the on-screen instructions to download the software files.
6. Download the software update file to your local PC’s desktop. Make sure to select the “MAC” radial button for all downloads (Fig. 3) .

Fig. 3
MAC Download Steps

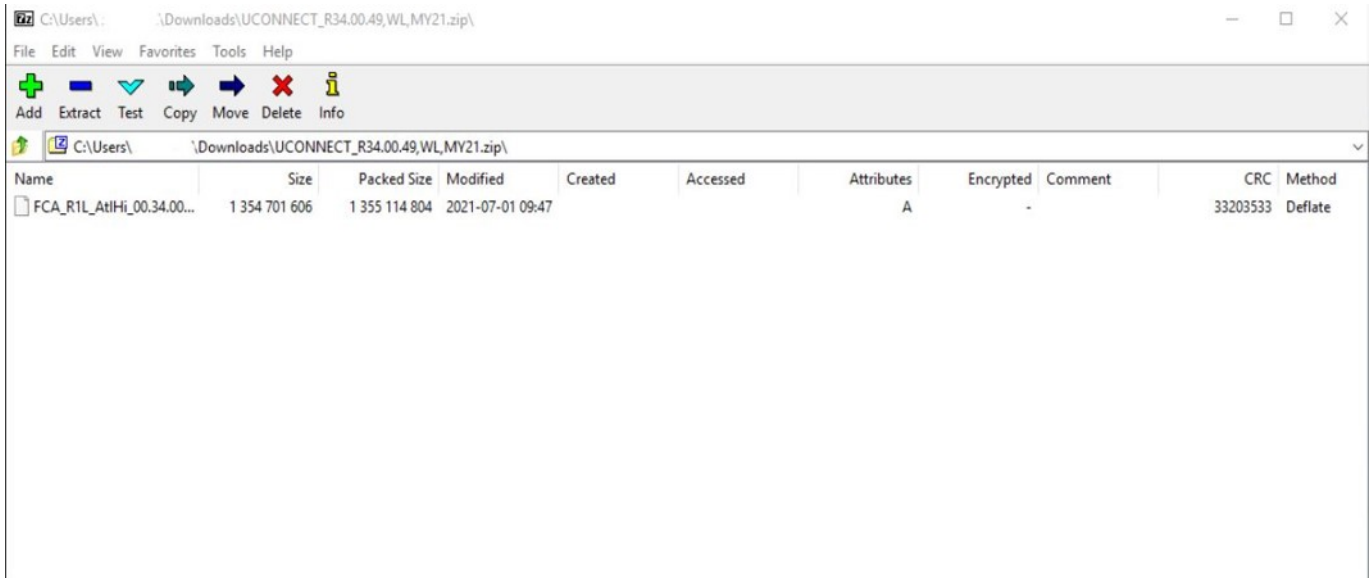
7. Be sure to download the file to your PC's desktop and open it (Fig. 4) .

Fig. 4
Extracted File

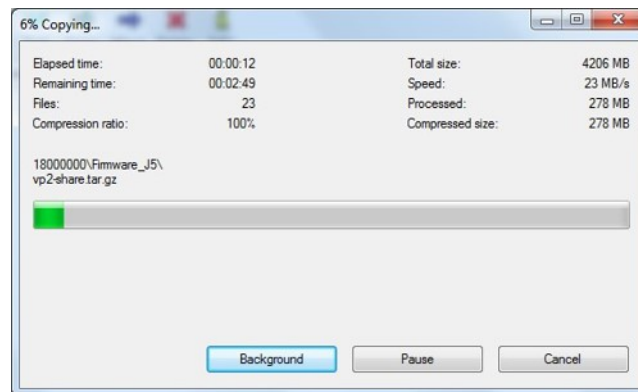
8. Extract the downloaded file to the USB flash drive (Fig. 5) .

Fig. 5
Extract File To USB (Example)

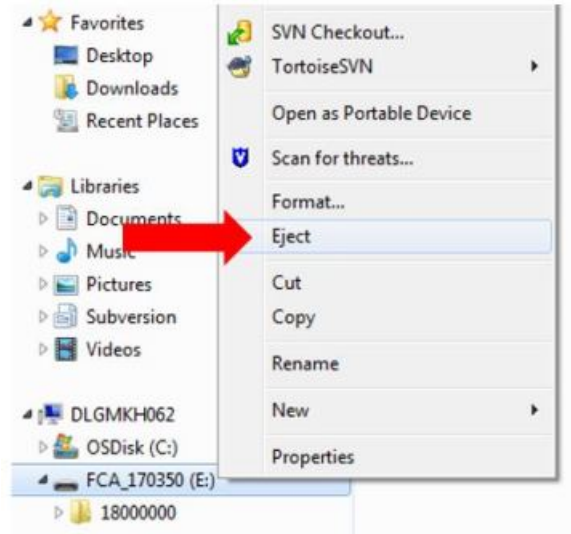
10. Perform the following steps to properly eject the USB flash drive (Fig. 6) .
 - a. Right click on the location of the USB flash drive.
 - b. Click “Eject” to avoid data corruption.
 - c. Remove the USB flash drive from the PC.

Fig. 6
Ejecting The USB Flash Drive

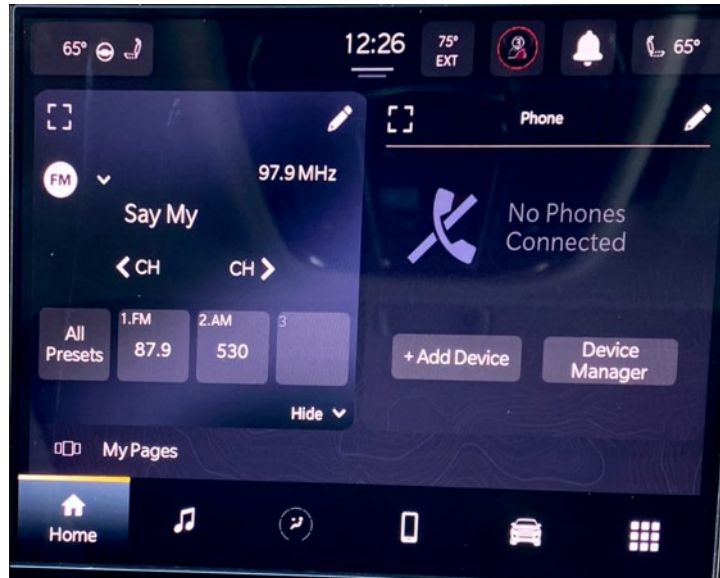
14. Vehicle must be out of “Ship Mode”. Starting at the radio ‘Home’ screen (Fig. 7) .

Fig. 7
Home Screen

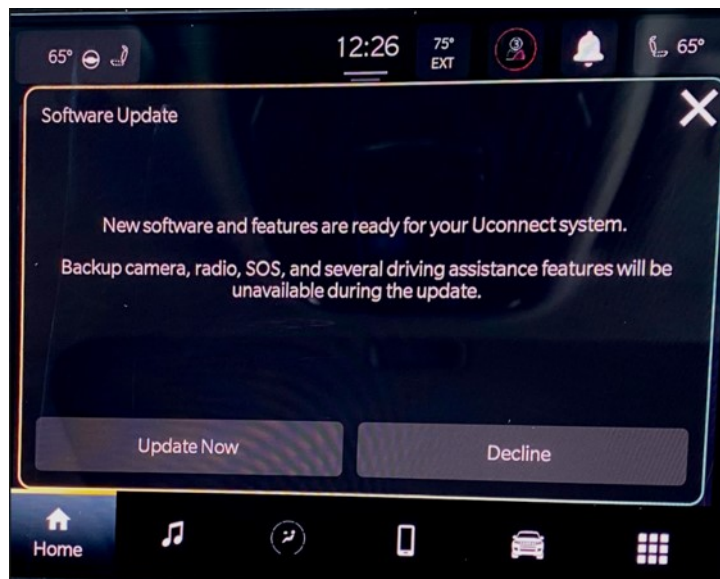
15. Insert the USB flash drive into the USB port.
16. The radio will prompt you if you want to update to the newest software version (Fig. 8) .

Fig. 8
Software Update Screen

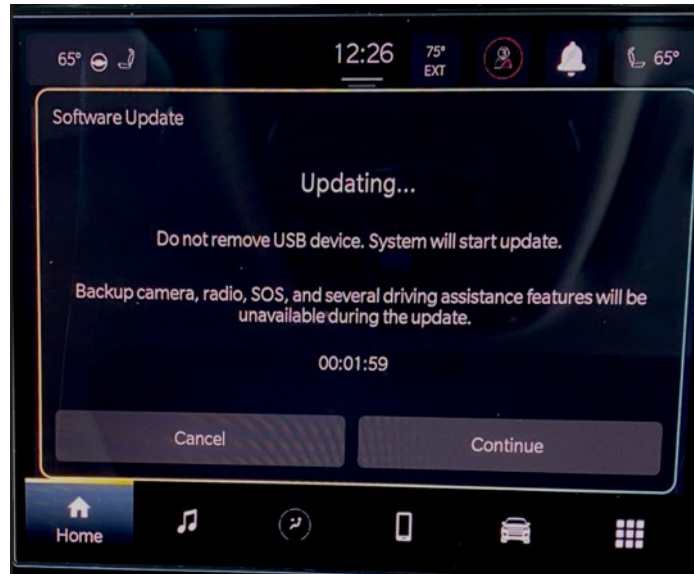
18. The radio will prompt you if you want to continue updating to the newer software (Fig. 9) .

Fig. 9
Software Updating Screen

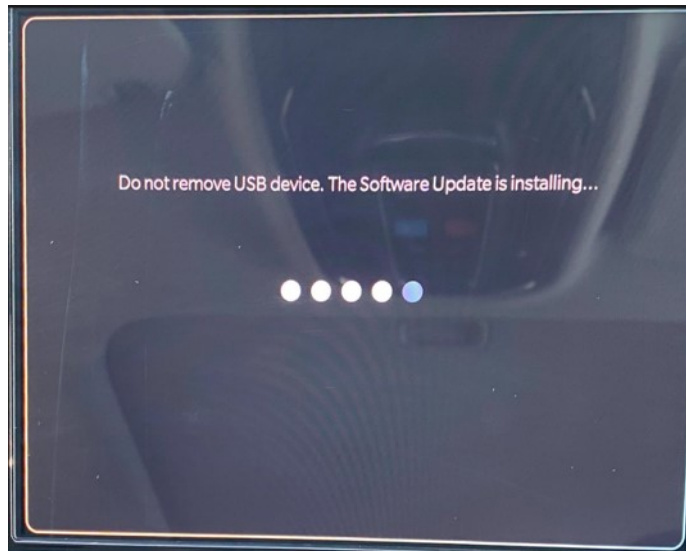
19. Select "Continue" (Fig. 10) .

Fig. 10
Installing Update Screen

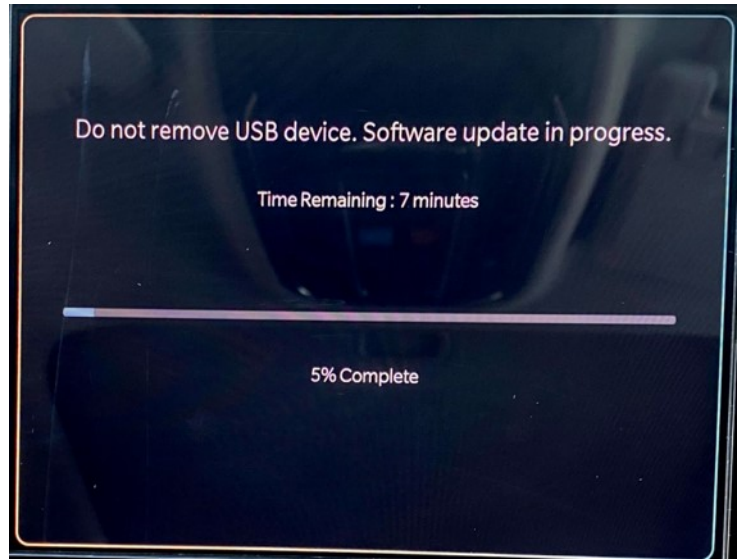
20. The update will take approximately 15-20 minutes (Fig. 11) .

Fig. 11
Update In Progress Screen

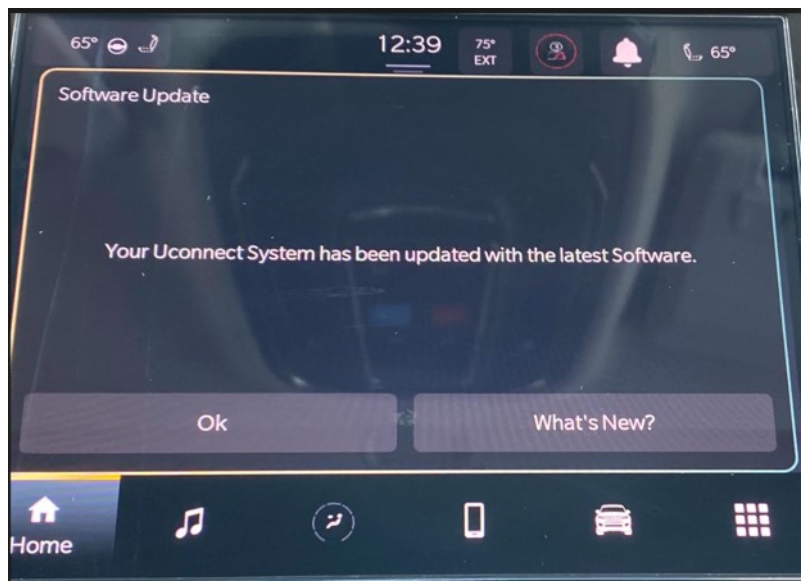
21. The radio will reboot and you will observe the update screen after the splash screen once the update has been successful.(Fig. 12) .

Fig. 12
Software Updated Screen

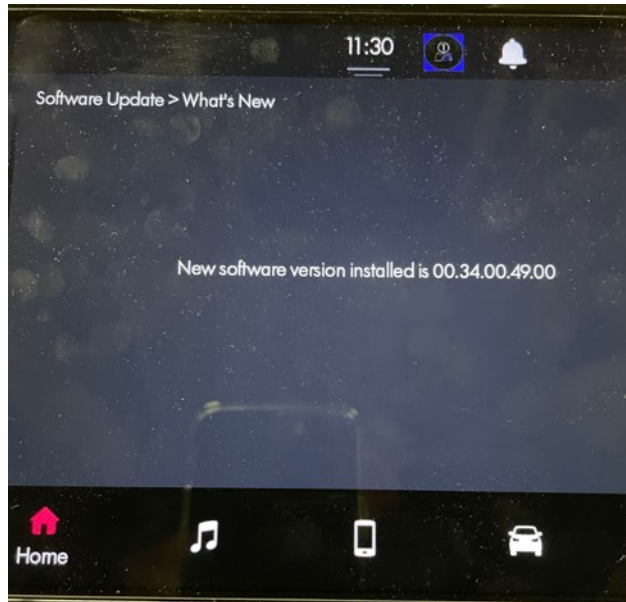
22. Select “What’s new” to confirm the software has been updated to 34.00.49 (Fig. 13) .

Fig. 13
What's New Screen
