NUMBER: 08-119-21 REV. A

GROUP: 08 - Electrical

UAX, UCX, UAV and UCV Radio Over the Air Software Version Updates

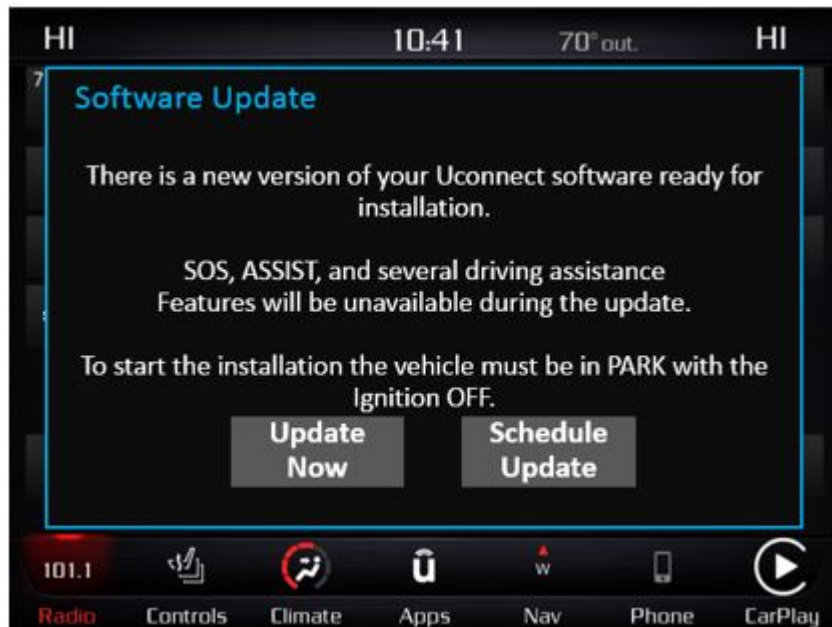
Fig. 1

Customers will see a notification on their radio screen when new software is available for their radio (Fig. 1) . The owner will have the option to update the radio or schedule the update for later. **There is not an option to decline the update indefinitely, the update must be performed.**

Software Acceptance Screen

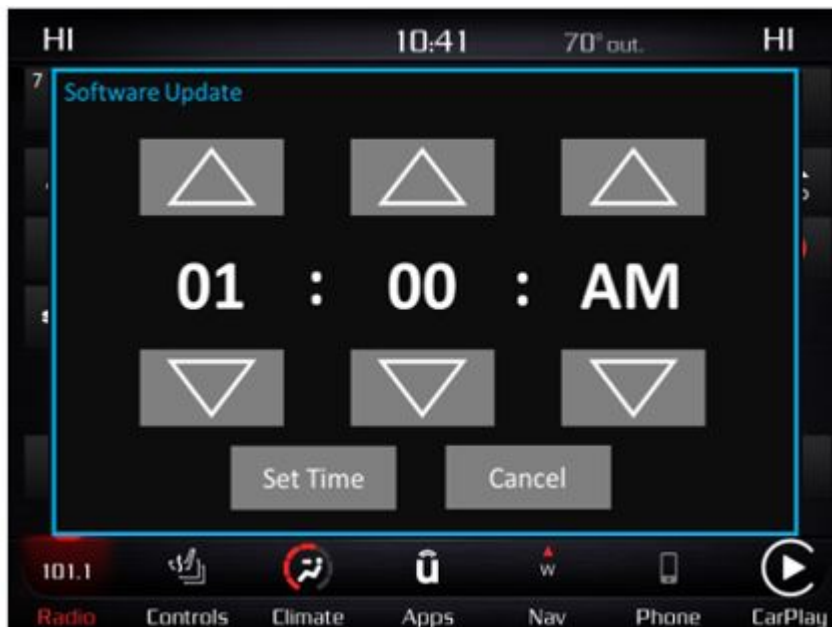
Fig. 2

NOTE: If selecting “Schedule Update” the screen below will be displayed. The customer can select the exact time they want the update to begin (Fig. 2) .

Schedule Update Screen

1. The vehicle transmission needs to be in the park position, or have the vehicle in neutral with parking brake engaged if equipped with a manual transmission. The ignition needs to be off.
2. Whether the customer selects “Update Now” or “Schedule Update” (Fig. 2) and sets a time, they can shut off the vehicle and leave. The update will be completed automatically (Fig. 3) .

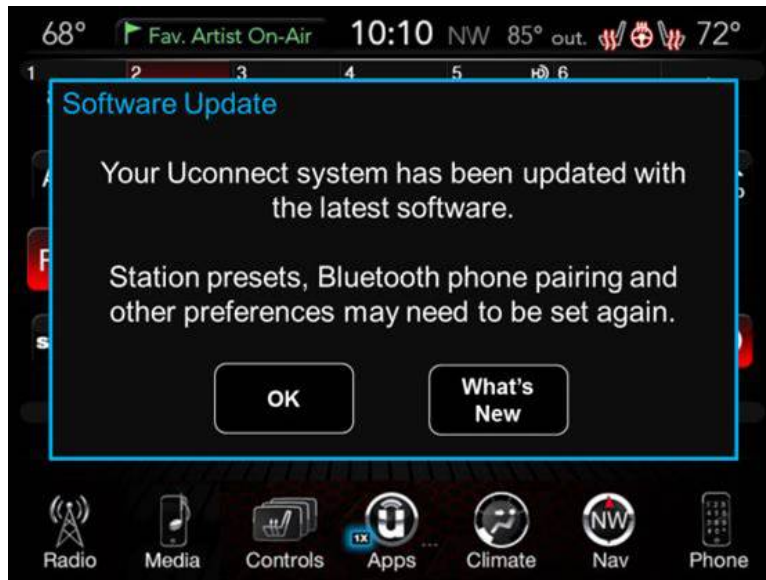
3. Upon completion of update, the radio will display a confirmation message (Fig. 4) .

Fig. 4
Update Confirmation Screen
