Audio Head Unit Software Update (Denso-Ten)

Service Category Audio/Visual/Telematics

Section Navigation/Multi Info Display

Market USA

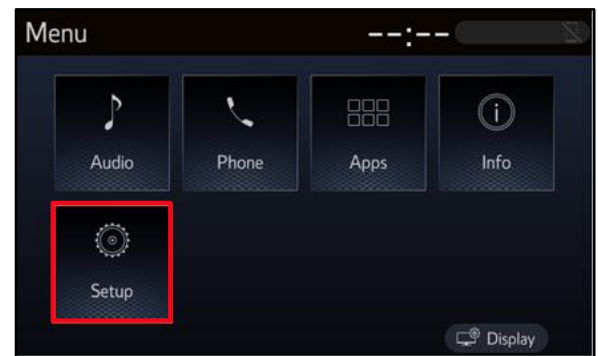
Figure 1.

1. Turn the ignition to IG-ON/Ready-OFF.
2. Is the vehicle currently being updated a 2020 – 2022 model year Highlander, Highlander HV, RAV4 and RAV4 HV, or 2021– 2022 model year RAV4 Prime equipped with Premium Audio?
 - **YES** — Continue to step 3.
 - **NO** — Go to step 8.
3. Is the radio experiencing a continuously rebooting condition?
 - **YES** — Continue to step 4.
 - **NO** — Go to step 8.
4. Apply the parking brake.
5. Shift the gear selector to Reverse.
6. Leave the vehicle in Reverse for a minimum of five minutes.
7. After the five minutes have elapsed, shift the gear selector back to Park. The radio will now boot up normally.
8. Press the Menu button on the radio faceplate, then select Setup.

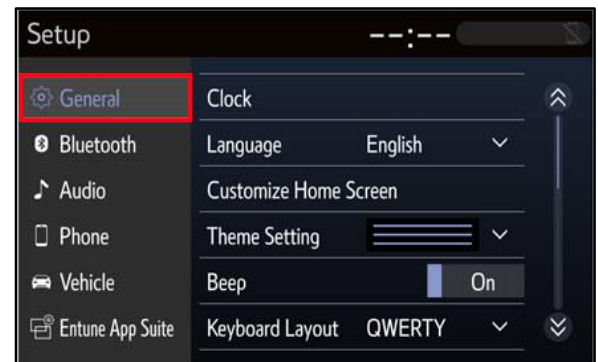
Figure 2.

9. Select General on the Setup screen.

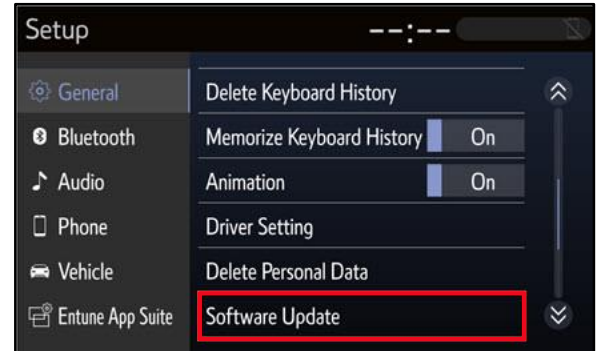
Figure 3.

10. Scroll down and select Software Update.

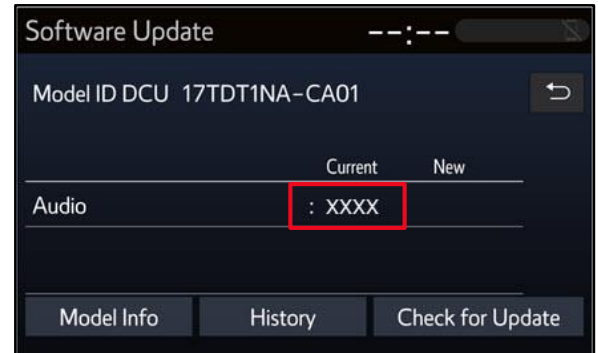
Figure 4.

11. Verify that the software version is the same or earlier than indicated in the Introduction.

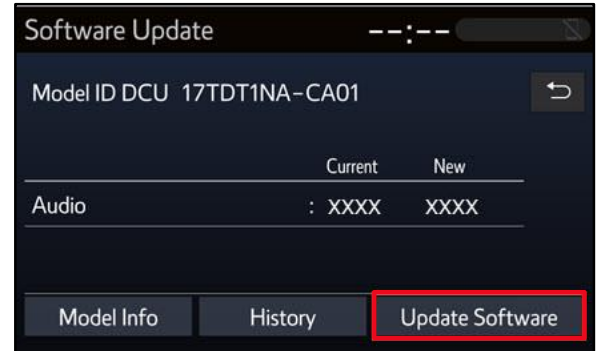
Figure 5.

15. Select the Update Software button in the lower right-hand corner.

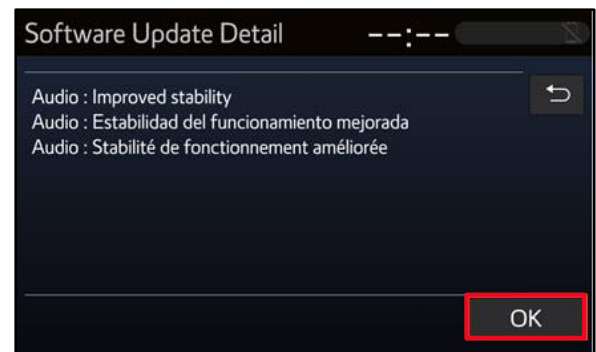
Figure 6.

16. Select OK on the Software Update Detail screen.

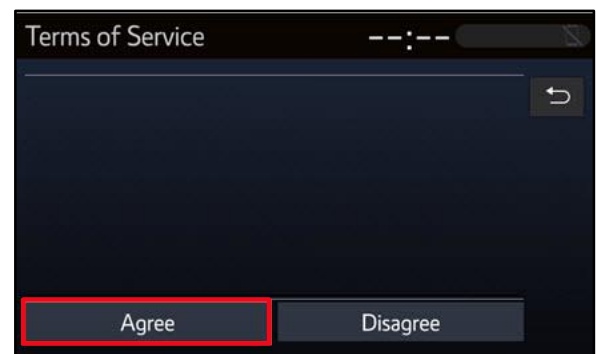
Figure 7.

17. Select Agree on the Terms of Service screen.

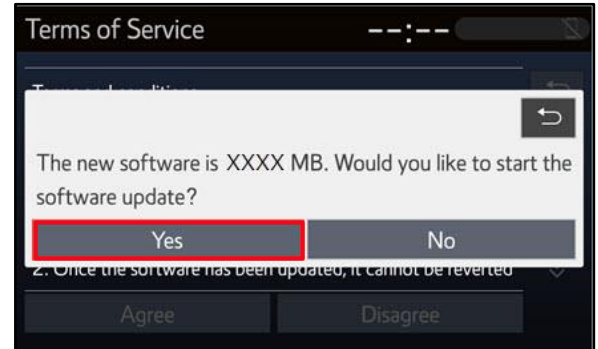
Figure 8.

18. Select Yes on the “Would you like to start the software update?” pop-up.

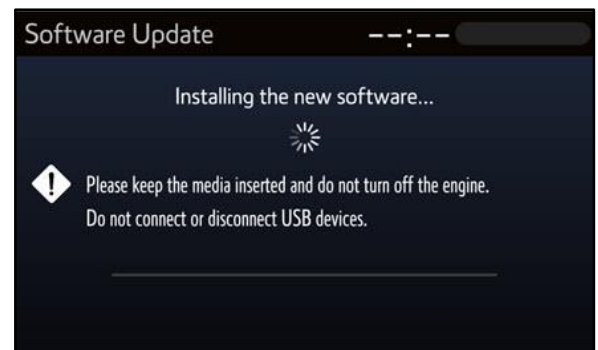
Figure 9.

19. Once the head unit begins installation, the update will take approximately 10 minutes.

- Do NOT turn OFF the ignition or ACC BEFORE the software is ready for updating.
- Do NOT remove the USB flash drive until instructed in step 23.

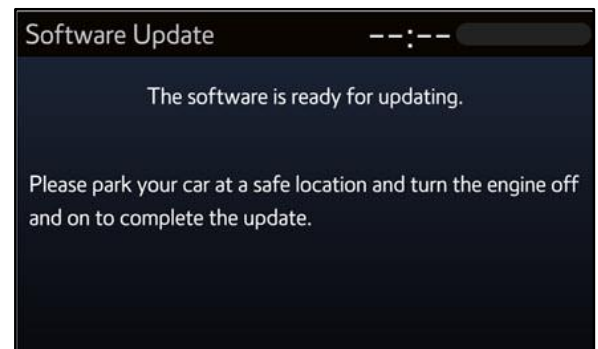
Figure 10.

20. When the “The software is ready for updating” screen appears, turn OFF the ignition.

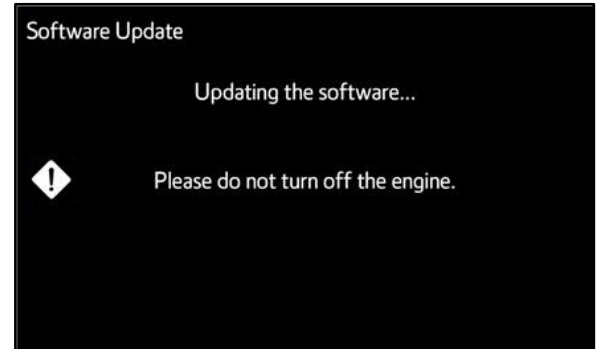
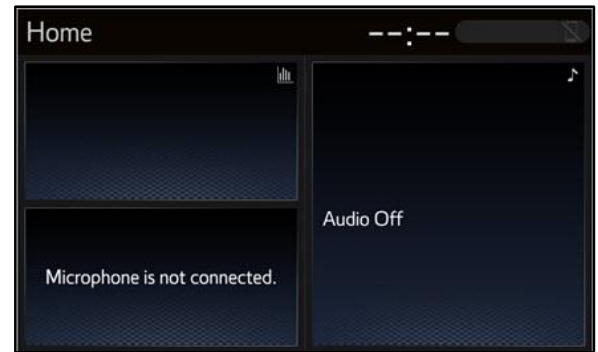
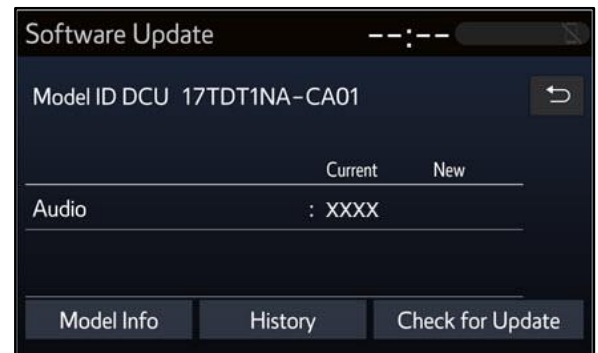
22. AFTER turning the ignition ON, the Software Update screen will appear. Do NOT turn OFF the ignition or remove the USB flash drive. The head unit will reboot during this time.

23. Once the software update is complete and the Home screen appears, remove the USB flash drive.

24. Perform steps 9 – 12 to verify the software version matches the current software version information table below.
