Service Action

Code: 93N1

Subject	Software Update for Remaining Range Display																													
Release Date	December 16, 2021																													
Affected Vehicles

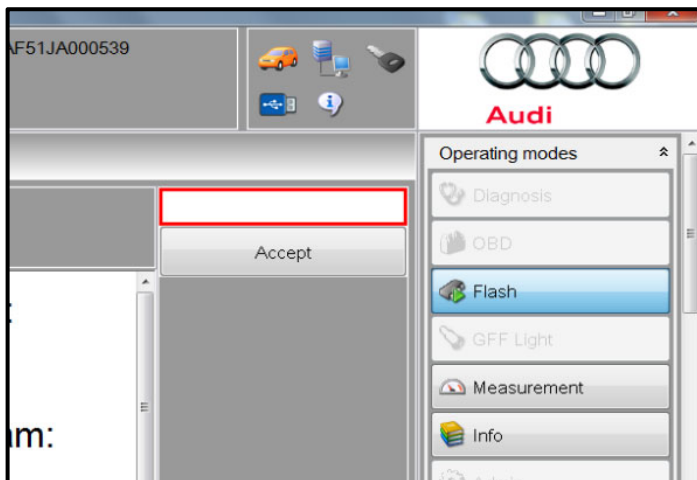
- Enter the corrective action code (SVM code) as listed below.

SVM code
93N1A378

- Select “Accept”.
- Follow the on-screen prompts.

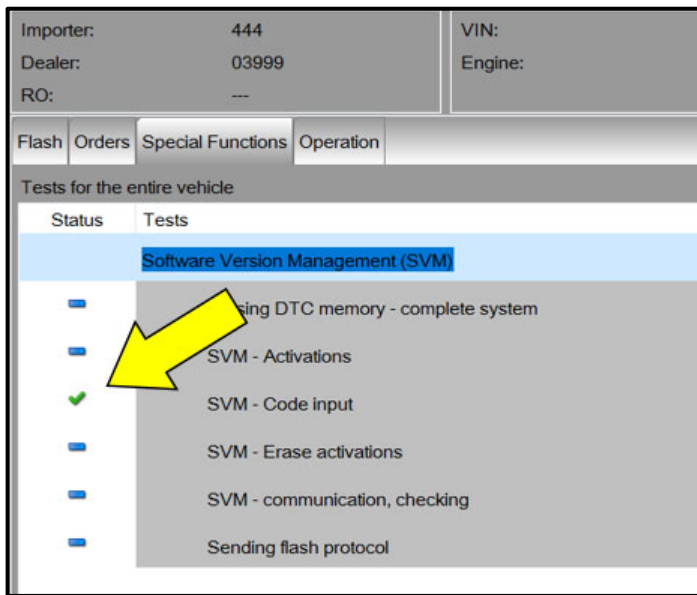
This extra ignition cycle step must be followed, otherwise faults stored during the update may not be cleared upon exiting the Flash program.

- After receiving confirmation that the update completed successfully (green check mark) <arrow>, the ignition must be turned off for 60 seconds and then turned back on.

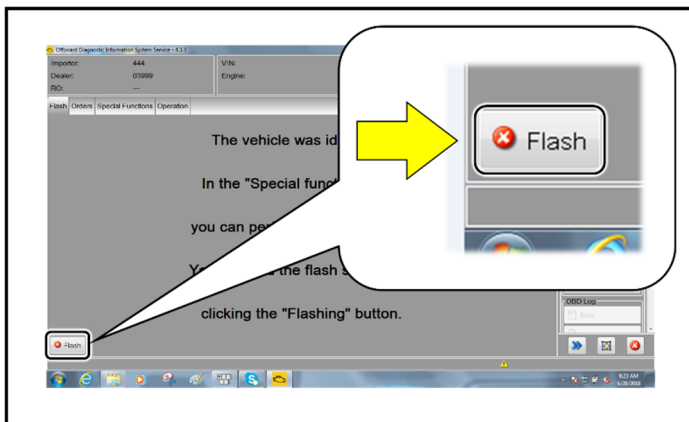
- Click "Flash" to exit the flash session.
