# Service Action

## Code: 96G4

<b>Subject</b>	<b>Gateway Control Module Software</b>																																			
<b>Release Date</b>	December 09, 2021																																			
<b>REVISION SUMMARY</b>	<b>Updated gateway part numbers in claiming instructions</b>																																			
<b>Affected Vehicles</b>

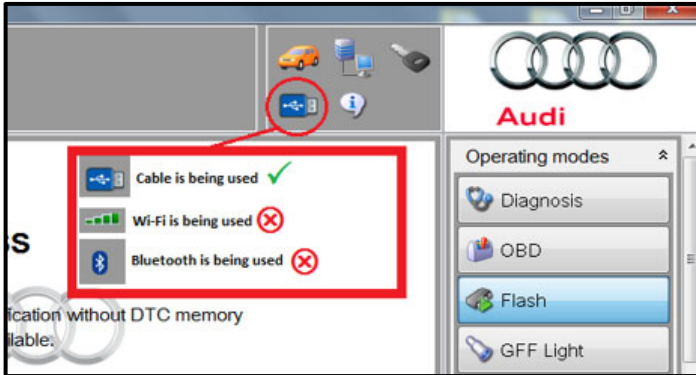
- Confirm that scan tool is communicating with the diagnostic head by USB cable.
  - If the Bluetooth or WiFi symbol is shown, then disconnect the diagnostic head from the vehicle and reconnect the USB cable to the diagnostic head and then reattach to the vehicle.

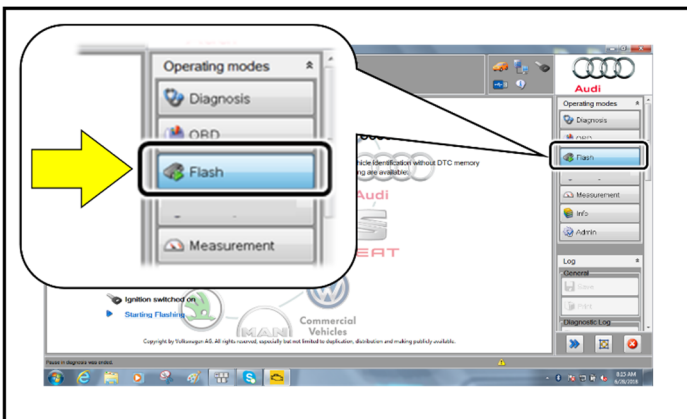
- From the home screen of the scan tool highlight “Flash” <1>.
- Follow the on-screen prompts.

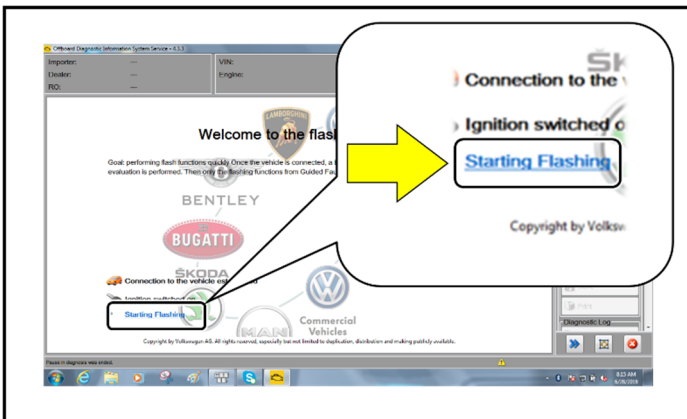
- Select “Starting Flashing” and follow the on-screen prompts.

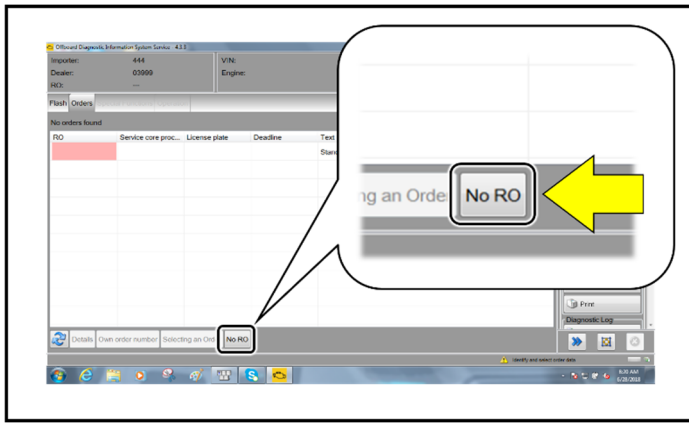
- Select "No RO".

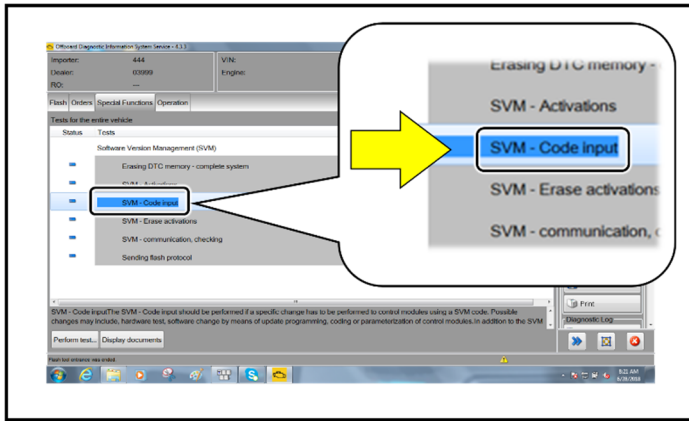
- Highlight "SVM – Code Input".

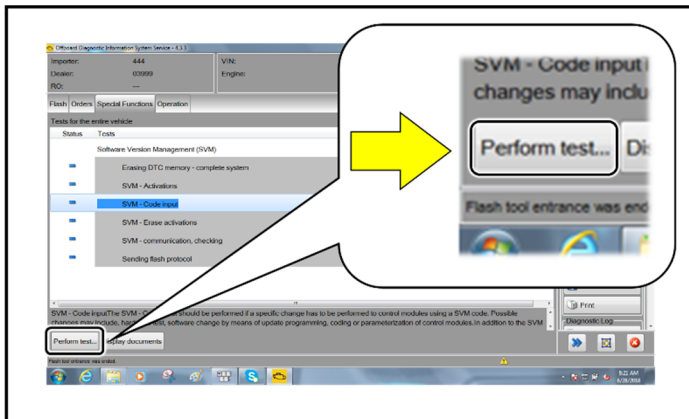
- Select "Perform test".

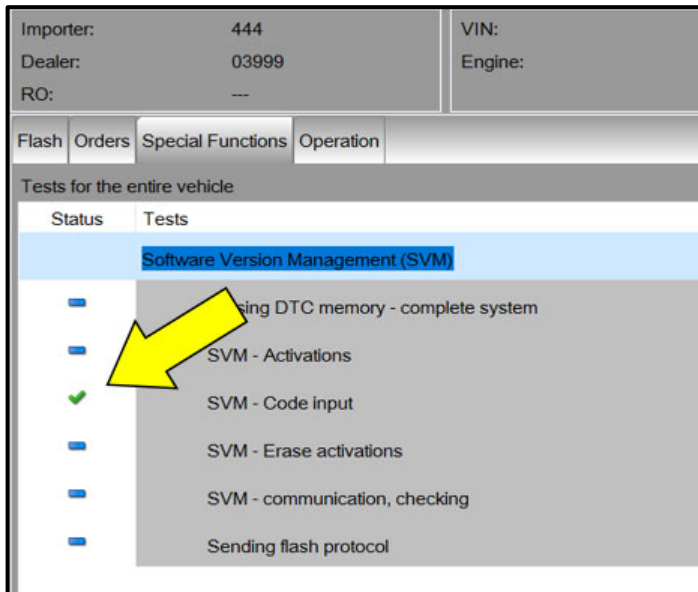
- After receiving confirmation that the update completed successfully (green check mark) <arrow>, the ignition must be turned off for 60 seconds and then turned back on.

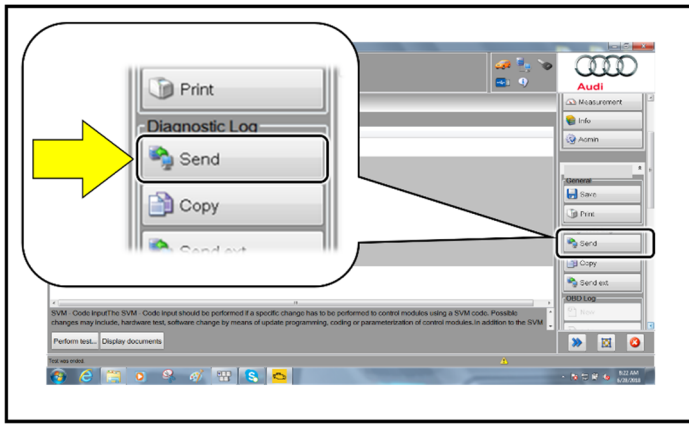
- After receiving confirmation that the flash completed successfully, select “Send” to send the diagnostic protocol online.
- Follow the on-screen prompts.

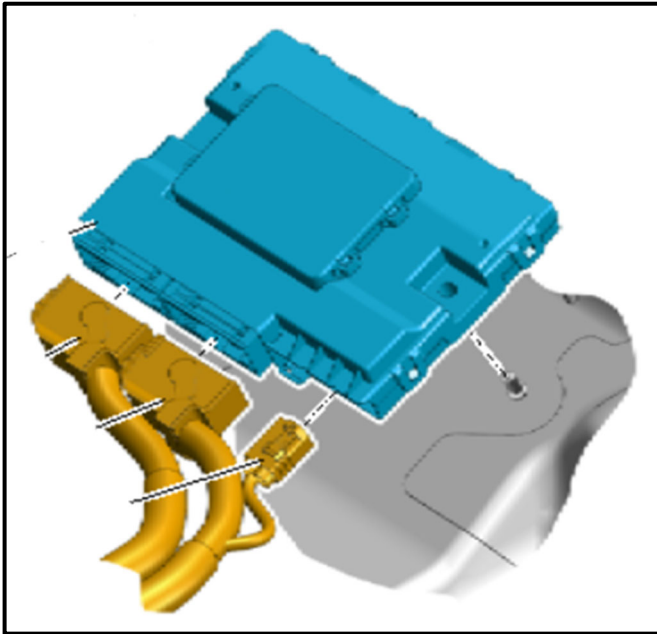
- Replace the Gateway control module -J533-:
  - See ELSA Repair Manual: *Repair manual > Electrical System > Electrical Equipment > 97 Wiring > Control Modules > Data Bus on Board Diagnostic Interface J533, Removing and Installing*
  - Perform GFF test plan for replacing the Gateway control module -J533-.
