GROUP	MODEL
FUE	2021-2022MY Sorento (MQ4a) w/Theta 2.5L GDI
NUMBER	DATE
055	December 2021

SUBJECT: **SERVICE ACTION: 2.5L GDI WITH MIL ON DTC P2074XX  
ECM LOGIC IMPROVEMENT (SA489A)**

This bulletin provides the procedure to update the software logic of the Engine Control Module (ECM) system on some 2021-2022MY Sorento (MQ4a) vehicles with Theta 2.5L GDI engines, produced from September 30, 2020 through October 25, 2021, which may exhibit an MIL 'ON' with DTC P2074XX due to throttle position to Mass Air Flow Sensor (MAF) correlation value reading error under high load. Follow the procedure outlined in this publication to apply the improved logic to the 'ECM' system using the KDS ECU Upgrade function as described in this bulletin. For confirmation that the latest reflash has been applied to a vehicle you are working on, verify the ROM ID using the table on page 3 of this bulletin.

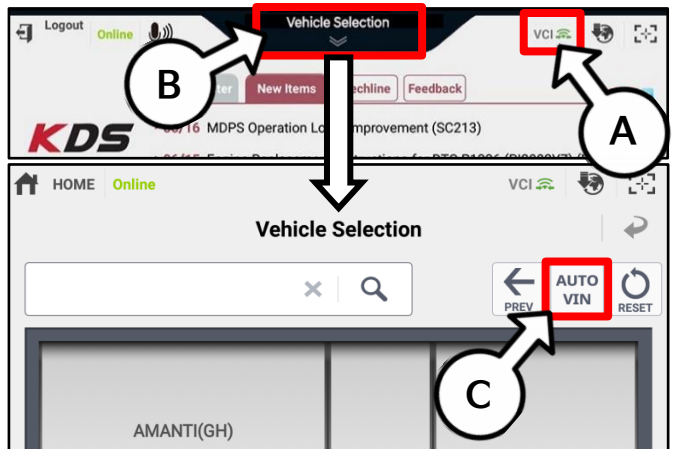
3. Confirm communication with VCI (A) and then configure the vehicle (B) using the 'AUTO VIN' (C) feature.

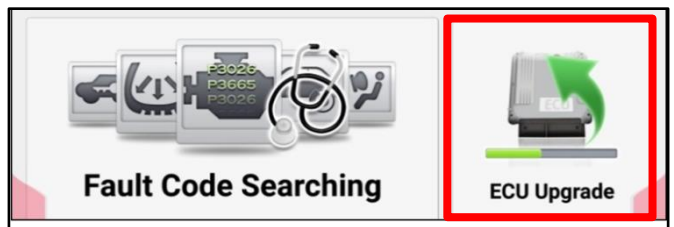
4. Select 'ECU Upgrade'.

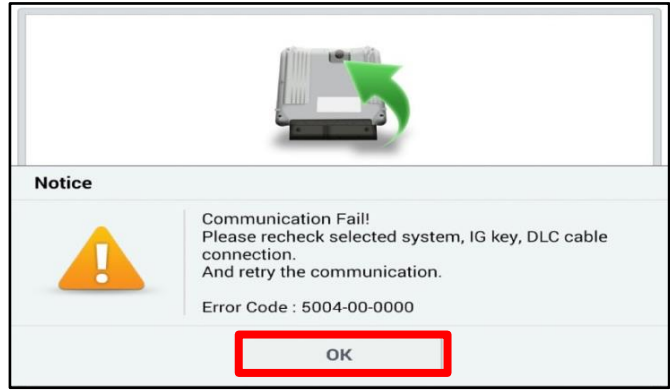
9. If a "Communication Fail" screen appears, verify that the VCI-II and KDS are communicating properly. Select 'OK' and restart the procedure from step 4.

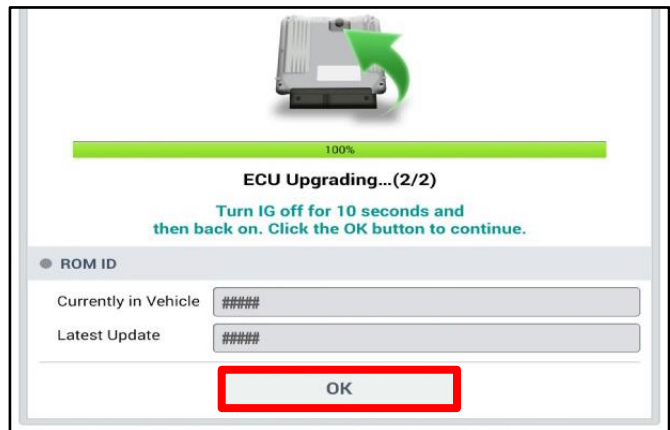
10. When instructed on the KDS, turn the ignition OFF for ten (10) seconds then back on. Select 'OK' to continue.

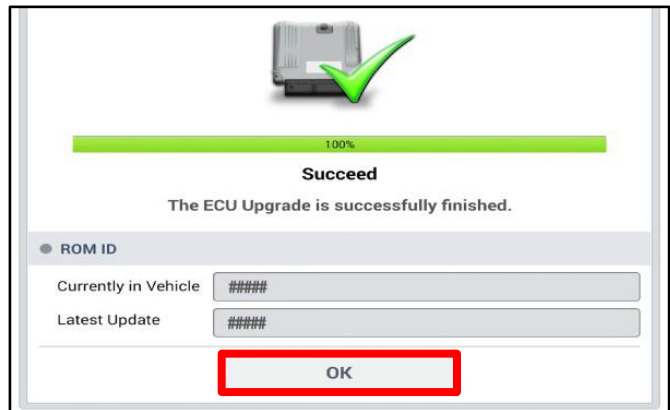
11. Once the upgrade is complete, select 'OK' to finalize the procedure.

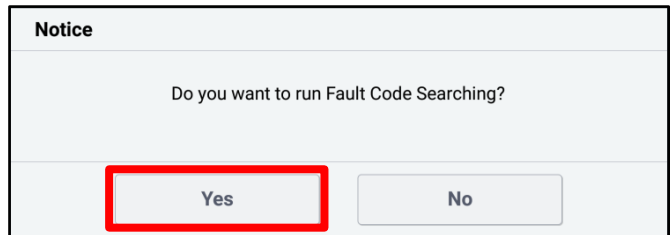
12. When prompted, select 'YES' to check for Diagnostic Trouble Codes (DTC) and erase any DTCs stored such as EPS, ESC, and TPMS that may have been set during the upgrade.
