GROUP	MODEL
ENG	2022MY Sorento (MQ4a) Telluride (ON)
NUMBER	DATE
232 (Rev 1, 12/20/2021)	December 2021

TECHNICAL SERVICE BULLETIN

SERVICE ACTION: ACCELERATION LOGIC IMPROVEMENT (ECU & TCU) (SA490)

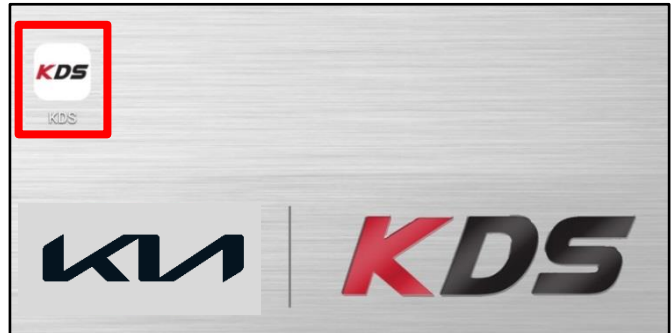
2. With the ignition ON, turn ON the KDS tablet. Select 'KDS' from the home screen.

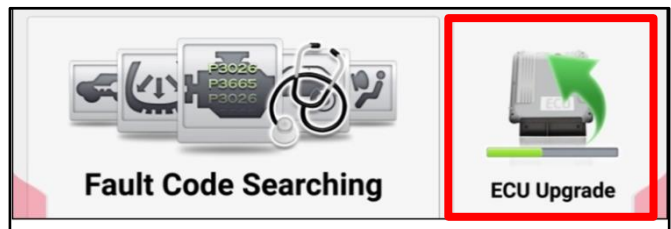
4. Select 'ECU Upgrade'.

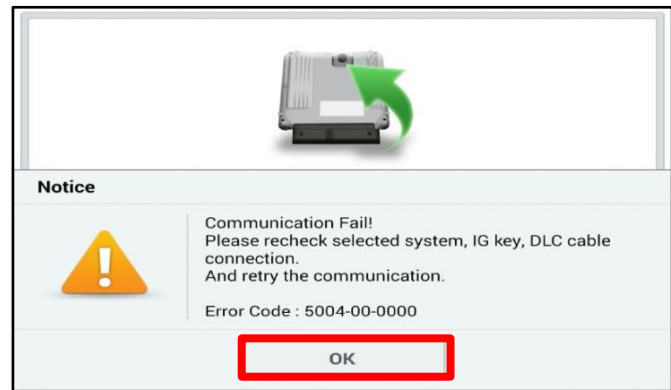
9. If a "Communication Fail" screen appears, verify that the VCI-II and KDS are communicating properly. Select 'OK' and restart the procedure from step 4.

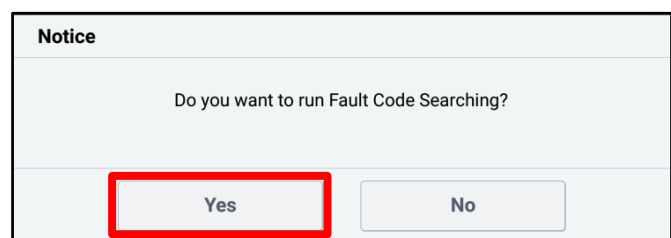
12. When prompted, select 'YES' to check for Diagnostic Trouble Codes (DTC) and erase any DTCs stored such as EPS, ESC, and TPMS that may have been set during the upgrade.
