Release Date	12/09/2021	Technical Service Bulletin		
24HV UPDATE

Engine Control Module Software Update – (FED_EMS)

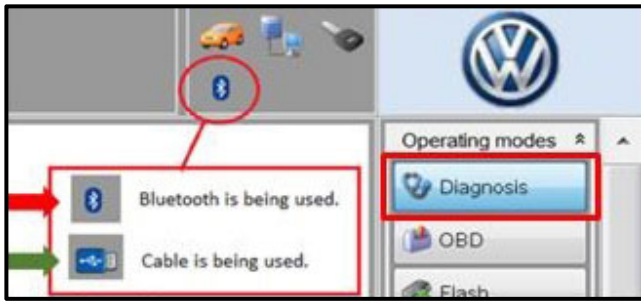
- Confirm that scan tool is communicating with the diagnostic head by USB <Green Arrow>.
 - If the Bluetooth symbol is shown <Red Arrow> then disconnect the diagnostic head from the vehicle and reconnect the USB cable to the diagnostic head and then reattach to the vehicle.
- Upon ODIS startup, verify the “Diagnosis” operating mode is selected <as shown>.
- Once the GFF scan is complete, select “Special functions” <arrow 1>, then “Adapting software” <arrow 2>, then select “Perform test” <arrow 3>.

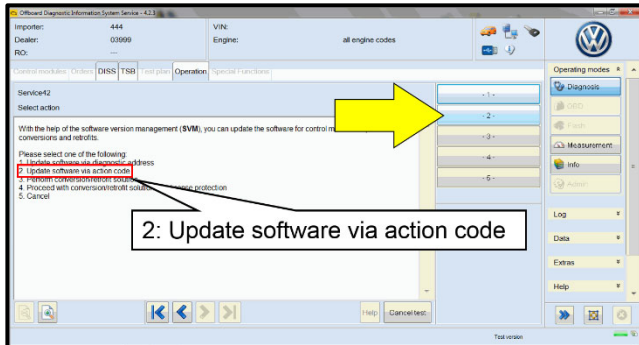
- Select the correct option to “Update software via action code” OR “Software update via measured code”.

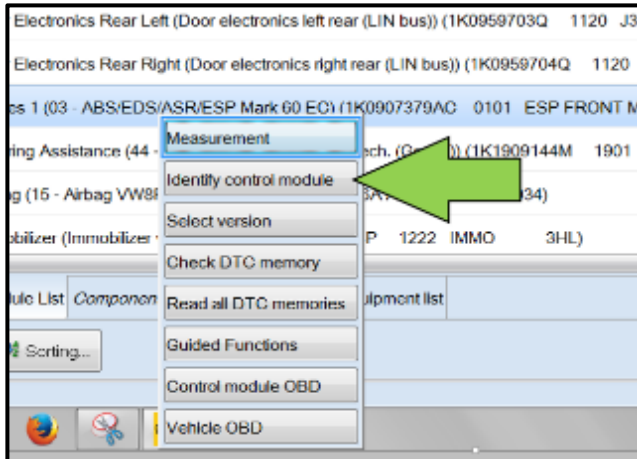
- After the software update is completed and before sending the GFF Log Online:
 - Select the “Control Module” tab.
 - Scroll down and right click on the module that was updated (0001).
 - Select “Identify Control Module” <arrow>.
