GROUP	MODEL
ENG	2022MY Sorento (MQ4a) Telluride (ON)
NUMBER	DATE
232	December 2021

TECHNICAL SERVICE BULLETIN

SUBJECT: SERVICE ACTION: ACCELERATION LOGIC IMPROVEMENT (ECU & TCU) (SA490)

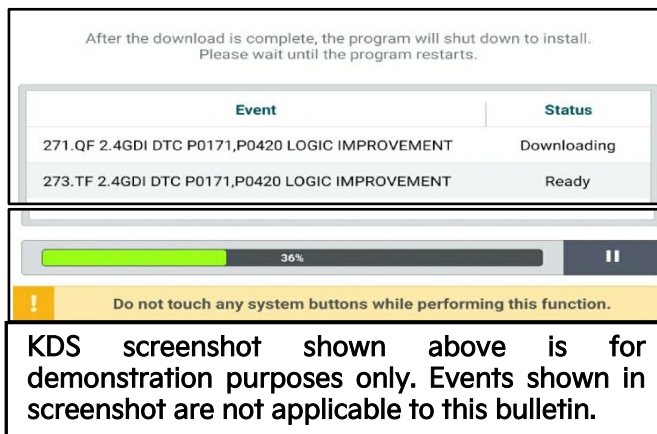
- The KDS will check the server for recently uploaded Events and then automatically download ECU Upgrade Event #582 (MQ4a) or #584 (ON) AND TCU Upgrade Event #583 (MQ4a) or #585 (ON).

The vehicle must be identified in Vehicle Selection to download an Event for that vehicle.

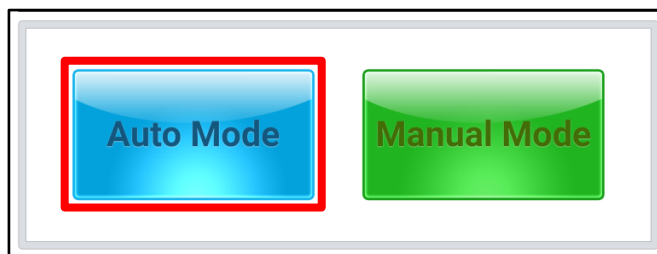
- Select Auto Mode.

Do NOT attempt to perform a Manual Mode upgrade UNLESS Auto Mode fails. Always follow the instructions given on the KDS in either Auto or Manual mode.

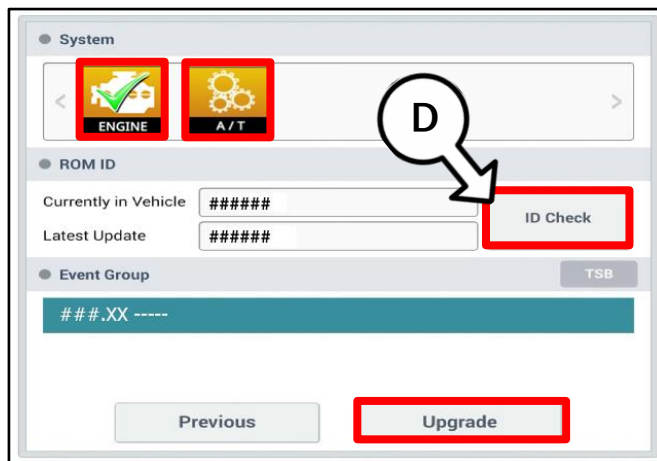
- Select the ENGINE and A/T systems under the System selection menu. Touch ID Check (D) and confirm that the latest update is available. Select ECU Upgrade Event #582 (MQ4a) or #584 (ON) AND TCU Upgrade Event #583 (MQ4a) or #585 (ON), and select Upgrade to continue.

Each vehicle must have both upgrades performed: Engine and A/T.

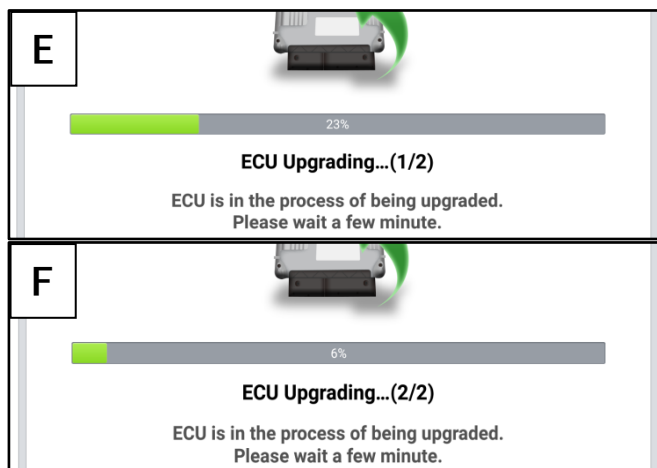
- The ECU upgrade will begin and the progress of the upgrade will appear on the bar graph. Upgrade part (1/2) (E) will download the upgrade event to the VCI-II. Upgrade part (2/2) (F) will upgrade the ECU.

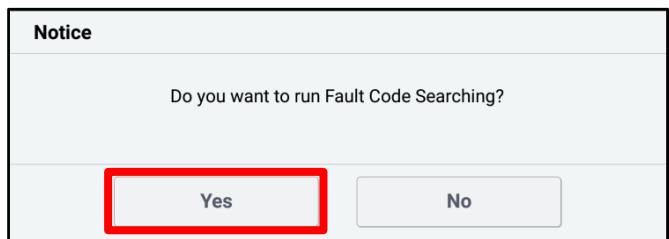
- When prompted, select 'YES' to check for Diagnostic Trouble Codes (DTC) and erase any DTCs stored such as EPS, ESC, and TPMS that may have been set during the upgrade.
