GROUP	MODEL
FUE	2021-2022MY Sorento (MQ4a) w/Theta 2.5L GDI
NUMBER	DATE
054	December 2021

SUBJECT: **SERVICE ACTION: 2.5L GDI WITH MIL ON DTC P2074XX  
ECM LOGIC IMPROVEMENT (SA489)**

This bulletin provides the procedure to update the software logic of the Engine Control Module (ECM) system on some 2021-2022MY Sorento (MQ4a) vehicles with Theta 2.5L GDI engines, produced from September 30, 2020 through October 25, 2021, which may exhibit an MIL ON with DTC P2074XX due to throttle position to Mass Air Flow Sensor (MAF) correlation value reading error under high load. Follow the procedure outlined in this publication to apply the improved logic to the 'ECM' system using the KDS ECU Upgrade function as described in this bulletin. For confirmation that the latest reflash has been applied to a vehicle you are working on, verify the ROM ID using the table on page 3 of this bulletin.

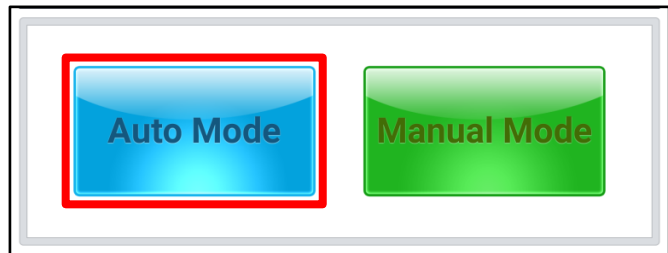
- Select Auto Mode.

Do NOT attempt to perform a Manual Mode upgrade UNLESS Auto Mode fails. Always follow the instructions given on the KDS in either Auto or Manual mode.

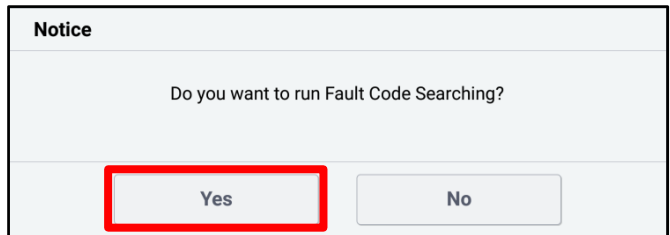
- When prompted, select 'YES' to check for Diagnostic Trouble Codes (DTC) and erase any DTCs stored such as EPS, ESC, and TPMS that may have been set during the upgrade.
