Service Bulletin

Bulletin No.: 20-NA-178

Subject: Service Driver Assist and/or Take Steering Messages on Start-up, Advanced Driver Assist Systems (ADAS) Features Not Available with DTCs U1614, U1615, U1616 Set

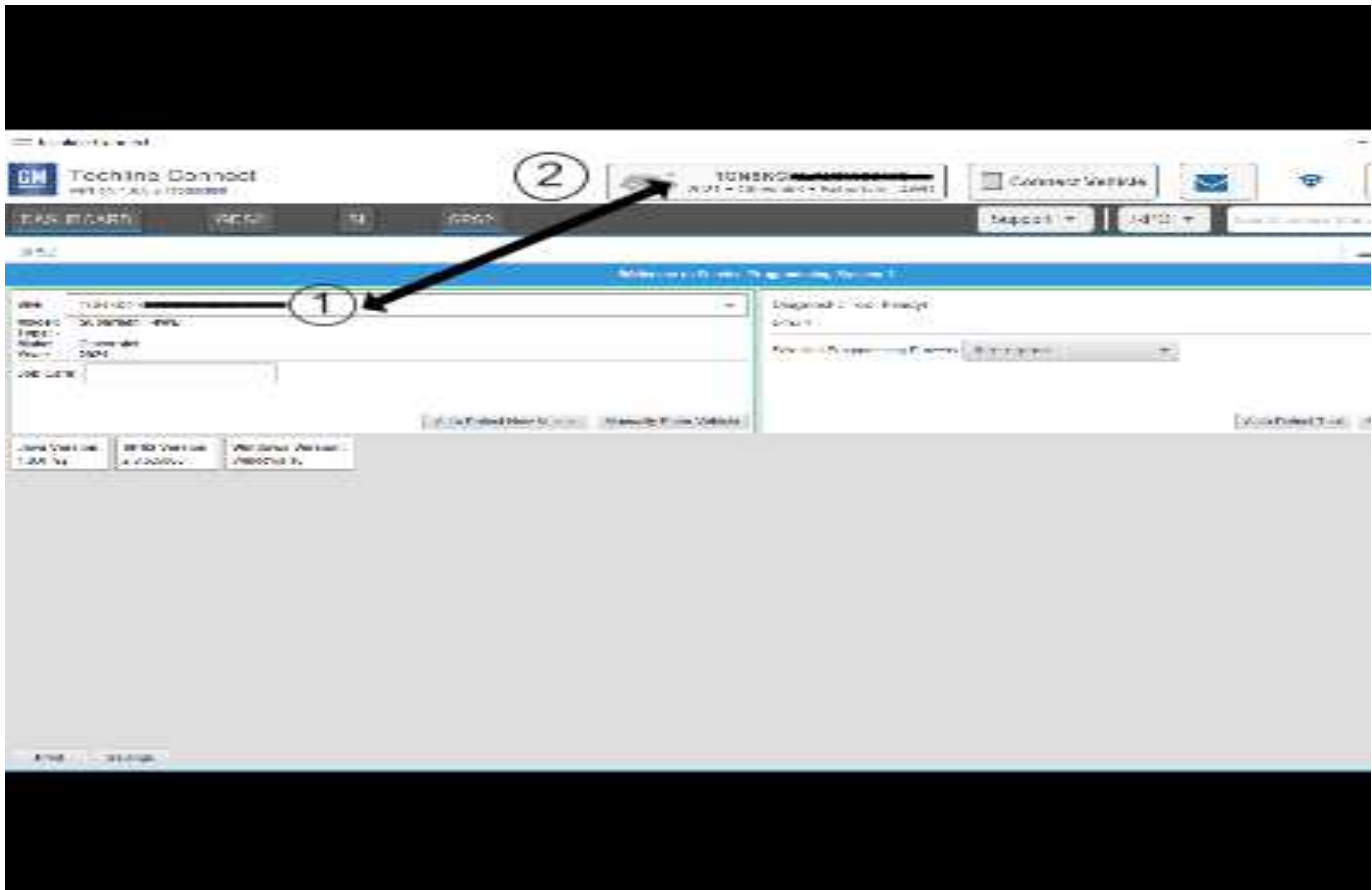
Caution: Be sure the VIN selected in the drop down menu (1) is the same as the vehicle connected (2) before beginning programming.

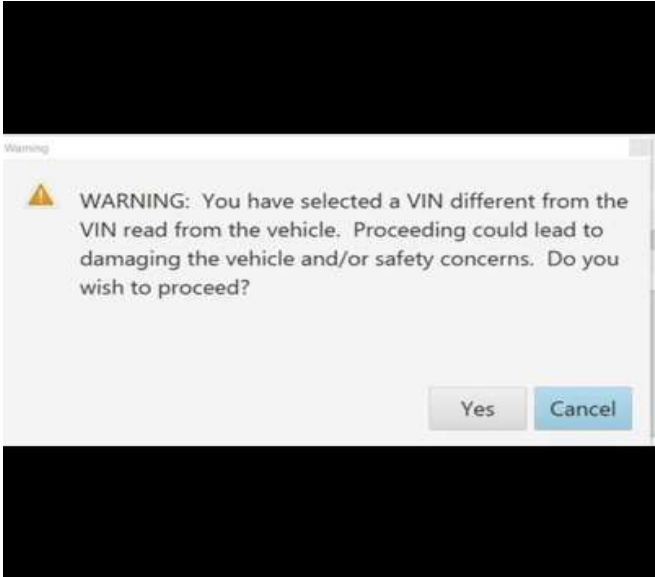
5877000

Important: If the vehicle VIN DOES NOT match, the message below will be shown.

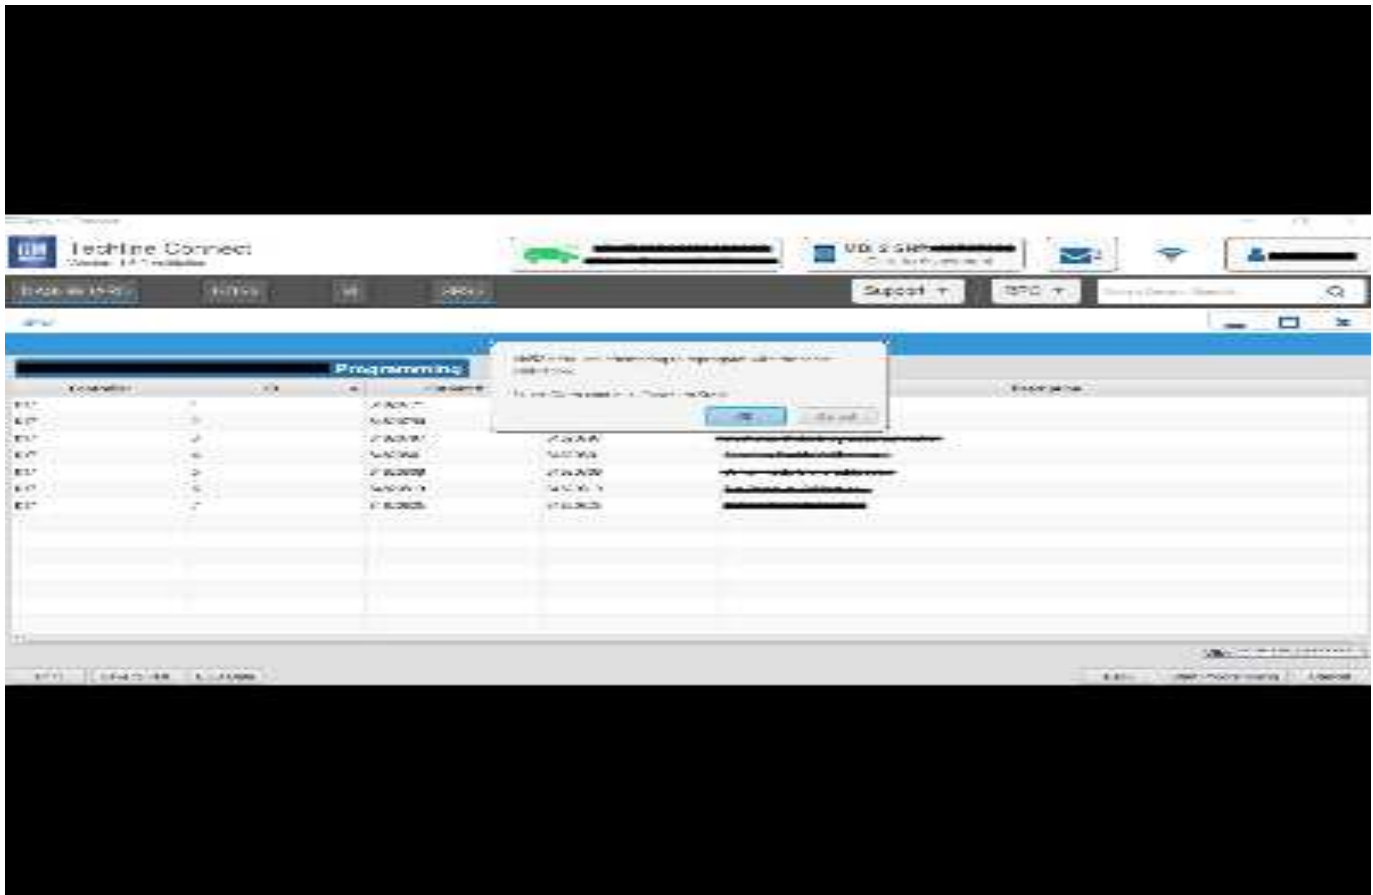
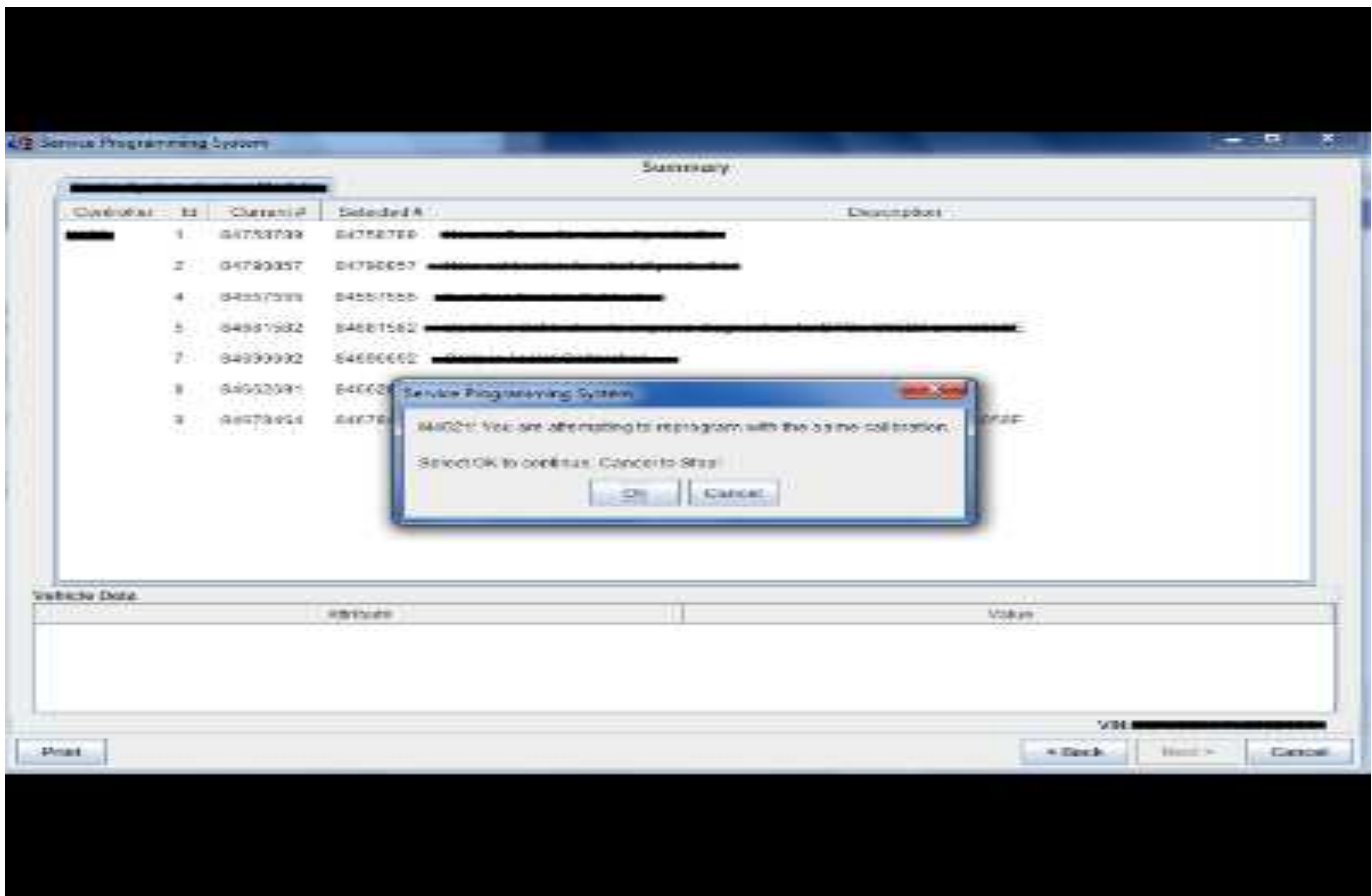
Important: Techline Connect and TIS2WEB screens shown above.
