# Service Bulletin

Bulletin No.: 21-NA-112

**Subject:** Vehicle Software Update (VeSCoM)

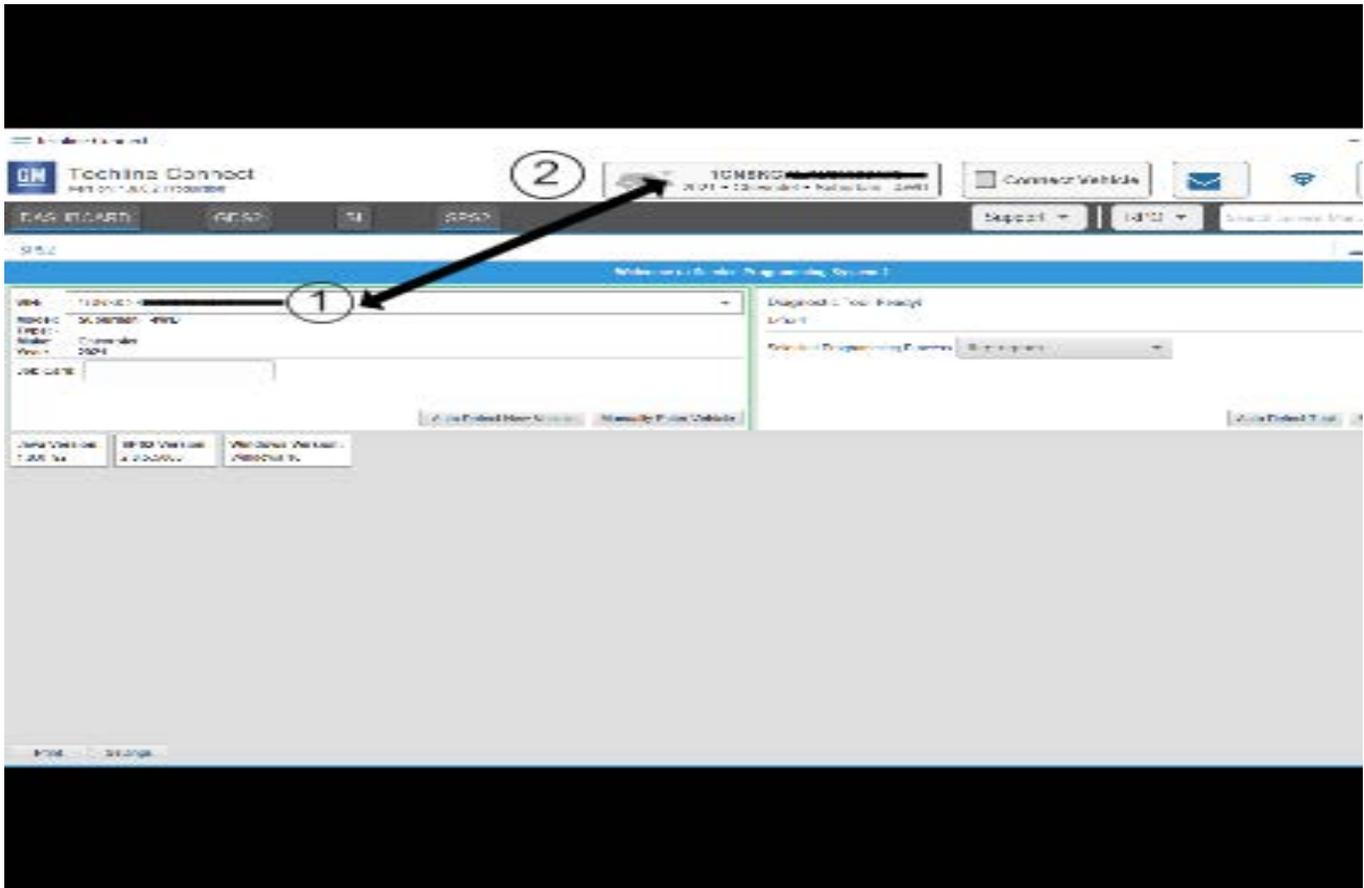
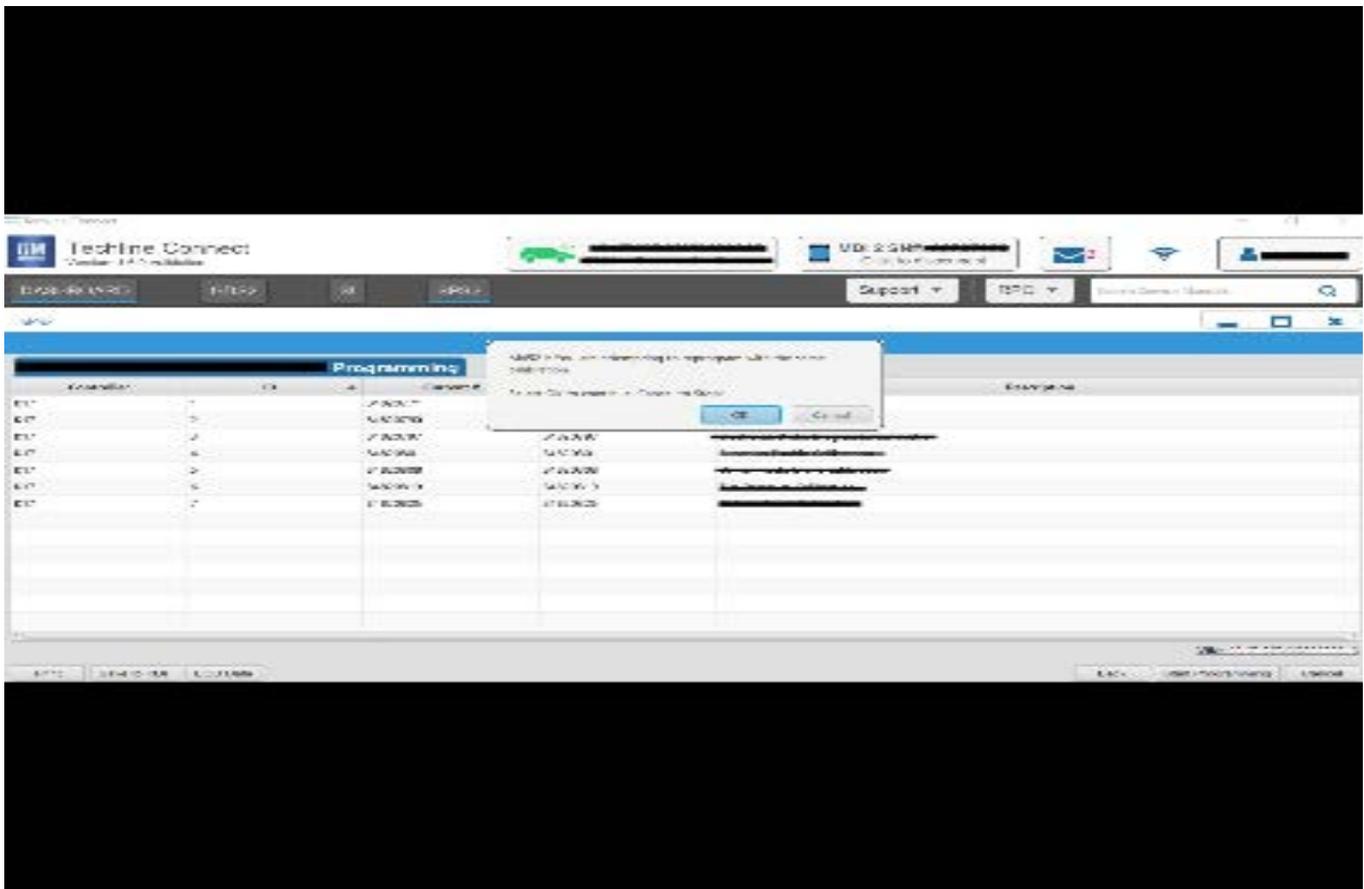
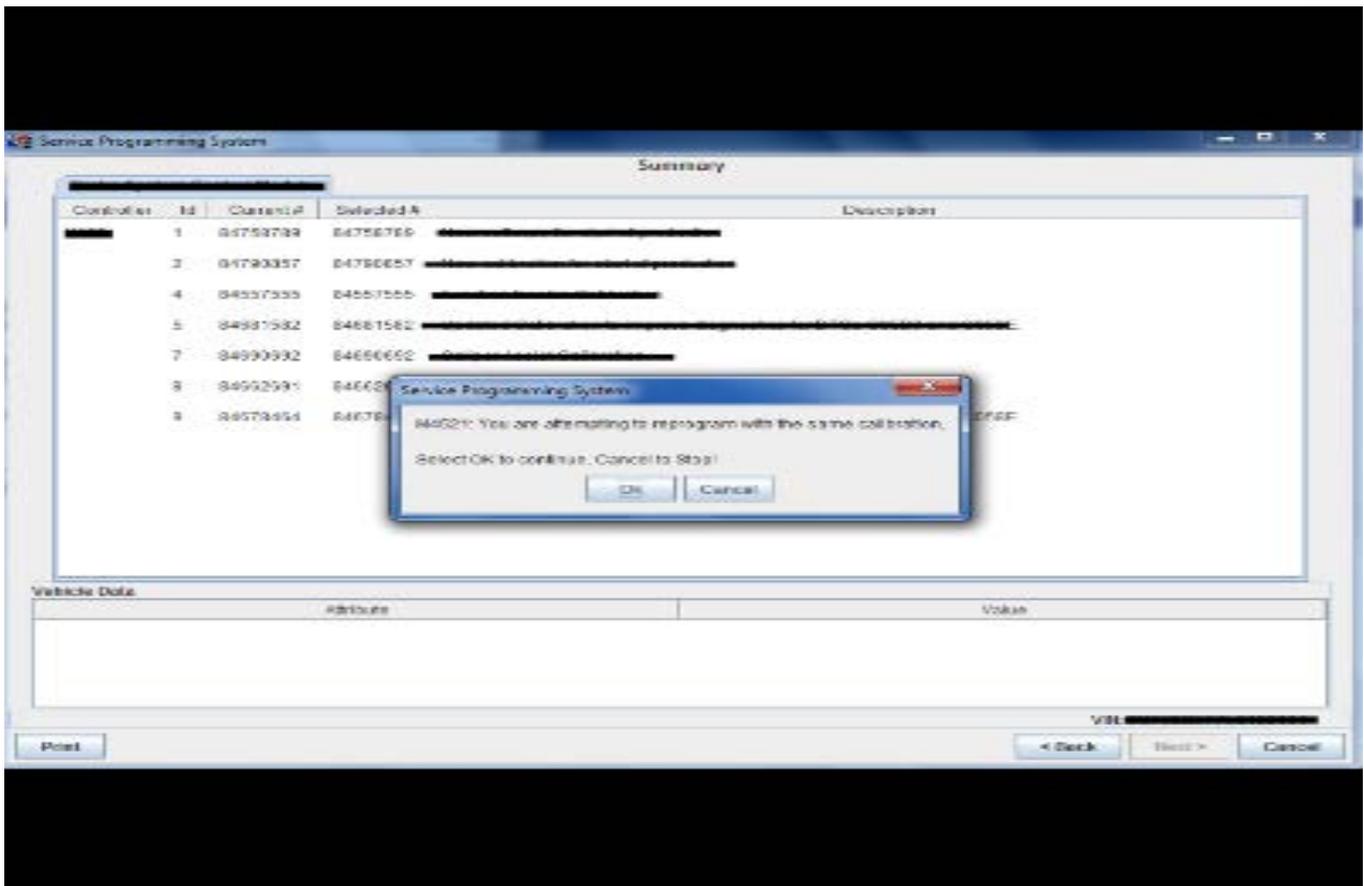
**Caution:** Be sure the VIN selected in the drop down menu (1) is the same as the vehicle connected (2) before beginning programming.

**Important:** Techline Connect and TIS2WEB screens shown above.

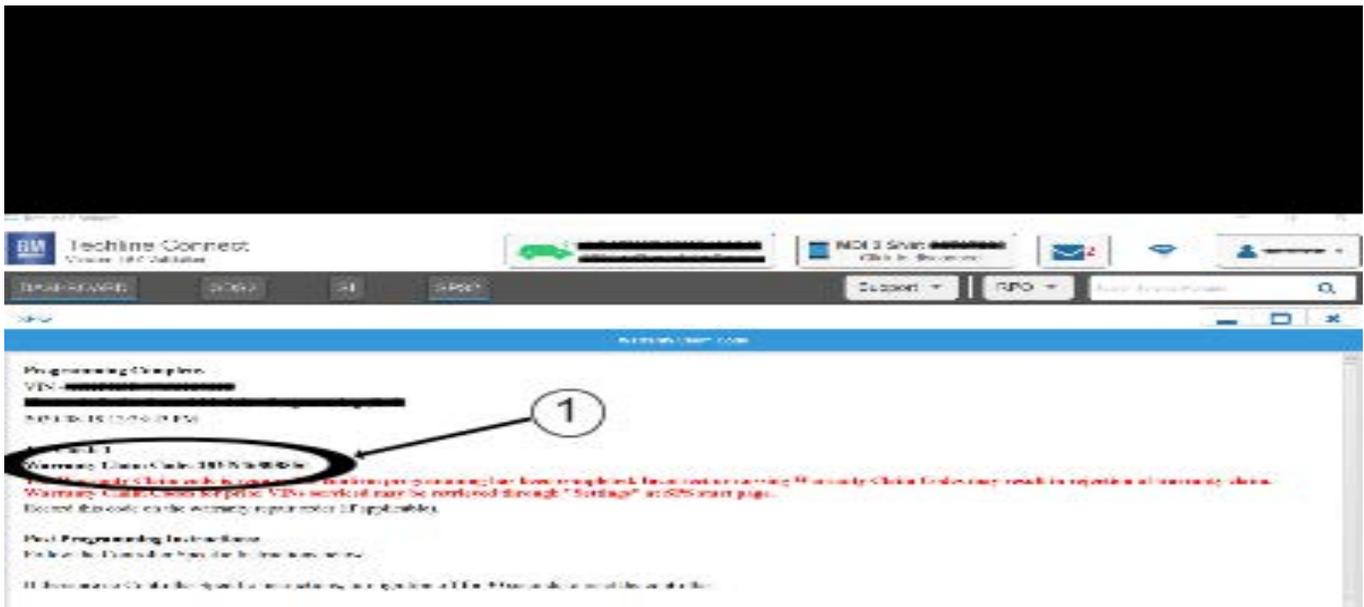
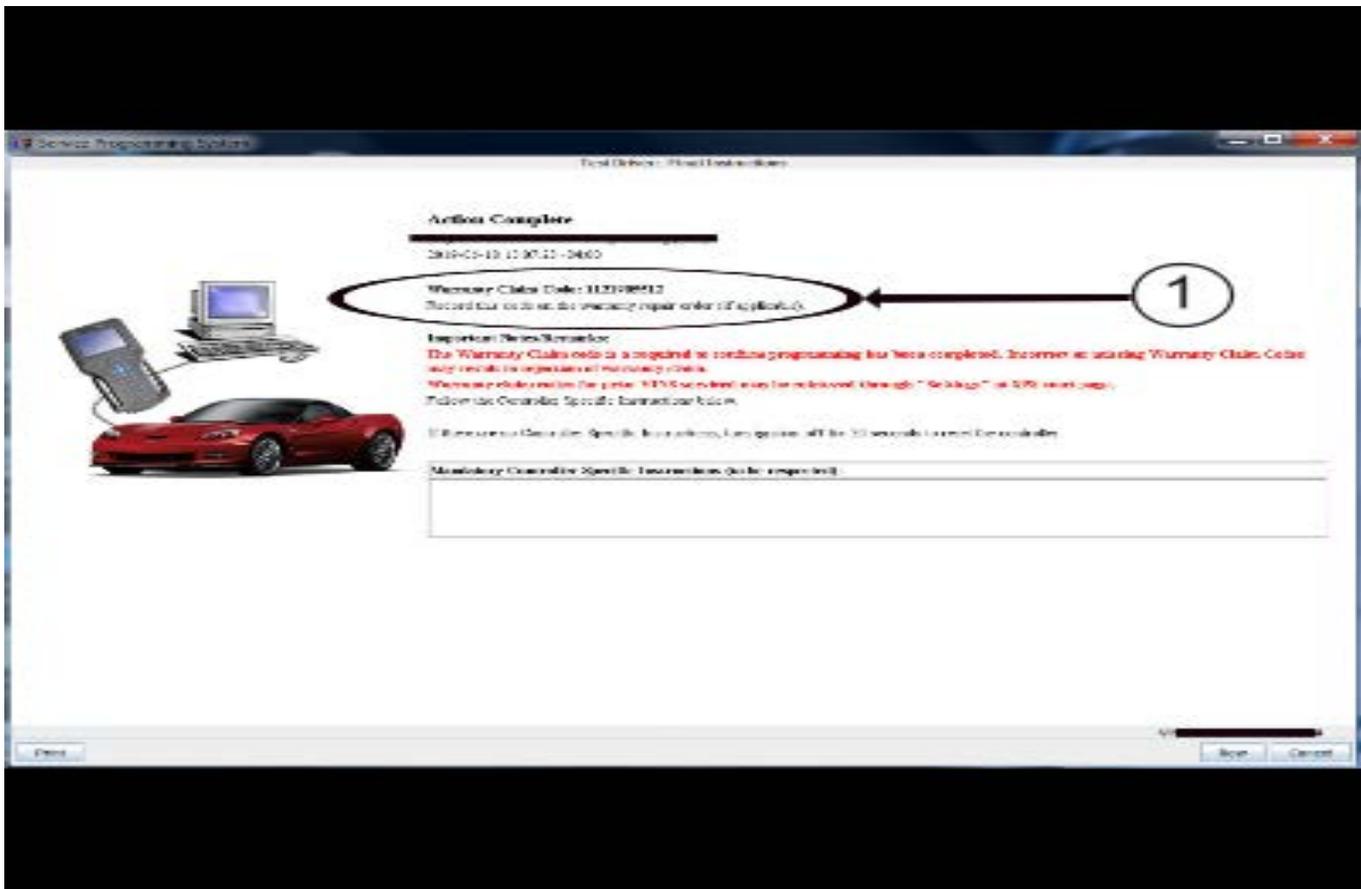
5431209

**Note:** The screenshots above are an example of module programming and may not be indicative of the specific module that is being programmed. Module selection and VIN information have been blacked out.
