Service Action

Code: 93M3

Subject	Drivetrain Software															
Release Date	December 22, 2021															
REVISION SUMMARY	Updated work instructions with information regarding a “Please charge battery” message															
Affected Vehicles

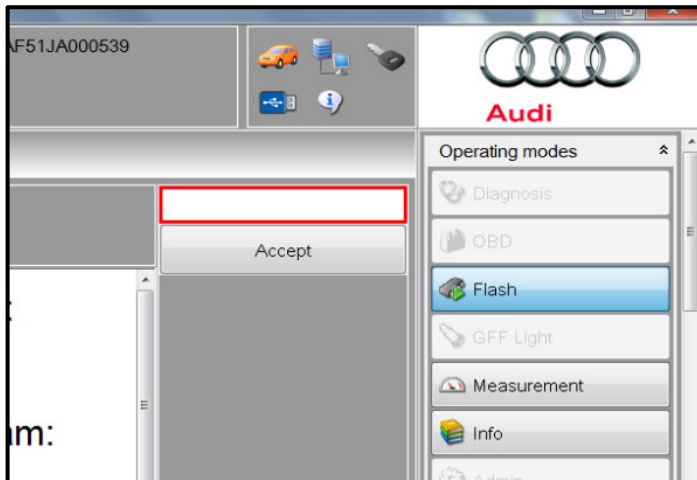
- Enter the corrective action code (SVM code) as listed below.

SVM code
93M3A053

- Select “Accept”.
- Follow the on-screen prompts.

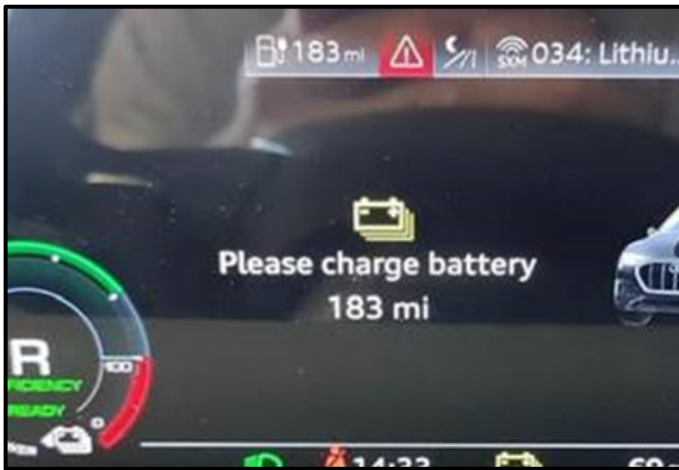
- After the update has been performed, the message "Please charge battery" will appear in the instrument cluster, regardless of the battery's current state of charge. Please connect the vehicle's high-voltage battery charger briefly and start the charging procedure. The message in the instrument cluster will disappear after a few seconds. This step can also be performed independently at a later time (if no battery charger/charging station is available).
- **Proceed to Section C**
