Service Action

Code: 96G2

Subject	Gateway Control Module Software																		
Release Date	December 21, 2021																		
REVISION SUMMARY	Updated part numbers in claiming section																		
Affected Vehicles

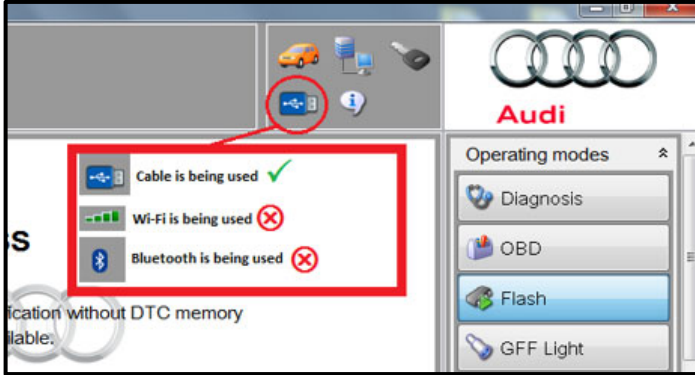
The procedure may cancel itself if the hazard warning lights are not switched on. The hazard warning lights prevent the system from switching to bus sleep mode during the update.

- Confirm that scan tool is communicating with the diagnostic head by USB cable.
 - If the Bluetooth or WiFi symbol is shown, then disconnect the diagnostic head from the vehicle and reconnect the USB cable to the diagnostic head and then reattach to the vehicle.

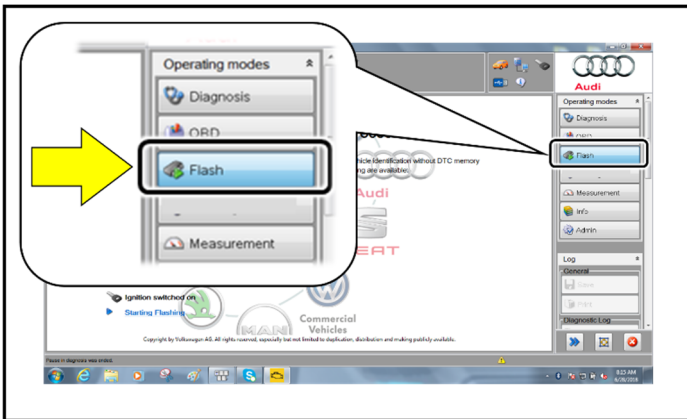
- From the home screen of the scan tool highlight “Flash” <1>.
- Follow the on-screen prompts.

Operating mode “Flash” must be used. Performing this update using “Diagnosis” (Guided Fault Finding) could result in non-payment of the claim.

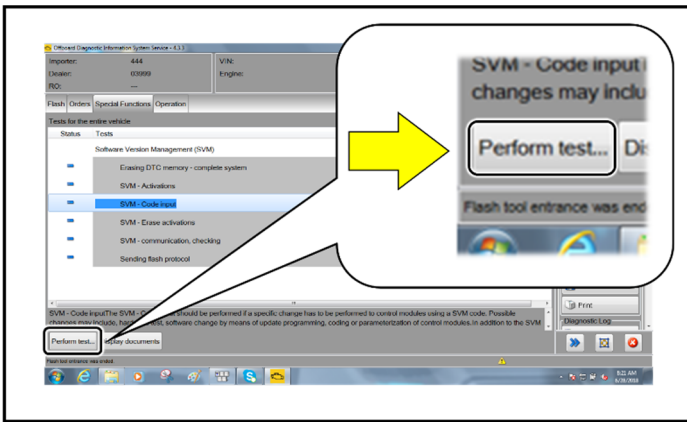
- Select "Perform test".

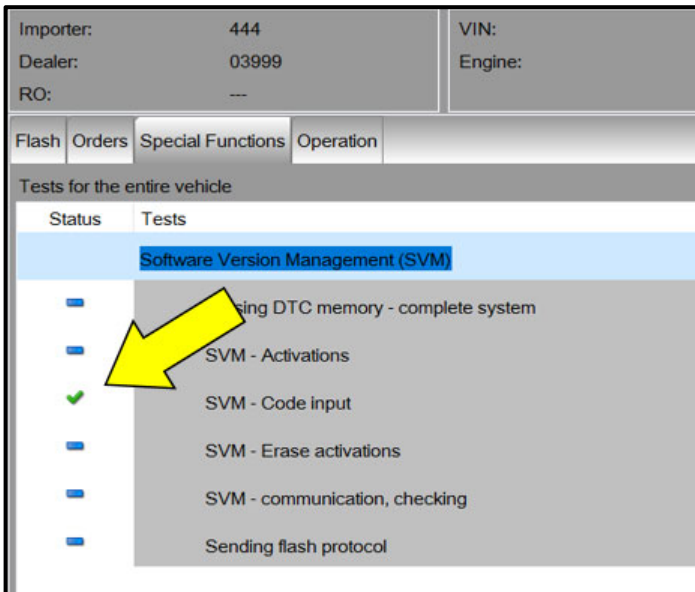
When the progress bar reaches 90%, it will stay at 90% for up to 15 minutes. This is normal. DO NOT cancel the flash process.

- After receiving confirmation that the update completed successfully (green check mark) <arrow>, the ignition must be turned off for 60 seconds and then turned back on.
