# Mack Chassis - Diagnostic Trouble Code ( DTC ) P208A Lighting The Malfunction Indicator Lamp ( MIL ) - US14+OBD13 And US14+OBD15 Emissions, Common Model Years 2015 And 2016

Software updates with enhancements are available for the engine control module (ECM) and aftertreatment control module (ACM) for VOLVO D11, D13 and D16 engines on OBD2015 vehicles built from January 1, 2015 to December 31, 2015.

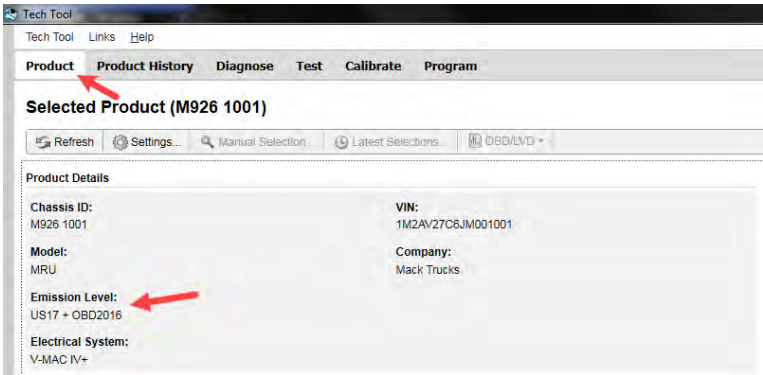
- Details can be found in the Product Details box on the Product tab in PTT as seen below:

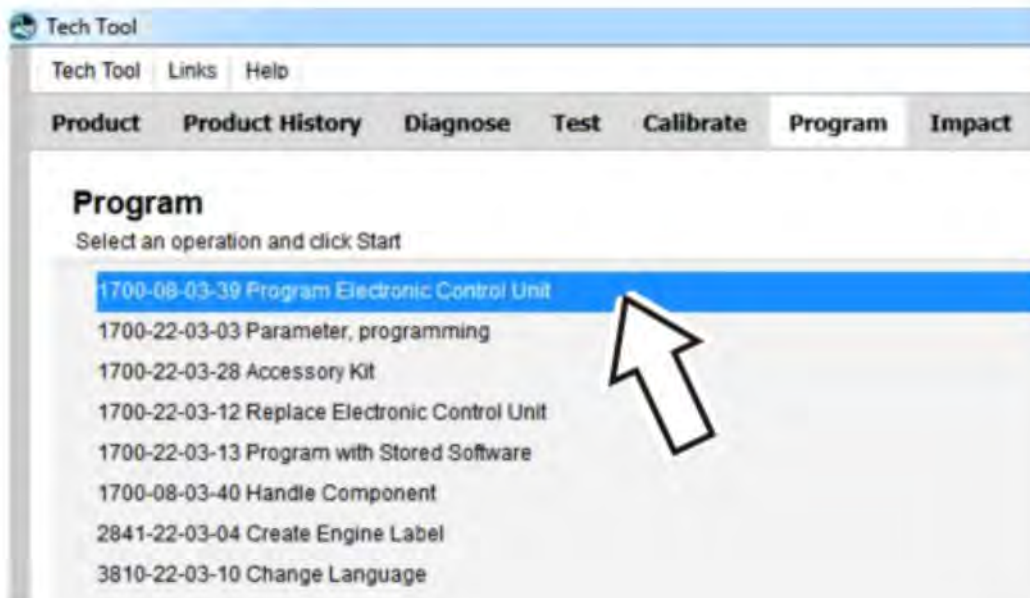
9. From the Main Menu select Program and then Program Electronic Control Unit 1700-08-03-39. Then click Start.

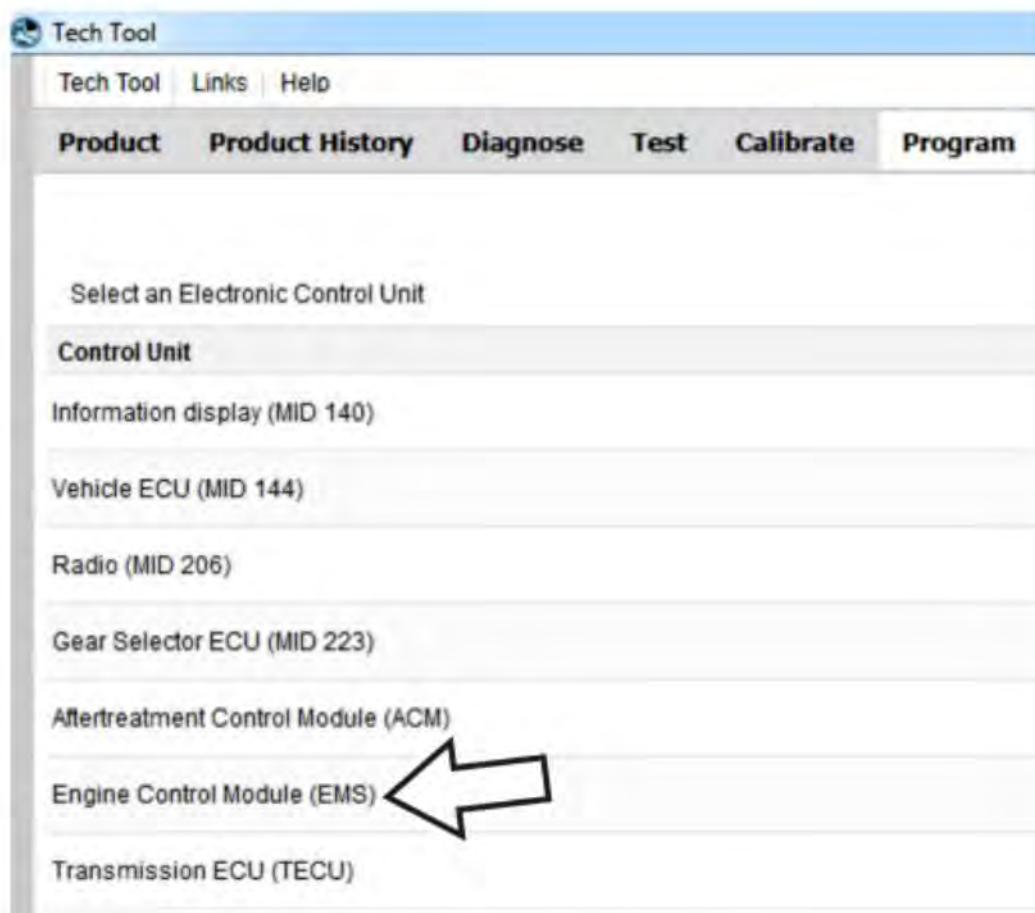
10. Select Engine Control Module (EMS).

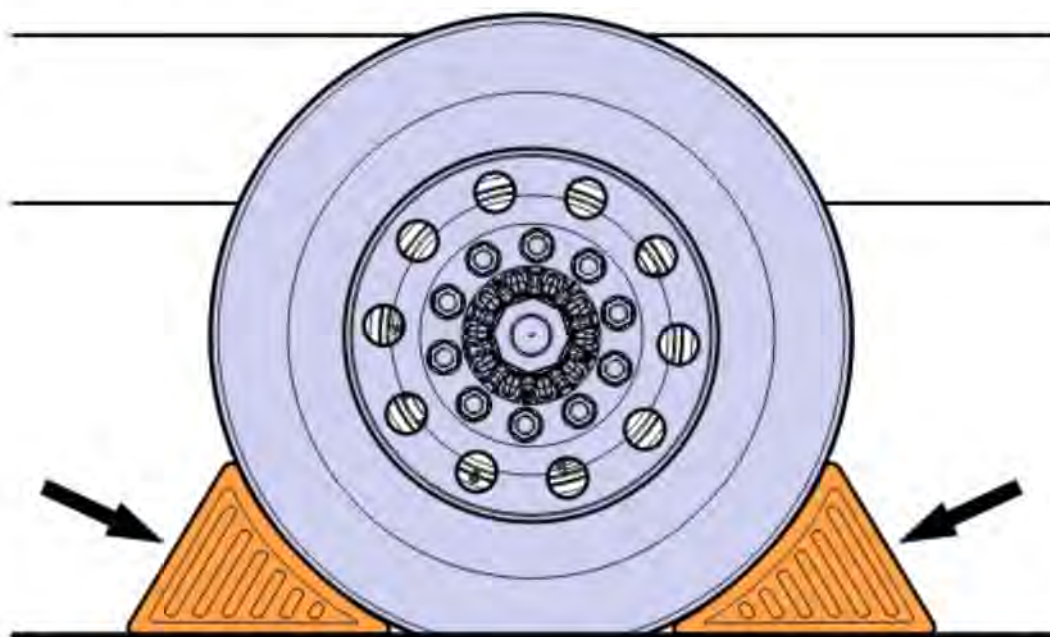
1. Park the vehicle on a level surface.
2. Apply the parking brake.
3. Place the transmission in neutral or park.
4. Install the wheel chocks.

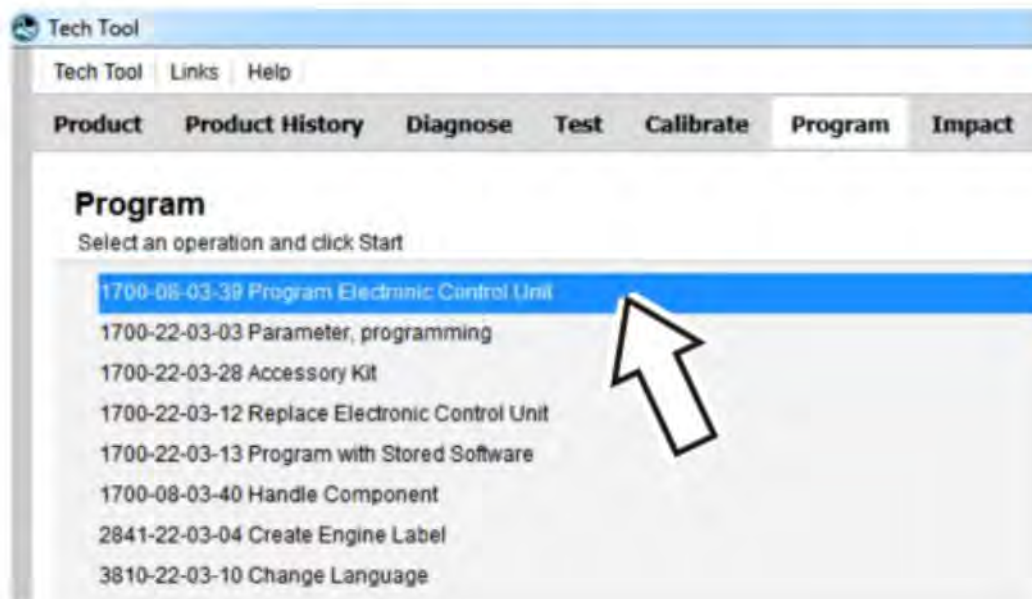
9. From the Main Menu select Program and then Program Electronic Control Unit 1700-08-03-39. Then click Start.

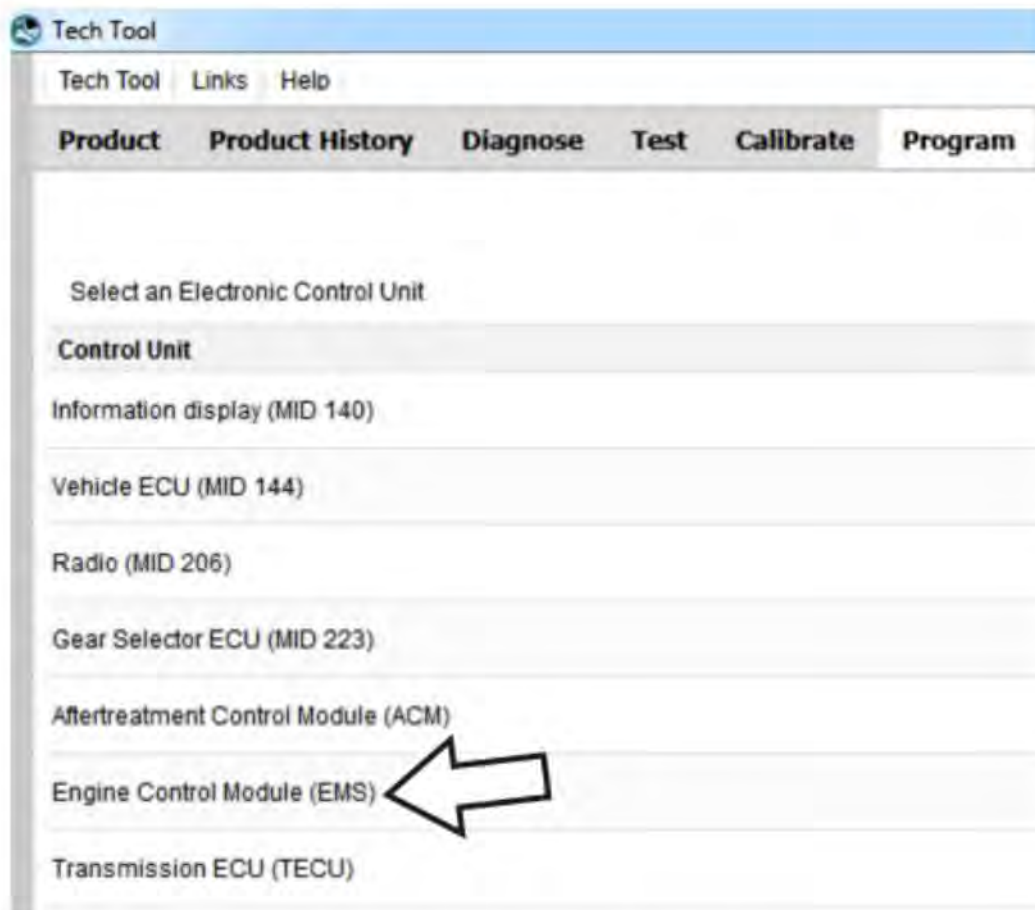
10. Select Engine Control Module (EMS).

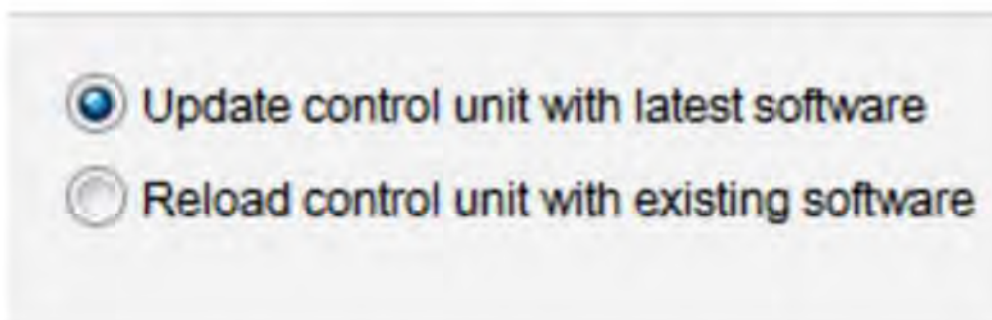
## Programming options

11. Select Program to update the ECM with the latest software.
