# Mack Chassis - Diagnostic Trouble Code ( DTC ) P226D Intermittently Lighting The Malfunction Indicator Lamp ( MIL ) - US14+OBD15 And US14+OBD16 Emissions (Non-Common Rail Fuel System), Commonly Model Years 2015 and 2016

Software updates with enhancements are available for the engine control module (ECM) and aftertreatment control module (ACM) for VOLVO D11, D13 and D16 engines on OBD2015 vehicles built from January 1, 2015 to December 31, 2015.

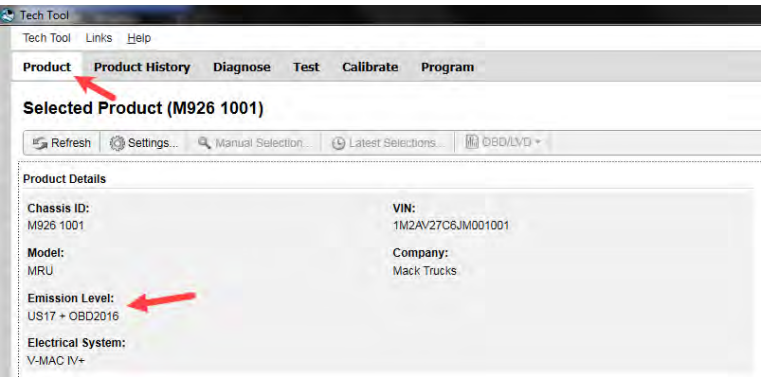
- Details can be found in the Product Details box on the Product tab in PTT as seen below:
