# Mack Chassis - Diagnostic Trouble Codes ( DTC's ) P24A0 And P249F Lighting The Malfunction Indicator Lamp ( MIL ) - US14+OBD15, US14+OBD16 (Common Model Years 2016 And 2017), US17+OBD16 And Newer ( Common Rail Fuel System, Model Year 2018)

## Information

Software updates with enhancements are available for the engine control module (ECM) and aftertreatment control module (ACM) for VOLVO D11, D13 and D16 engines on OBD2015 vehicles built from January 1, 2015 to December 31, 2015.

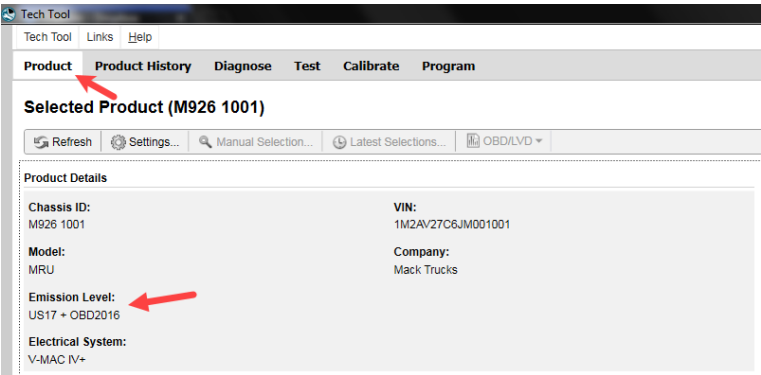
- Details can be found in the Product Details box on the Product tab in PTT as seen below:

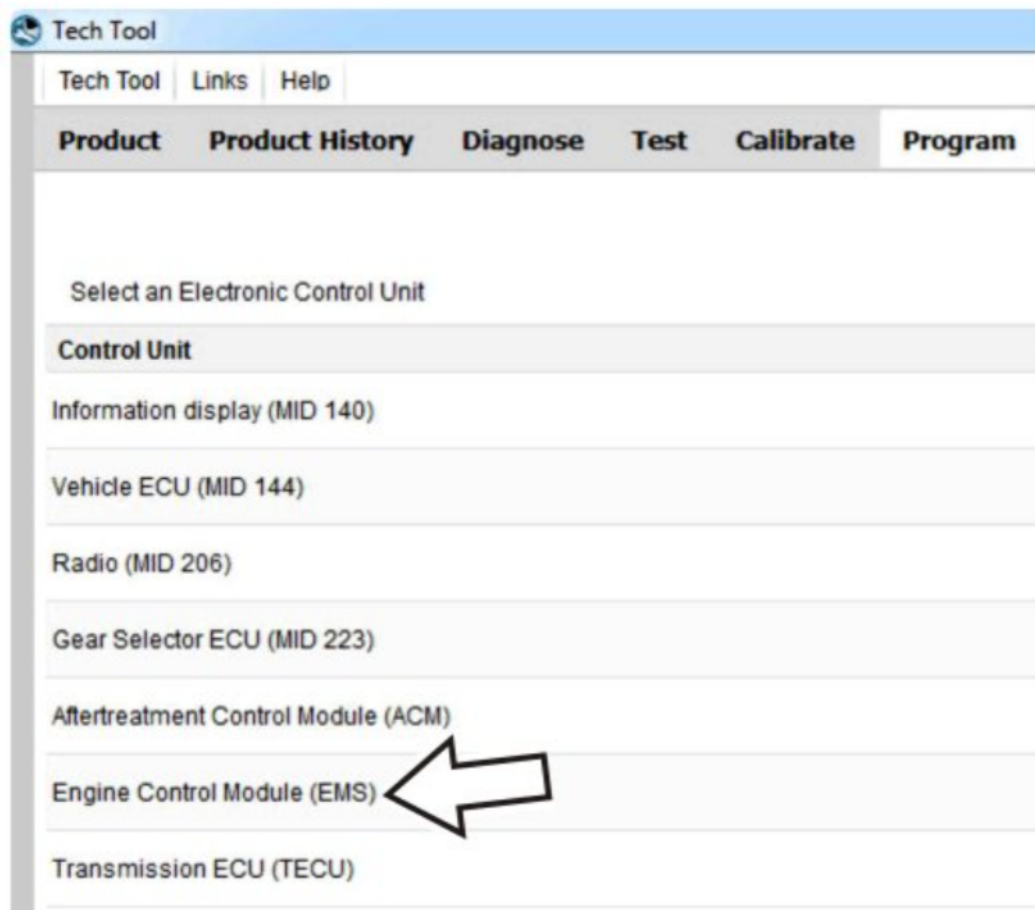
10. Select Engine Control Module (EMS).

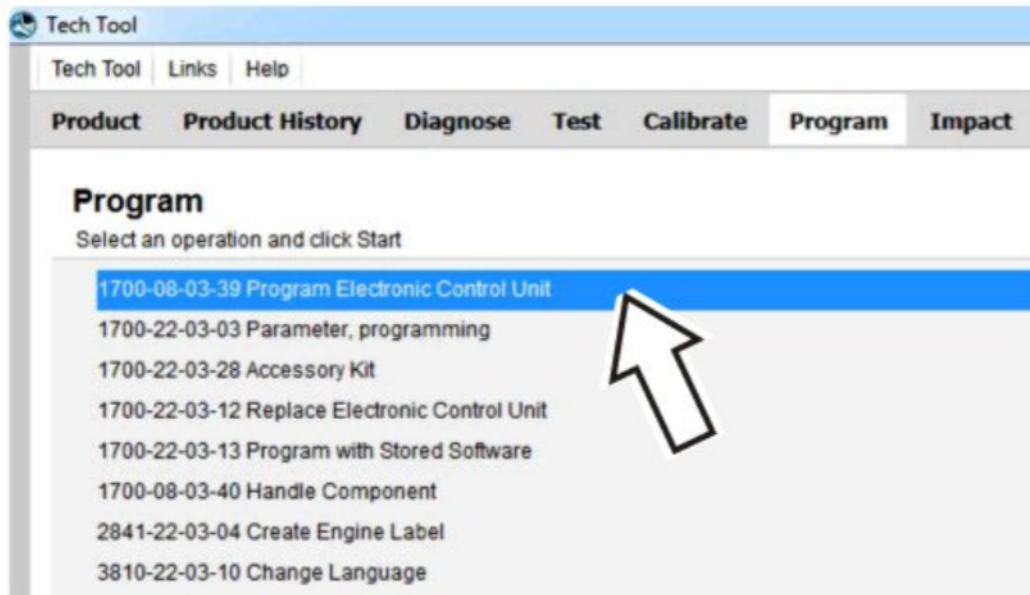
9. From the Main Menu select Program and then Program Electronic Control Unit 1700-08-03-39. Then click Start.
