# Mack Chassis - Diagnostic Trouble Code ( DTC ) P249C Intermittently Lighting The Malfunction Indicator Lamp ( MIL ) - US14+OBD15 And US14+OBD16 (Non-Common Rail Fuel System) Emissions, Common Model Years 2016 and 2017

Software updates with enhancements are available for the engine control module (ECM) and aftertreatment control module (ACM) for VOLVO D11, D13 and D16 engines on OBD2015 vehicles built from January 1, 2015 to December 31, 2015.

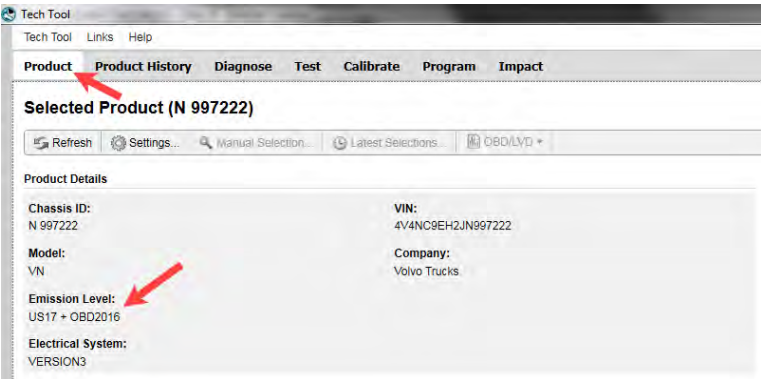
- Details can be found in the Product Details box on the Product tab in PTT as seen below:
