# SERVICE BULLETIN

## SOFTWARE UPDATE FOR INFOTAINMENT ISSUES

**APPLIED VEHICLES:** 2019-2020 Maxima (A36)

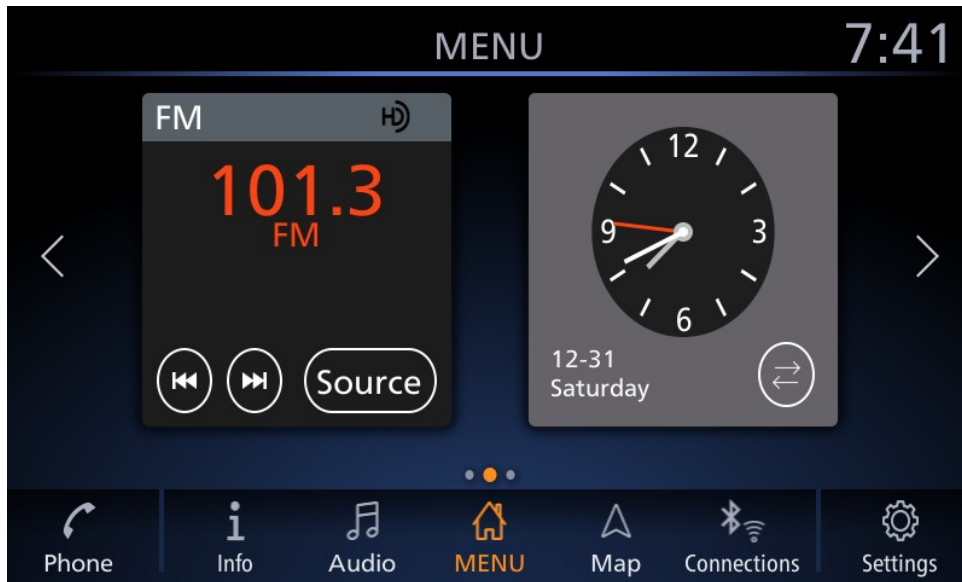
Figure 2

From the **MENU** screen shown in Figure 2:

- Select and hold the **MENU** button (not shown), and at the same time rotate the tuning knob more than 3 clicks in each direction (back and forth) until the **System Diagnosis Menu**, shown in Figure 3, displays.

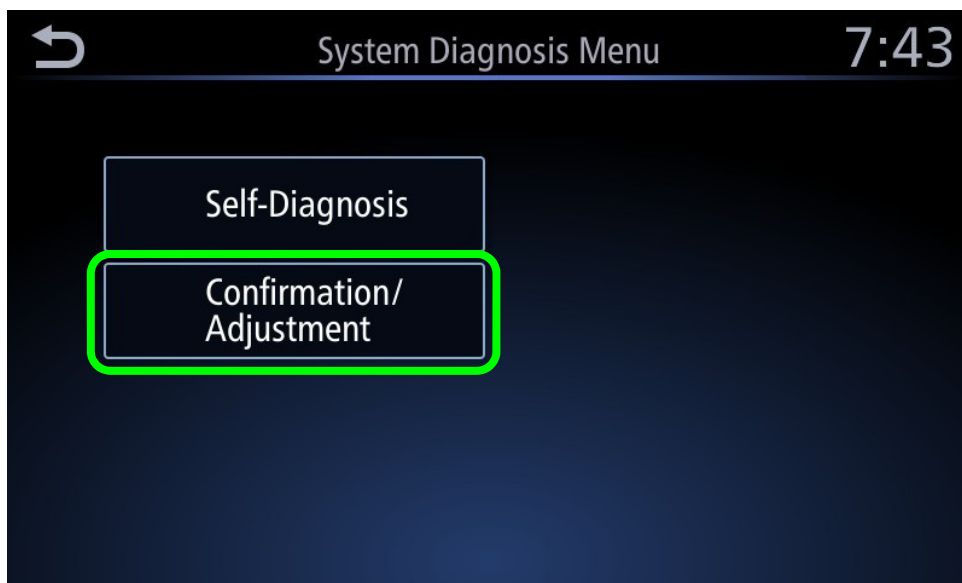
Figure 3

2. Select **Confirmation/Adjustment**.

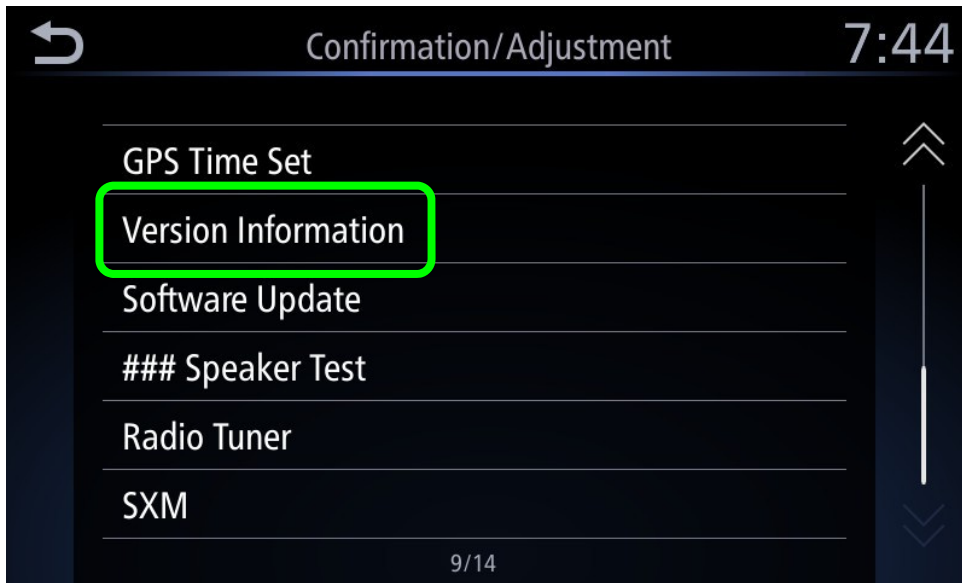
Figure 4

3. Select **Version Information**.

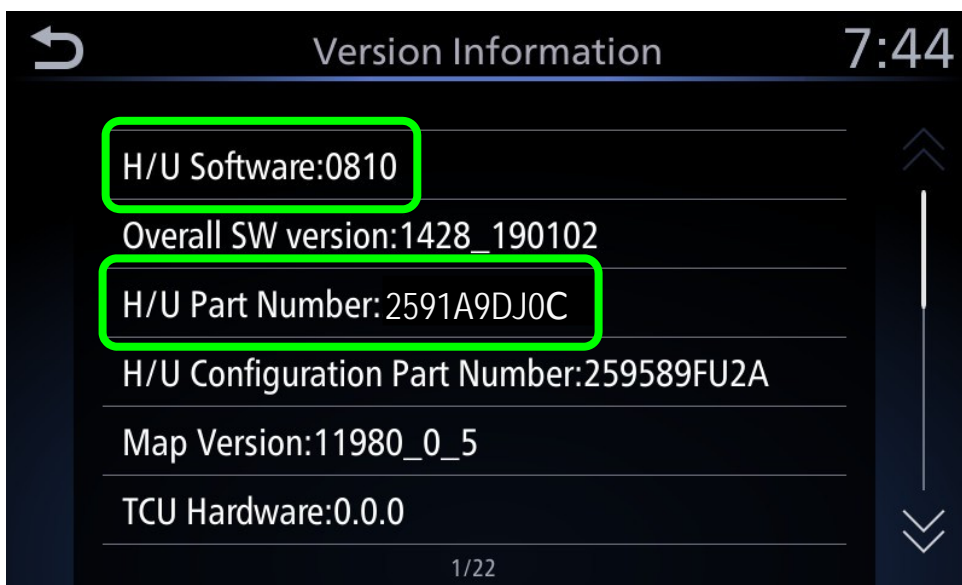
4. Using Figure 5 for reference, confirm the following:

- a. The **H/U Software** version is 810, and
  - b. The **H/U Part Number** is 25915-9DJ0C or 2591A-9DJ0C.
- If the **H/U Software** version and the **H/U Part Number** match, proceed to step 5 on page 5 to update the AV control unit.
  - If either the **H/U Software** version or the **H/U Part Number** do not match, this bulletin does not apply. Refer to the ESM for further diagnostic information.

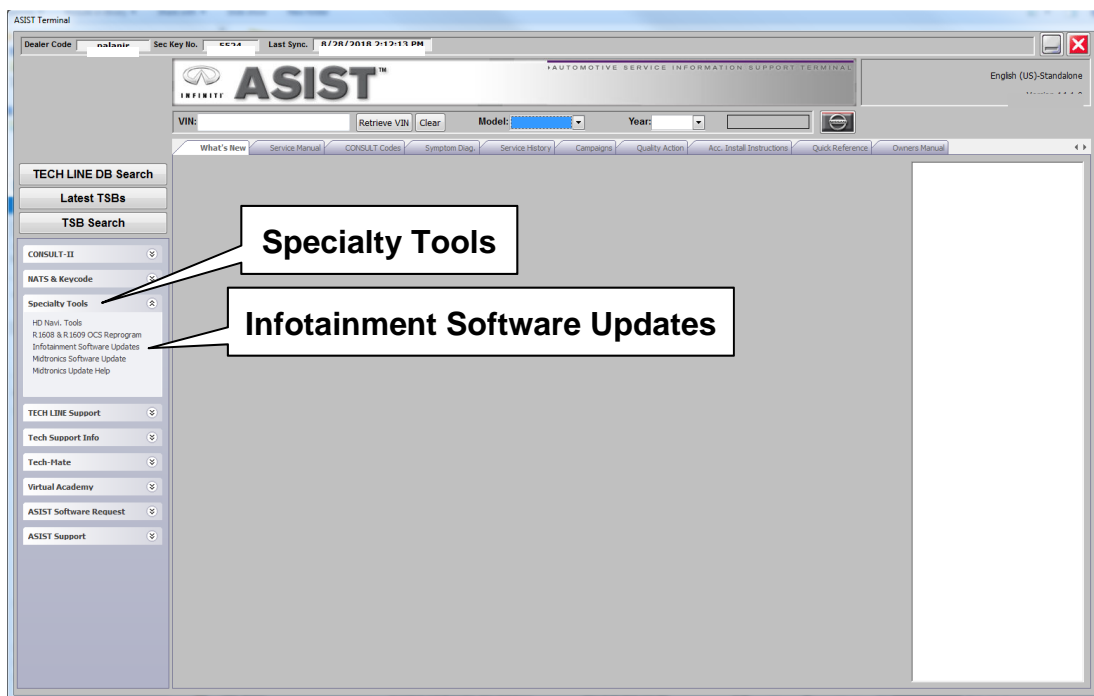
Figure 6

6. Open ASIST.
7. Select **Specialty Tools**, and then select **Infotainment Software Updates**.

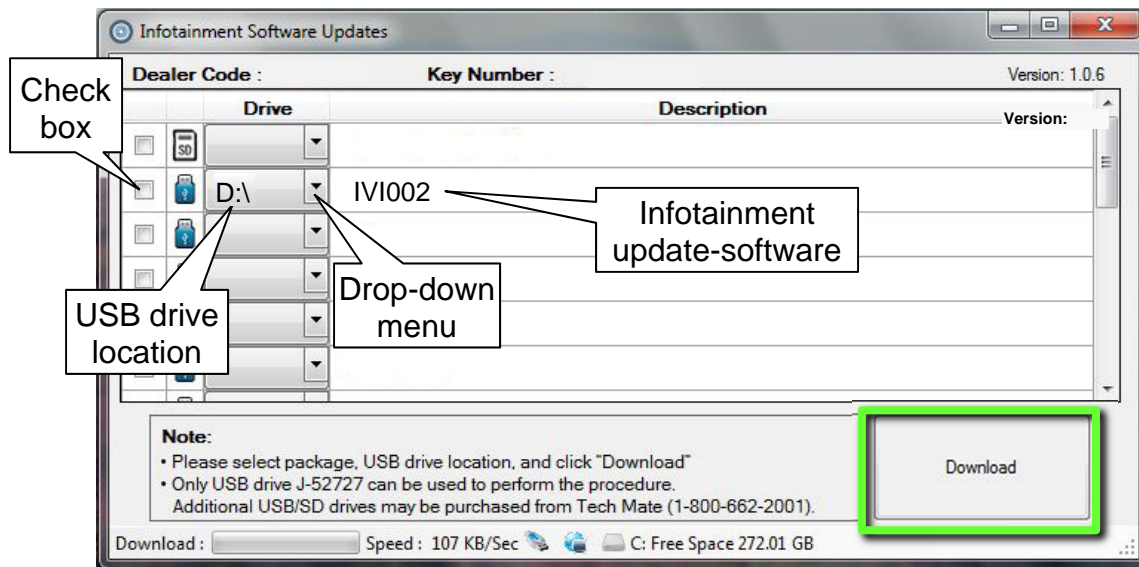
Figure 7

8. Select the check box next to the **IVI002** infotainment update-software (Figure 7).
9. Use the drop-down menu and select the location of the USB drive that was inserted into the CONSULT PC in step 5 on page 5.

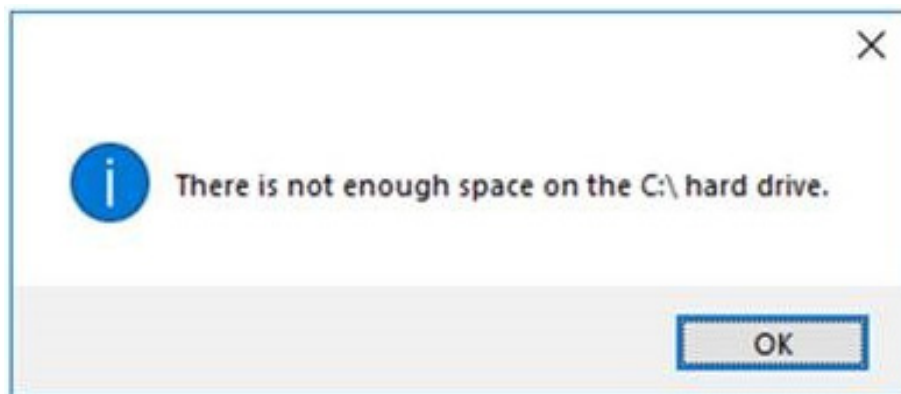
Figure 8

- If, while attempting to download the software to the CONSULT PC, you receive the message shown in Figure 8:
    - a. First, attempt to clear space on the CONSULT PC hard drive.
    - b. If space on the hard drive cannot be cleared, email Bosch at **nissan.dealers@us.bosch.com** for additional options.

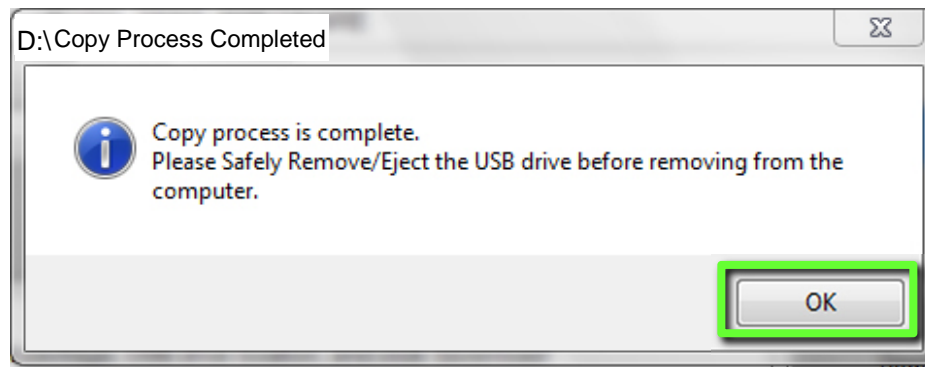
Figure 9

11. Select **OK**.

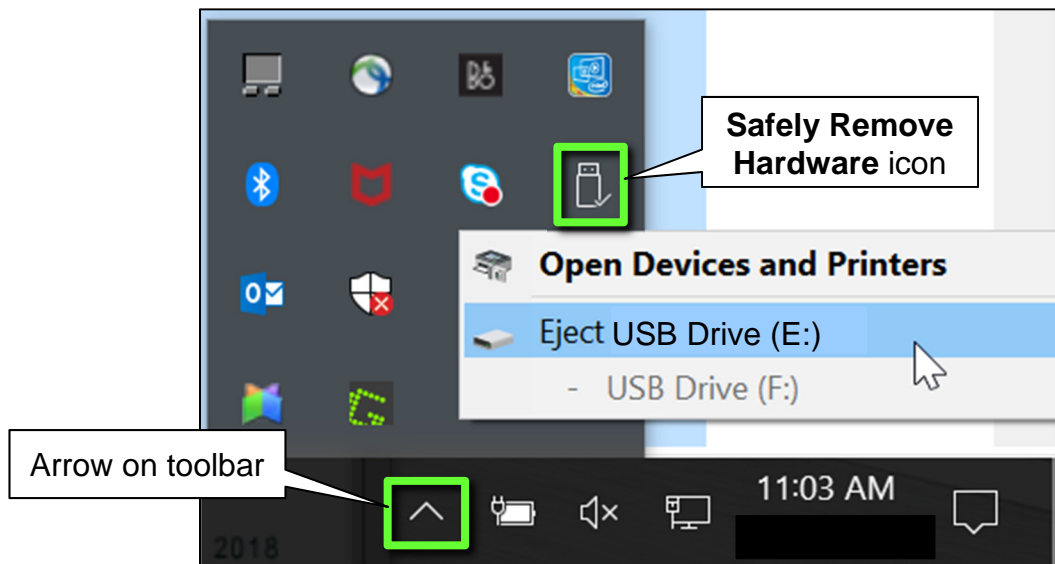
Figure 10

12. Once the transfer is complete, safely remove the USB drive from the CONSULT PC.
- From the PC toolbar, select the **Safely Remove Hardware** icon (Figure 10).
    - The icon is on the toolbar, or can be found after selecting the arrow.
  - Select the USB drive to be removed, and then remove the USB drive from the CONSULT PC.

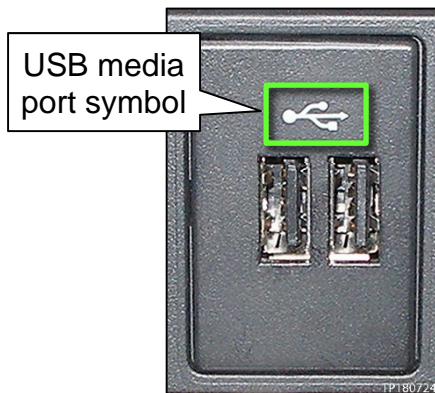
Figure 11

16. Insert the USB drive with infotainment update-software into the vehicle's USB media port (Figure 11).
- Do not remove the USB drive during the update to the vehicle until instructed to do so in this bulletin.

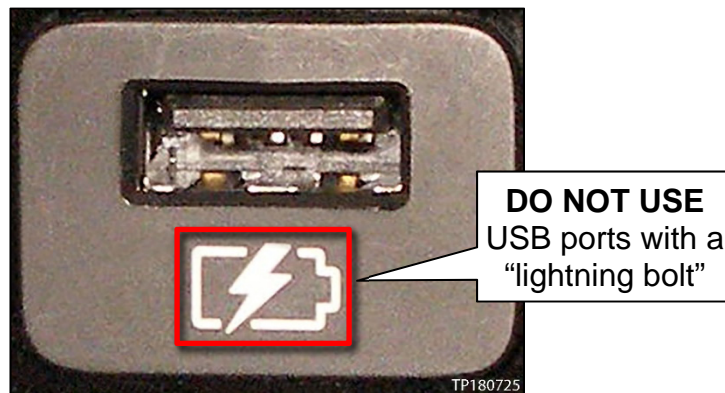
Figure 12

Do not insert the USB drive into a charging port (Figure 12). If used, the update-software and/or USB drive may become damaged. Only insert the USB drive in a USB media port.

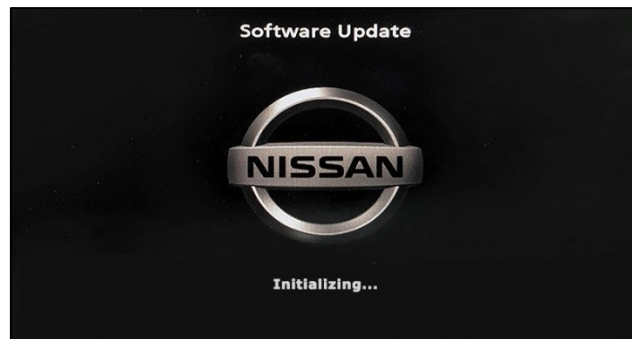
17. Wait approximately 10-30 seconds for the screen in Figure 13 to appear.

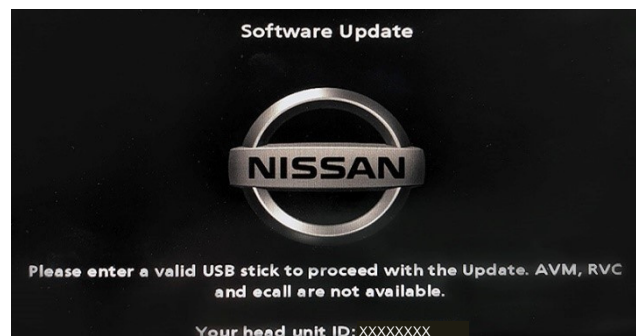
- The screen in Figure 14 may briefly appear. **Do not remove the USB drive.** The audio system will detect the USB drive and continue the update.

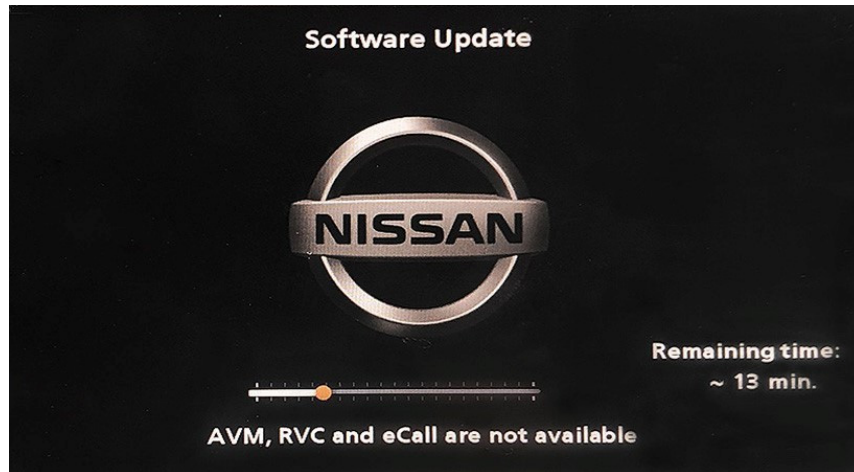
Figure 15

18. Wait for the update to complete.
- Follow the on-screen instructions while waiting.

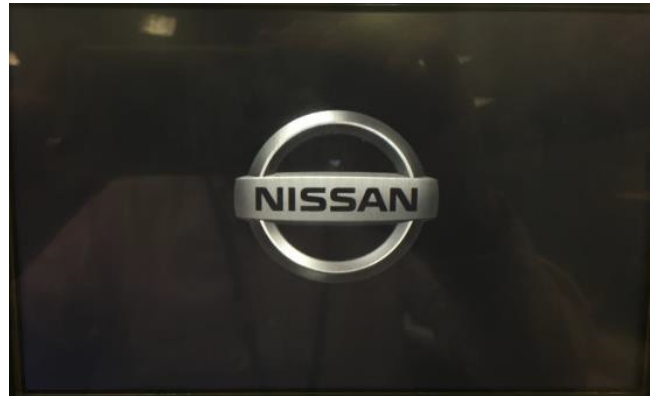
Figure 17

- 20. Allow the reboot to complete (approximately 30 seconds).
  - The Nissan logo will be displayed during the reboot.

- 24. Turn the ignition ON (engine OFF) and wait for the Nissan logo to appear (Figure 17).
  - If the Nissan logo does not appear (this might take up to 30 seconds), start over from step 21.

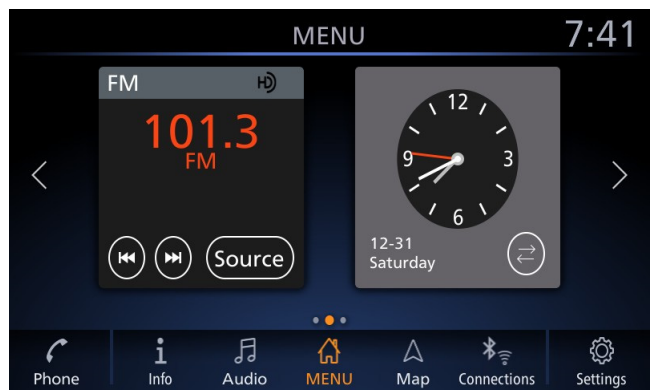
- 25. After the Nissan logo appears, wait about 1 minute.
  - The **MENU** screen in Figure 18 will be displayed.
