SERVICE BULLETIN

Classification: AN21-024	Reference: NTB21-119	Date: December 20, 2021
-----------------------------	-------------------------	----------------------------

INFOTAINMENT SYSTEM CONSTANTLY REBOOTS EVERY 4-5 MINUTES

APPLIED VEHICLES: 2021 Rogue (T33)
APPLIED GRADES: SV vehicles that are, or were, part of a rental fleet

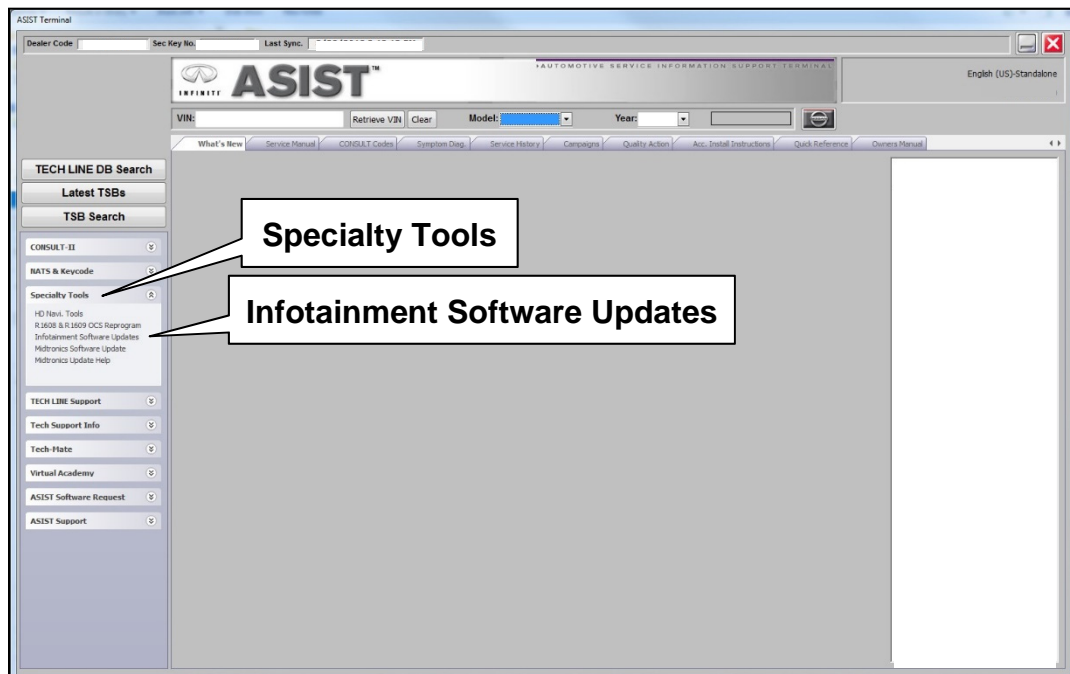
Figure 2

3. Select **Specialty Tools**, and then select **Infotainment Software Updates**.

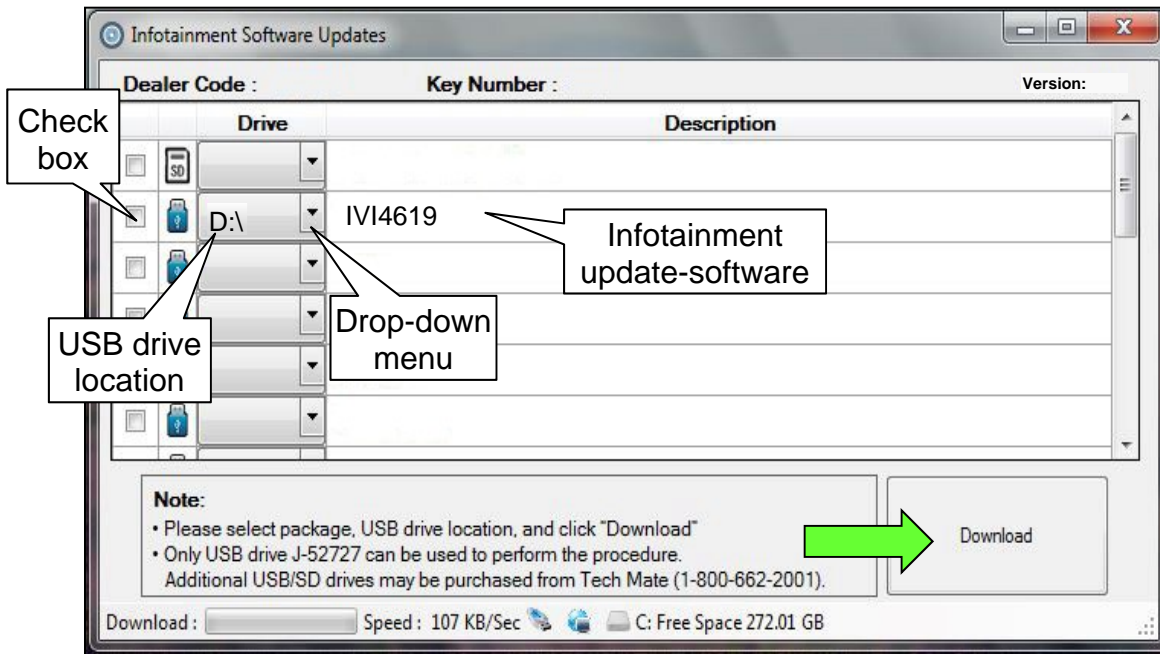
Figure 3

4. Select the check box next to infotainment update-software ID **IVI4619** (Figure 3).
5. Use the drop-down menu and select the location of the USB drive that was inserted in step 1 on page 3.

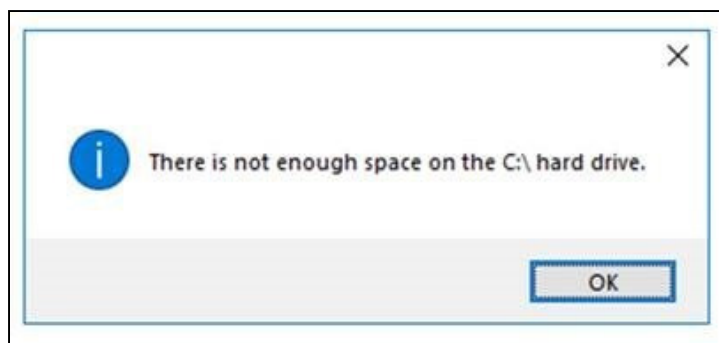
Figure 4

- o The update-software is estimated to take **4 hours** to download to the USB drive.
- o If, while attempting to download the software to the CONSULT PC, you receive the message shown in Figure 4:
 - a. First, attempt to clear space on the CONSULT PC hard drive.
 - b. If space on the hard drive cannot be cleared, email Bosch at **nissan.dealers@us.bosch.com** for additional options.

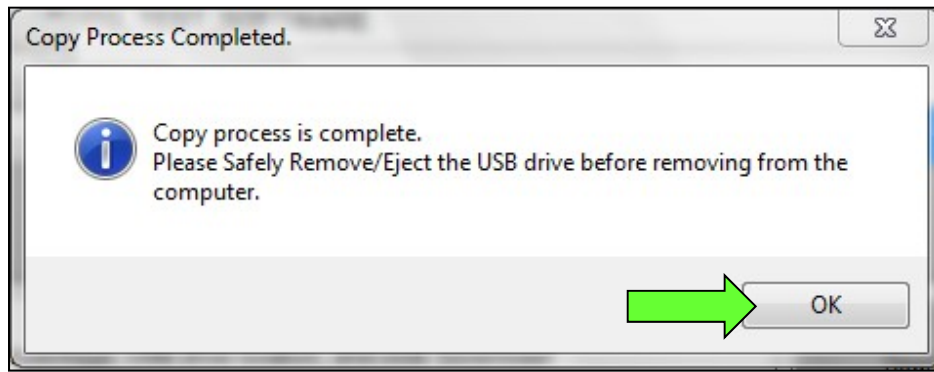
Figure 5

7. Select **OK**.

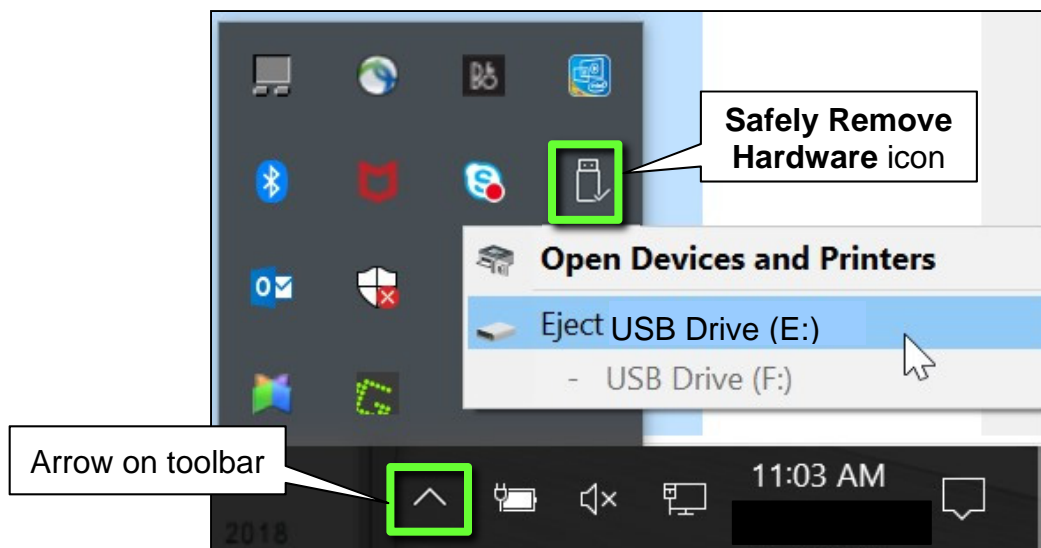
Figure 6

- a. From the PC toolbar, select the **Safely Remove Hardware** icon.
 - o The icon is on the toolbar, or can be found after selecting the arrow.
- b. Select the USB drive to be removed, and then remove the USB drive from the CONSULT PC.

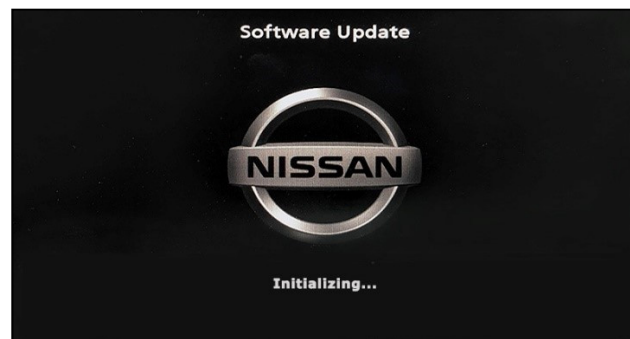
13. Wait approximately 10-30 seconds for the screen in Figure 9 to appear.

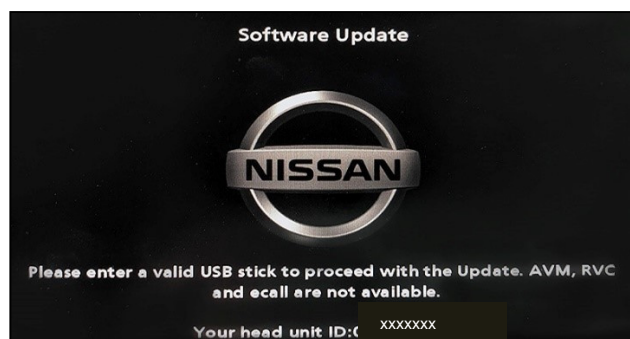
- The screen in Figure 10 may briefly appear. **Do not remove the USB drive.** The audio system will detect the USB and continue the update.

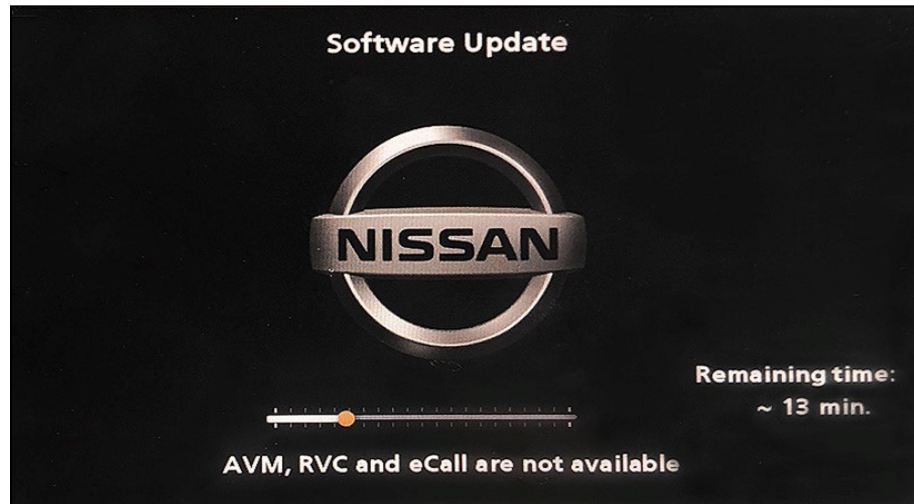
Figure 11

14. Wait for the update to complete.
 - Follow the on-screen instructions while waiting.

HINT: The update may take 15-25 minutes.

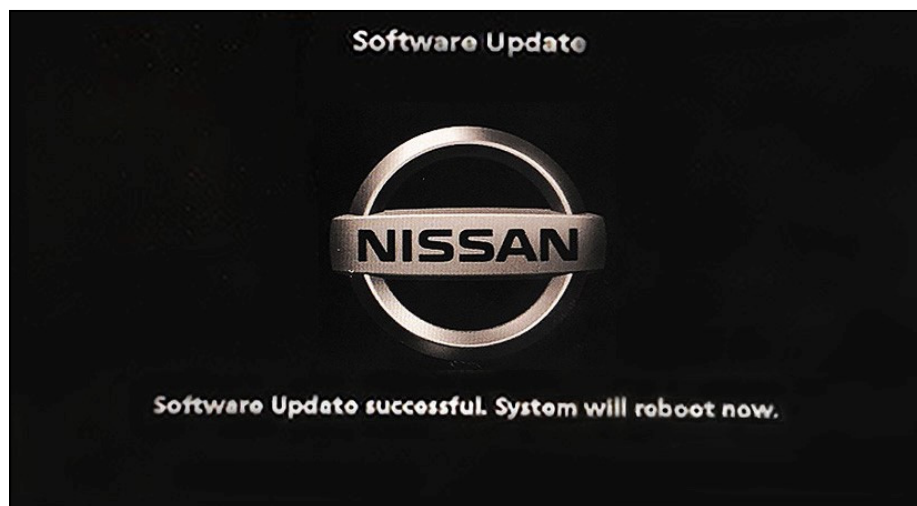
Figure 12

15. Once the update is complete (Figure 12), remove the USB drive; the system will reboot (restart).

HINT: The system will not reboot until the USB drive is removed.

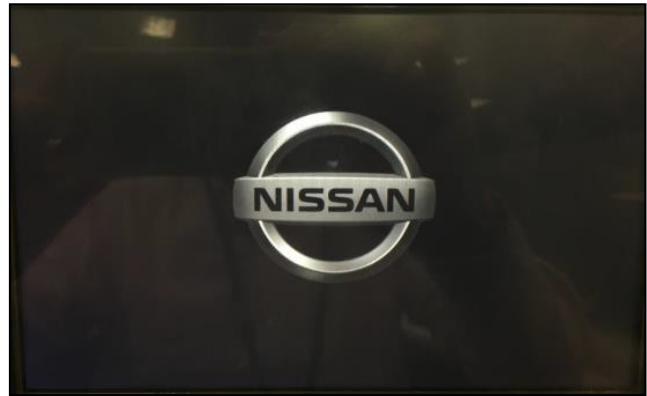
Figure 13

22. Turn the ignition ON (engine OFF) and wait for the Nissan logo to appear (Figure 13).
 - If the Nissan logo does not appear (this might take up to 30 seconds), start over from step 17.

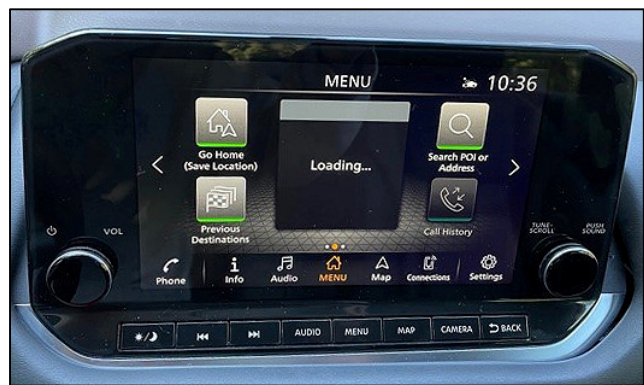
23. After the Nissan logo appears, wait about 1 minute.
 - The MENU (Home) screen in Figure 14 will be displayed.
