Aftersales Bulletin

00 24 65 01 00 – Service Action Programming EGS MIL Activation

This service action affects Ghost (RR4), Wraith (RR5) and Dawn (RR6) models produced from 11/19/2015 to 11/19/2021.

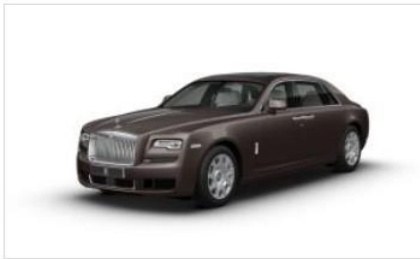
Check the current vehicle integration level using AIR:

Vehicle
ROLLS ROYCE Ghost Extended Wheelbase, 420KW

Development code	RR4
Colour	black-diamond metallic
Actual integration level	F001-21-11-530
Start of warranty	30 August 2018
