GLOBAL SAFETY FIELD INVESTIGATIONS DCS5666 URGENT - DISTRIBUTE IMMEDIATELY

Subject: N202307990 - Customer Satisfaction Program Special Coverage

Loss of Propulsion

Models: 2016 – 2018 Chevrolet Volt

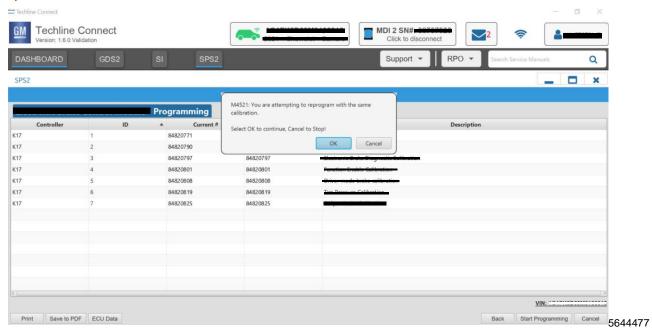
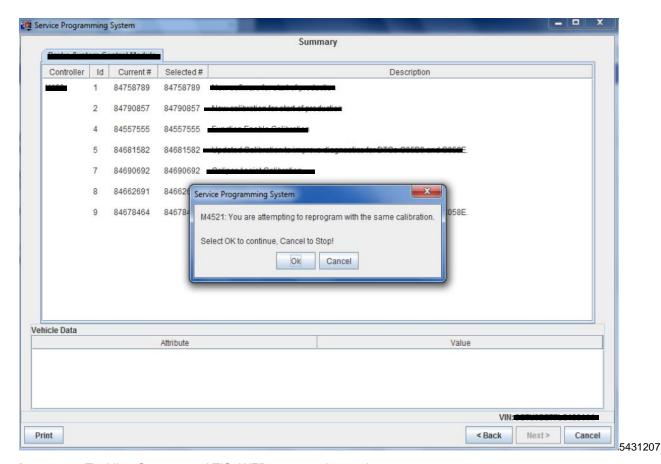
Important: Techline Connect and TIS2WEB screens shown above.

Important: If the same calibration/software warning is noted on the TLC or SPS Summary screen, select OK and follow screen instructions. After a successful programming event, the WCC is located in the Service Programming System dialogue box of the SPS Summary screen. No further action is required. Refer to the Warranty section of the bulletin.

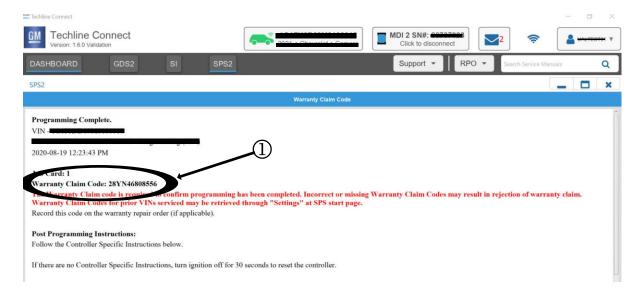
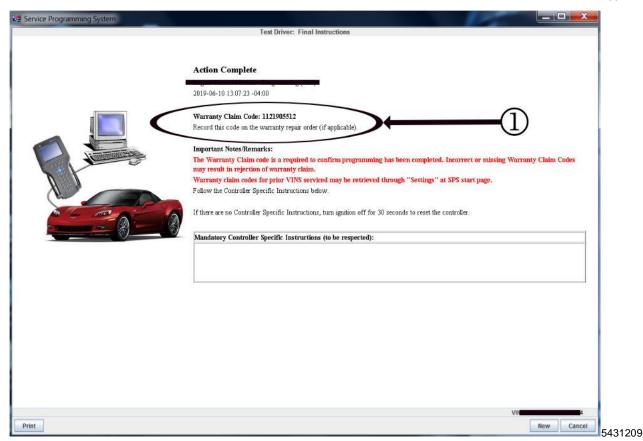
Note: The screenshots above are an example of module programming and may not be indicative of the specific module that is being programmed. Module selection and VIN information have been blacked out.

Important: To avoid warranty transaction rejections, you MUST record the warranty claim code provided on the Warranty Claim Code (WCC) screen shown above on the job card. Refer to callout 1 above for the location of the WCC on the screen.
