# Service Bulletin

Bulletin No.: 21-NA-262

**Subject: Malfunction Indicator Lamp (MIL) Illuminated - P015B**

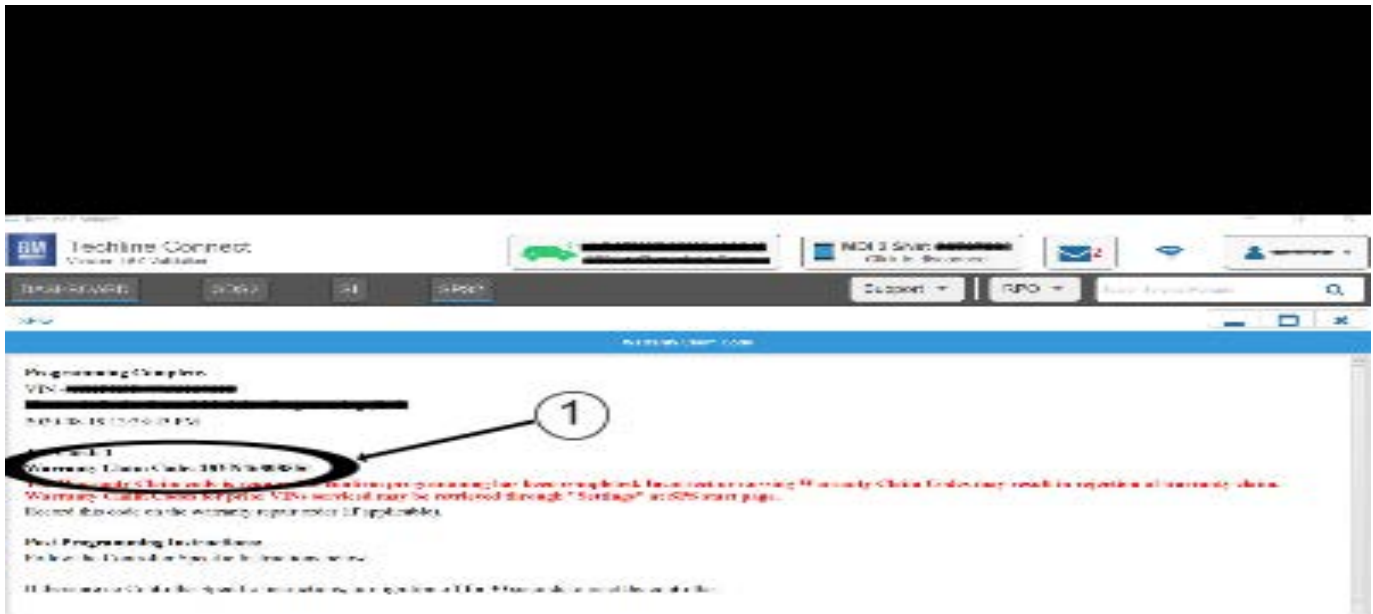
**Important:** If the same calibration/software warning is noted on the TLC or SPS Summary screen, select OK and follow screen instructions. After a successful programming event, the WCC is located in the Service Programming System dialogue box of the SPS Summary screen. No further action is required. Refer to the Warranty section of the bulletin.

1. Reprogram the ECM. Refer to *K20 Engine Control Module: Programming and Setup* in SI.
