**Subject:** Mis-Installed Mechatronic Transmission Modules (MTMs) on Endurant HD and PACCAR TX-12 Transmissions

**Document Number:** TAIB-0995

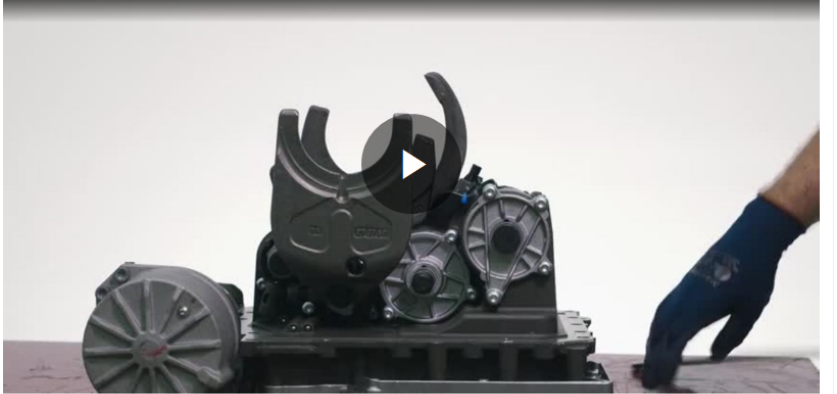
Mechatronic Transmission Module Install

1. Place the transmission in a horizontal position.

The transmission must be in a horizontal position prior to the MTM Installation procedure. Failure to do so causes the sliding clutches to move out of neutral and not align to the shift yokes. If the shift yokes are not aligned to the sliding clutches, position sensor fault codes set Active and the transmission will not shift out of neutral.

- The transmission must be in a horizontal position prior to the MTM Installation procedure. Failure to do so causes the sliding clutches to move out of neutral and not align to the shift yokes. If the shift yokes are not aligned to the sliding clutches, position sensor fault codes set Active and the transmission will not shift out of neutral.
- If the MTM is installed on the transmission and Rail E in the MTM is not aligned with Rail E in the Main Housing, Fault Code 320 (SPN 5942) sets Active and the transmission will not shift out of neutral.
- If the MTM is installed on the transmission and Rail B in the MTM is not aligned with Rail B in the Main Housing, Fault Code 275 (SPN 4219) sets Active and the transmission will not shift out of neutral.
- Rails B, C, and D positions can be viewed for proper MTM installation with the PTO cover removed.
