SAFETY RECALL W58 - LOSS OF CRANK POSITION

FEBRUARY 2021

Overlap with V08/V11/V16 Population

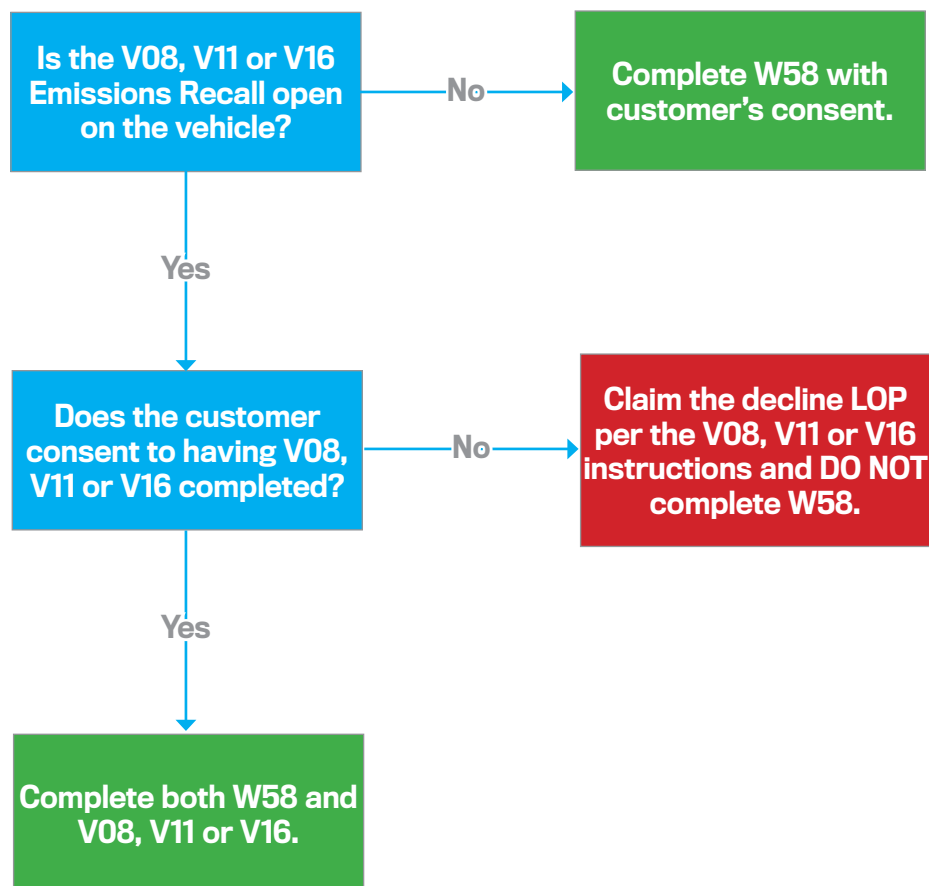
Recall Process Flowchart

Some of the VINs in the W58 safety recall population are also in the V08/V11/V16 Diesel Emissions Recall and Consent Decree population. If a vehicle is in both populations, W58 CANNOT be performed if V08/V11/V16 is not completed first, per the W58 dealer instructions.

If the customer does not wish to have V08/V11/V16 completed, please inform them that W58 cannot be completed on their vehicle because the V08/V11/V16 repair is contained within the W58 software. Inform the customer that FCA Group US LLC will remove their vehicle from the W58 safety recall population and put it into a different safety recall. The alternate safety recall does not require a software flash. Claim the V08/V11/V16 decline LOP, as indicated in the V08/V11/V16 Dealer instructions. After the claim is processed, FCA Group US LLC will contact the customer with information about the alternate safety recall.
