**NUMBER:** 08-026-21 REV. A

Mopar Overhead Multimedia Player (OMP) Enhancements

This bulletin involves updating the OMP with a USB flash drive. The new software is version 2.700.

2020 - 2021 (RU) Chrysler Pacifica

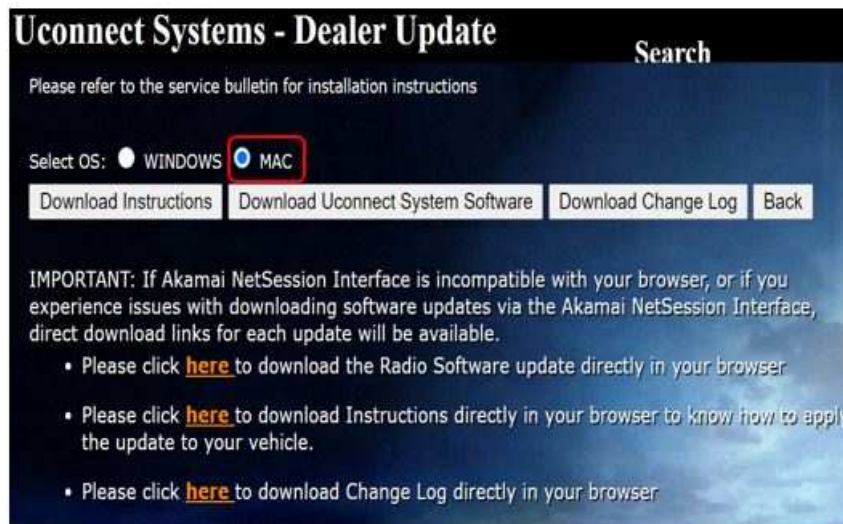
**Fig. 1**

3. Download the software update file (MERGE.bin) to your local PC's desktop. Make sure to select the "MAC" radial button for all downloads ([Fig. 1](#)).

**MAC Download Steps**

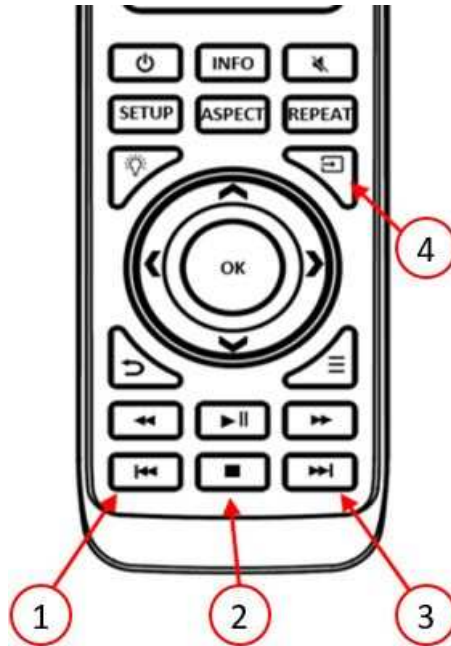
7. Using the remote press the **V.SEL** (input source) button and select “**USB**” mode on the left bottom corner, (Fig. 2) .

Fig. 2  
OMP Remote

- 1 - Prev
- 2 - Stop
- 3 - Next
- 4 - V.Sel
