NUMBER: 08-088-21 REV. A

GROUP: 08 - Electrical

Radio Enhancements

This bulletin involves updating the radio software level to 2036.06.

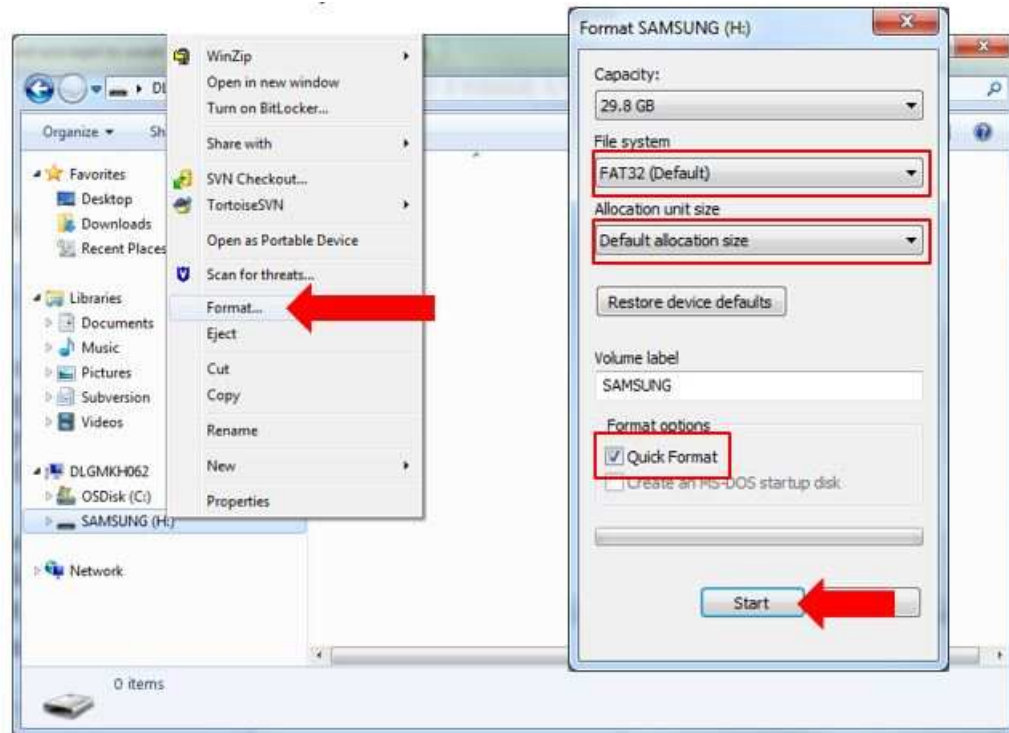
2. Perform the following steps to format the USB flash drive (Fig. 1) .
 - a. Select “FAT32” format.
 - b. Select “Default allocation size” under Allocation Unit Size.
 - c. Select “Quick Format” under Format Options.
 - d. Click “Start”.

Fig. 1
Formatting The USB Flash Drive

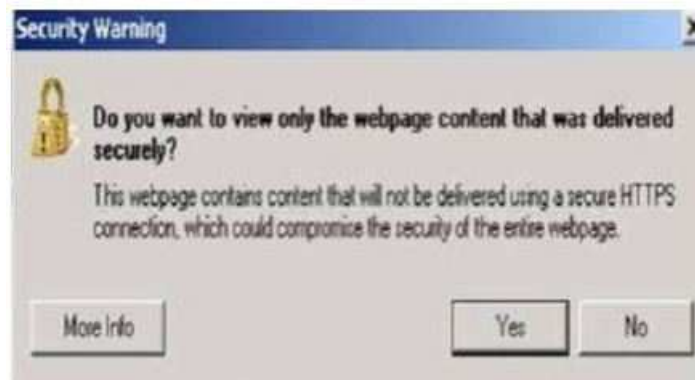
3. Go to DealerCONNECT>Service>Uconnect Command Center>Uconnect>More Information >Dealer software downloads to download the files.
4. If a security message appears “Do you want to view only the web page content that was delivered securely?” (Fig. 2) . Press “No” to continue.

Fig. 2
Pop-Up Security Message

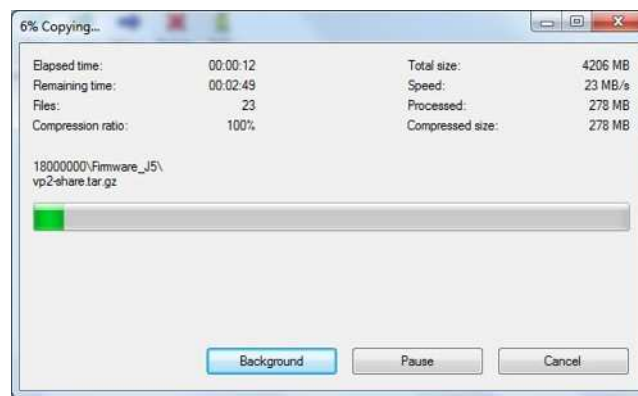
8. Extract the downloaded file to the USB flash drive (Fig. 5) .

Fig. 5
Extract File To USB

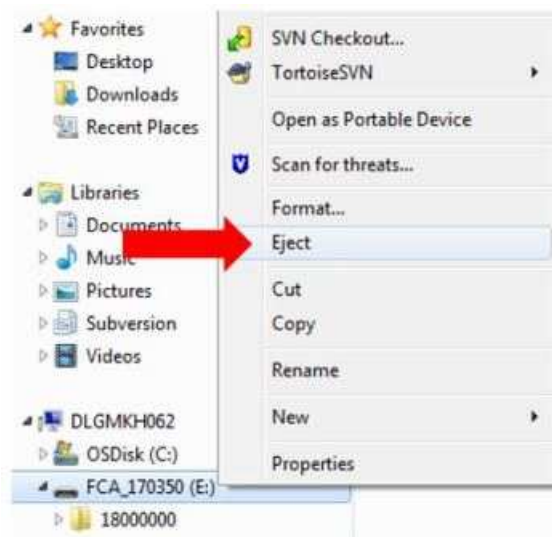
10. Perform the following steps to properly eject the USB flash drive (Fig. 6) :
- Right click on the location of the USB flash drive.
 - Click "Eject" to avoid data corruption.
 - Remove the USB flash drive from the PC.

Fig. 6
Ejecting The USB Flash Drive

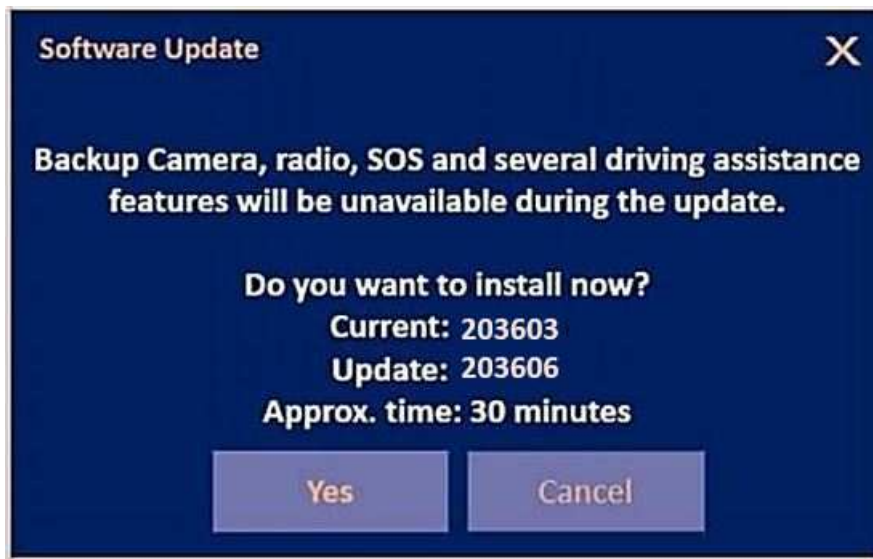
Fig. 7

16. Press "Yes" to start the update. The software update takes approximately 30 minutes to complete ([Fig. 7](#)) .

Update Ready to Install

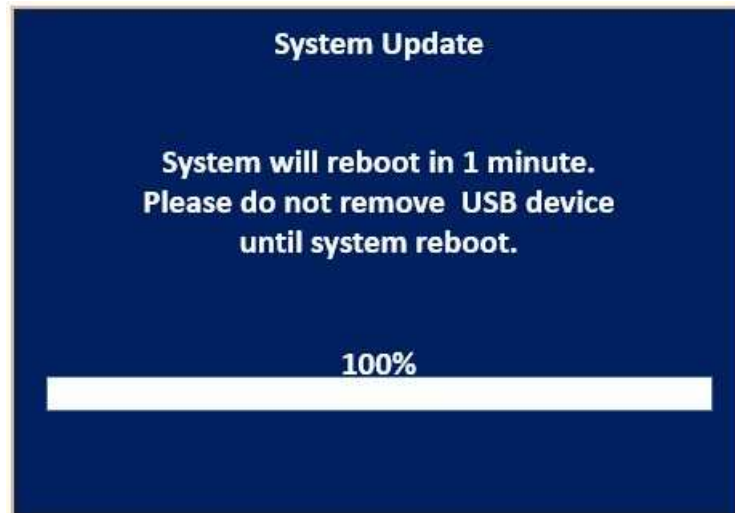
Fig. 8

NOTE: Do not remove the USB flash drive before you are instructed to [\(Fig. 8\)](#) .

Do Not Remove USB Flash Drive

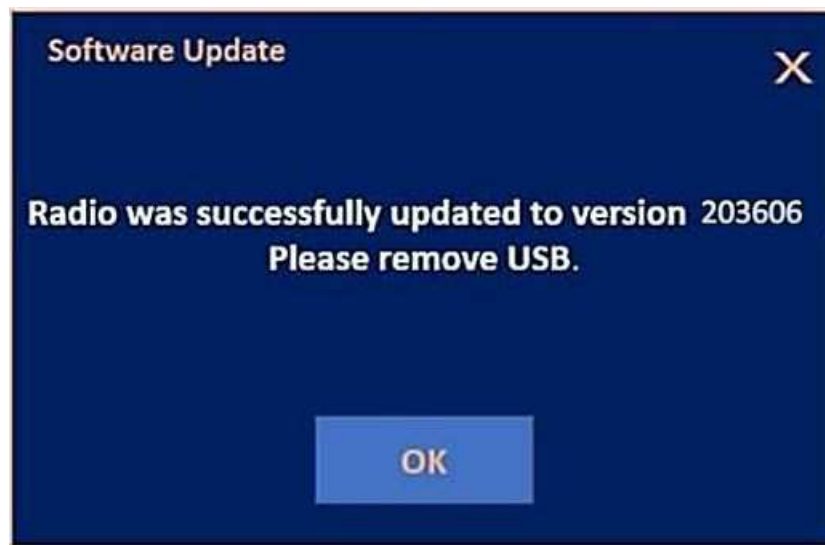
Fig. 9

19. Wait for the "Radio was successfully updated" screen [\(Fig. 9\)](#) .

Update Successful Screen
