NUMBER: 08-100-21

UAQ UCQ UAV and UCV Radio Over The Air Software Version Updates

2021	(JL)	Jeep Wrangler
2021	(JT)	Jeep Gladiator
2021	(DT)	RAM 1500 Pickup

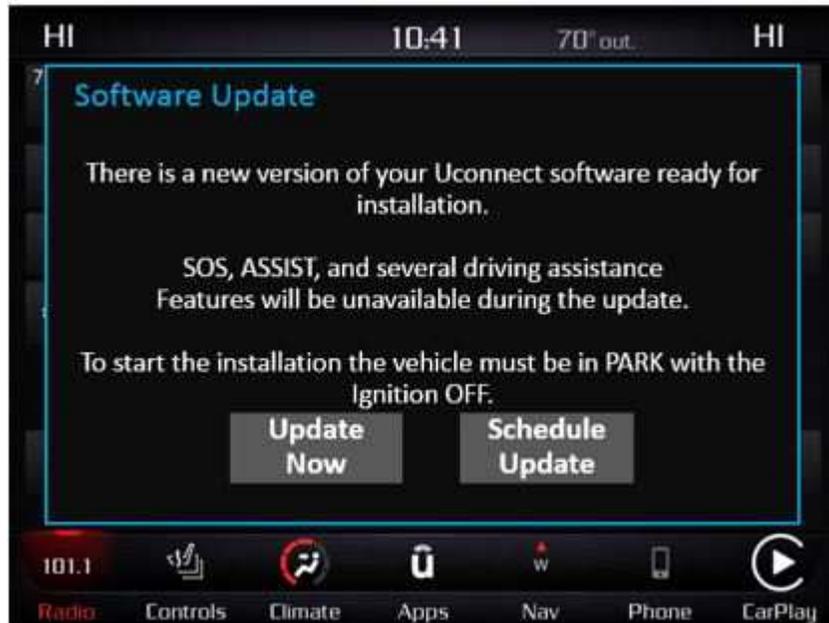
Fig. 1
Software Acceptance Screen

Vehicles sold in the U.S. and Canada can now receive software updates “over-the-air”. Updates to software will occur in a phased roll-out. The software is updated through the built-in cellular modem in the radio. Customers will see a notification on their radio screen when new software is available for their radio (Fig. 1) . The owner will have the option to update the radio or schedule the update for later. There is not an option to decline the update indefinitely, the update must be performed.

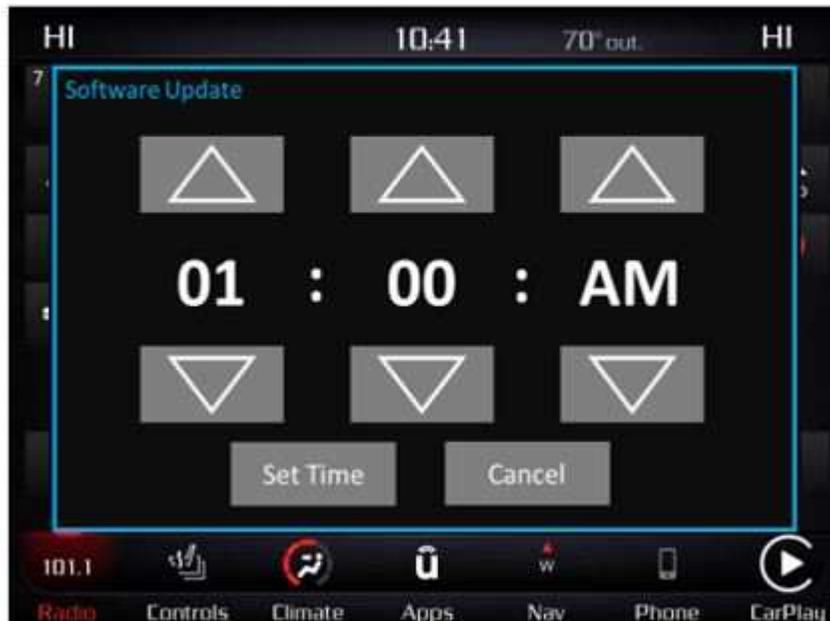
NOTE: If selecting “Schedule Update” the screen below will be displayed. The customer can select the exact time they want the update to begin (Fig. 2) .

Fig. 2
Schedule Update Screen

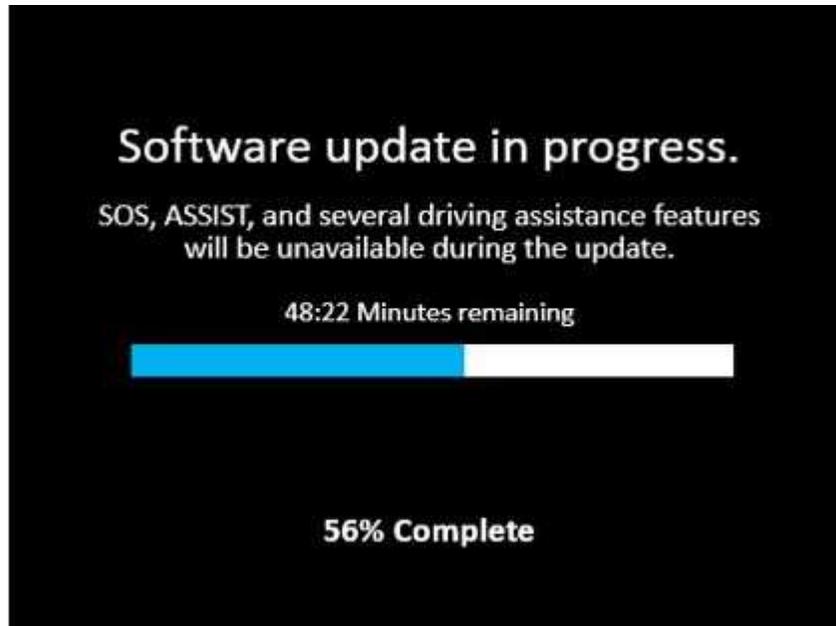
- Whether the customer selects “Update Now” or “Schedule Update” and sets a time, they can shut off the vehicle and leave. The update will be completed automatically (Fig. 3) .

NOTE: This phase may take several minutes to complete.

Fig. 3
Update In Progress Screen

1. The vehicle needs to be in the park position, or have the vehicle in neutral with parking brake engaged if equipped with a manual transmission. The ignition needs to be off.

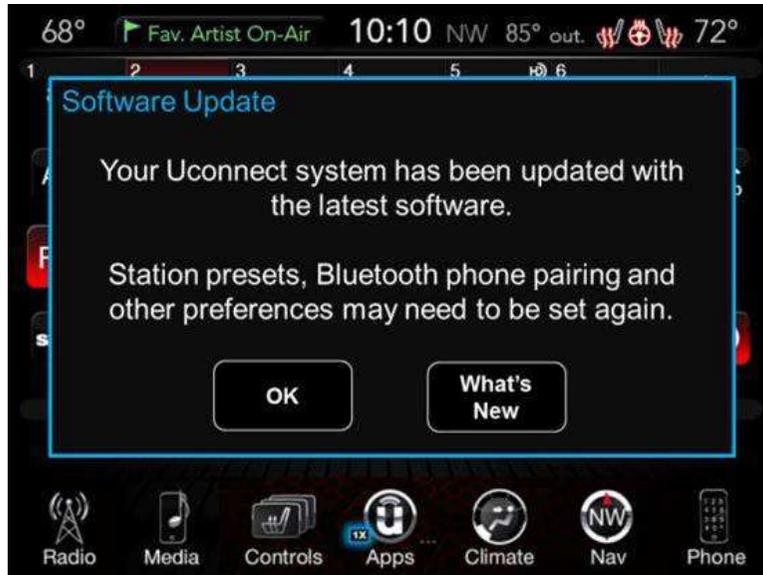
- Upon completion of update, the radio will display a confirmation message (Fig. 4) .

Fig. 4
Confirmation Screen
