**NUMBER:** 08-088-21

**GROUP:** 08 - Electrical

Radio Enhancements

This bulletin involves updating the radio software level to 2036.06.

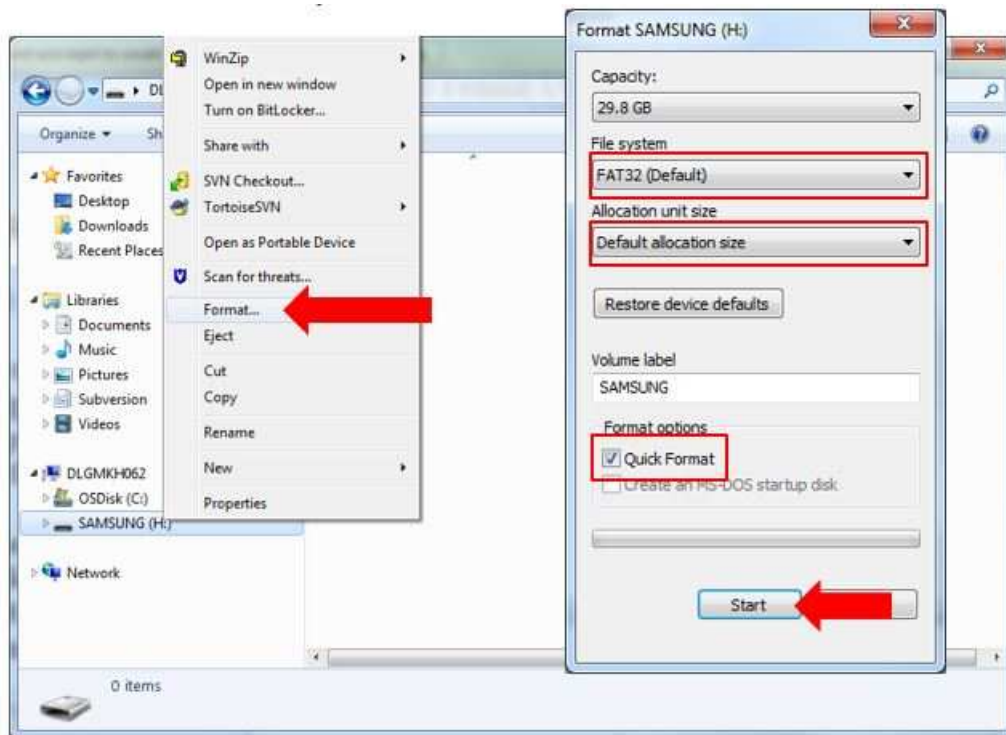
2. Perform the following steps to format the USB flash drive (Fig. 1) .
  - a. Select “FAT32” format.
  - b. Select “Default allocation size” under Allocation Unit Size.
  - c. Select “Quick Format” under Format Options.
  - d. Click “Start”.

Fig. 1  
Formatting The USB Flash Drive

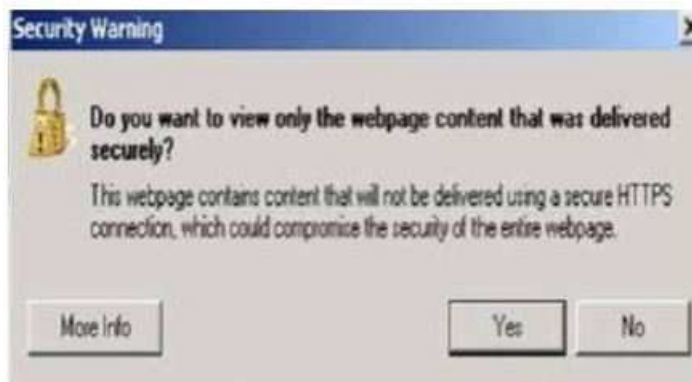
3. Go to DealerCONNECT>Service>Uconnect Command Center>Uconnect>More Information >Dealer software downloads to download the files.
4. If a security message appears “Do you want to view only the web page content that was delivered securely?” (Fig. 2) . Press “No” to continue.

Fig. 2  
Pop-Up Security Message

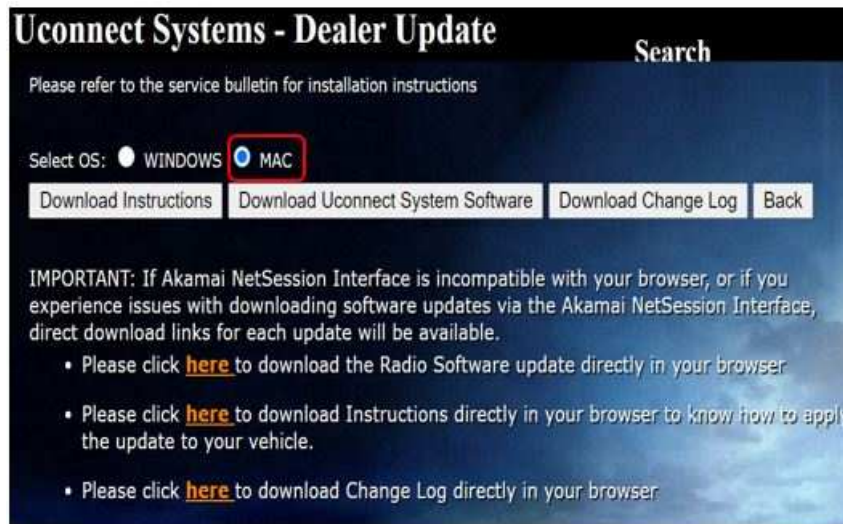
Fig. 3

5. Use a blank USB flash drive with at least 8 GB of space. Follow the on-screen instructions to download the software files.
6. Download the software update file to your local PC's desktop. Make sure to select the "MAC" radial button for all downloads (Fig. 3) .

**MAC Download Steps**

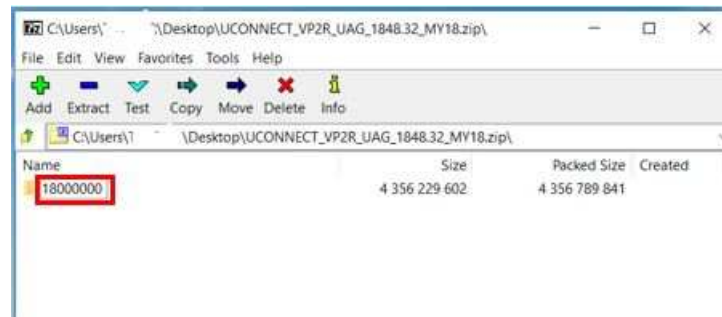
Fig. 4

7. Be sure to download the file to your PC's desktop and open it (Fig. 4) .

**NOTE: The USB should only contain a folder labeled "18000000" on it after files are extracted to it.**

**Extracted File**

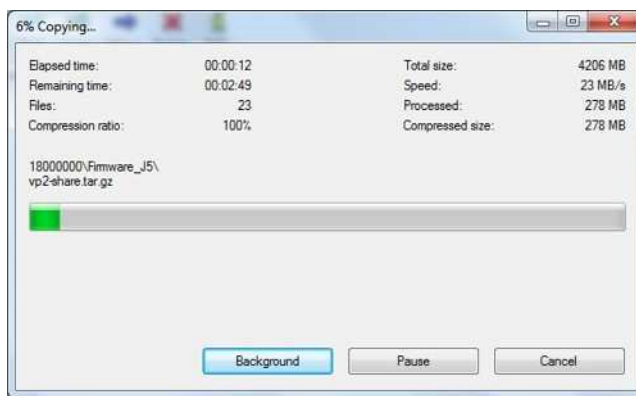
8. Extract the downloaded file to the USB flash drive (Fig. 5) .

**Fig. 5**  
**Extract File To USB**

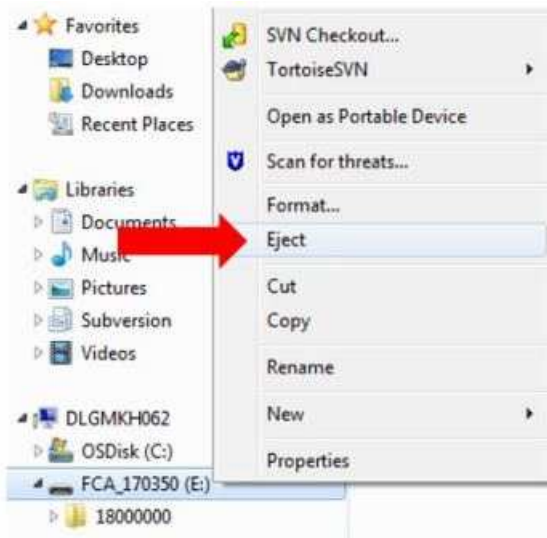
10. Perform the following steps to properly eject the USB flash drive (Fig. 6) :

- a. Right click on the location of the USB flash drive.
- b. Click “Eject” to avoid data corruption.
- c. Remove the USB flash drive from the PC.

**Fig. 6**  
**Ejecting The USB Flash Drive**

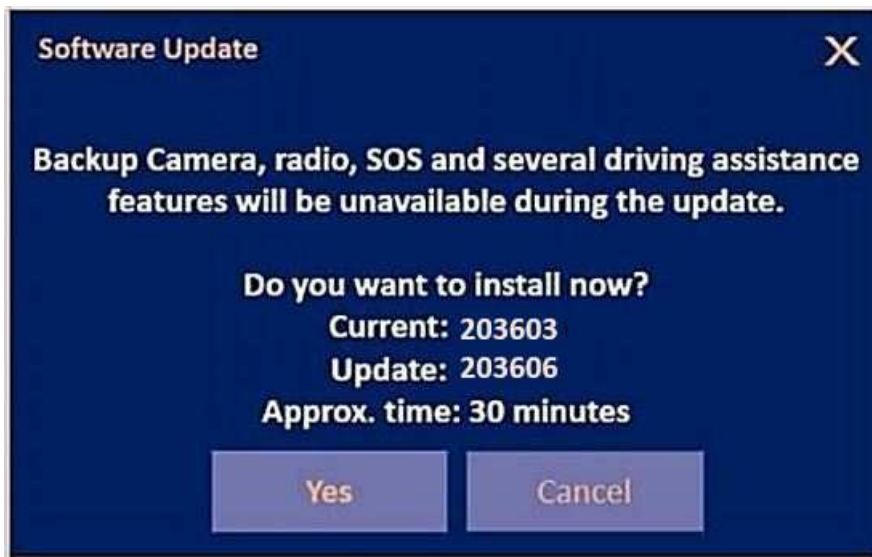
Fig. 7

16. Press "Yes" to start the update. The software update takes approximately 30 minutes to complete ([Fig. 7](#)).

Update Ready to Install

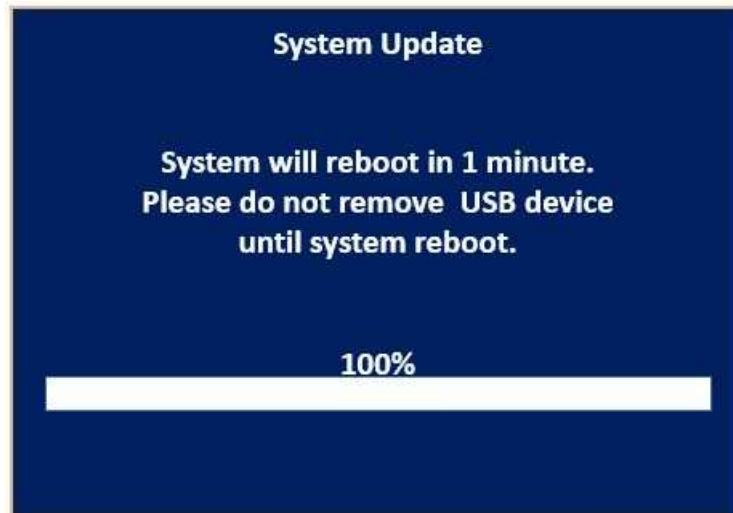
**NOTE:** Do not remove the USB flash drive before you are instructed to (Fig. 8) .

Fig. 8  
Do Not Remove USB Flash Drive

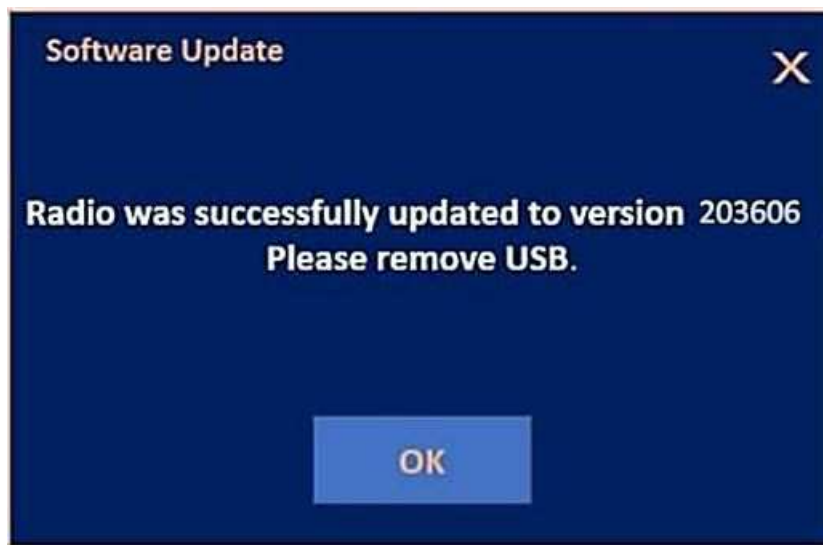
19. Wait for the "Radio was successfully updated" screen (Fig. 9) .

Fig. 9  
Update Successful Screen
