NUMBER: 08-114-21

UBR UER and UFR Radio Enhancements

This bulletin involves updating the radio software level to 34.00.49.

2021 (WL) Jeep Grand Cherokee

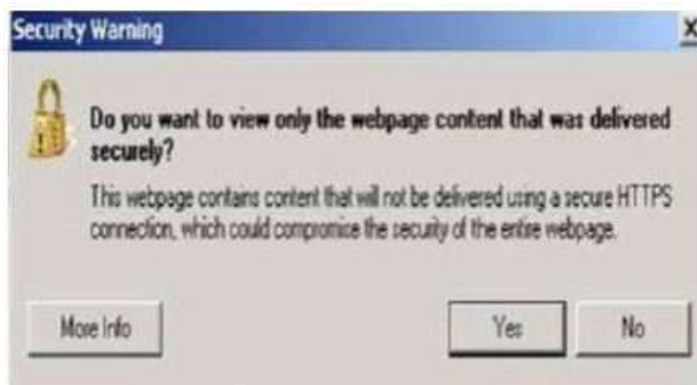
4. If a security message appears “Do you want to view only the web page content that was delivered securely?” (Fig. 2) . Press “No” to continue.

Fig. 2
Pop-Up Security Message

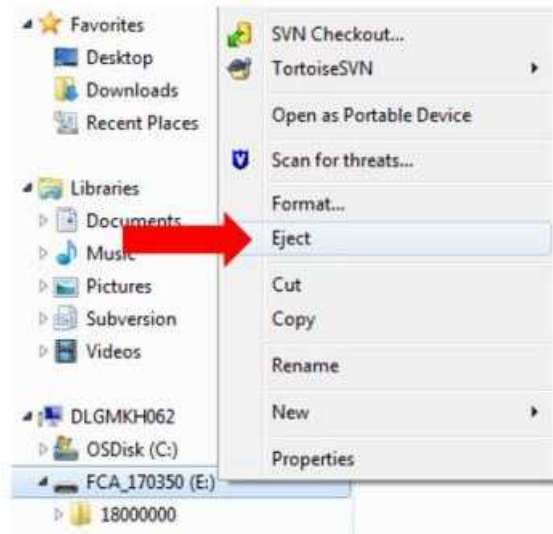
10. Perform the following steps to properly eject the USB flash drive (Fig. 6) :
 - a. Right click on the location of the USB flash drive.
 - b. Click “Eject” to avoid data corruption.
 - c. Remove the USB flash drive from the PC.

Fig. 6
Ejecting The USB Flash Drive

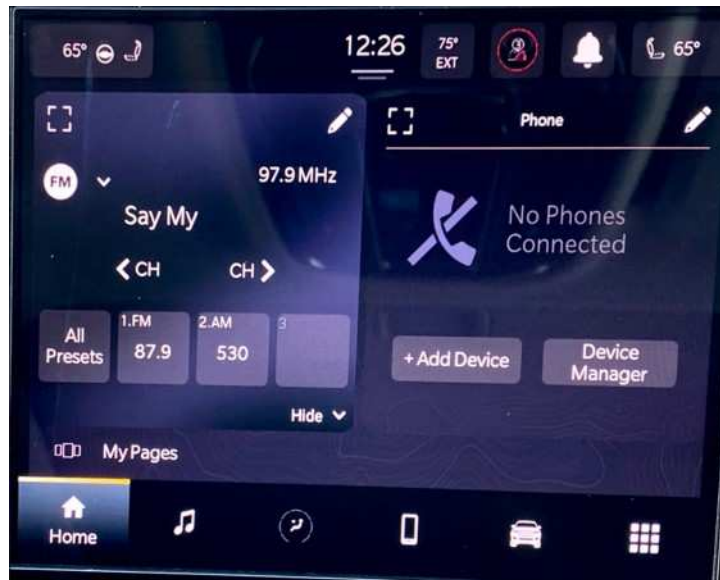
14. Vehicle must be out of “Ship Mode”. Starting at the radio ‘Home’ screen (Fig. 7) .

Fig. 7
Home Screen

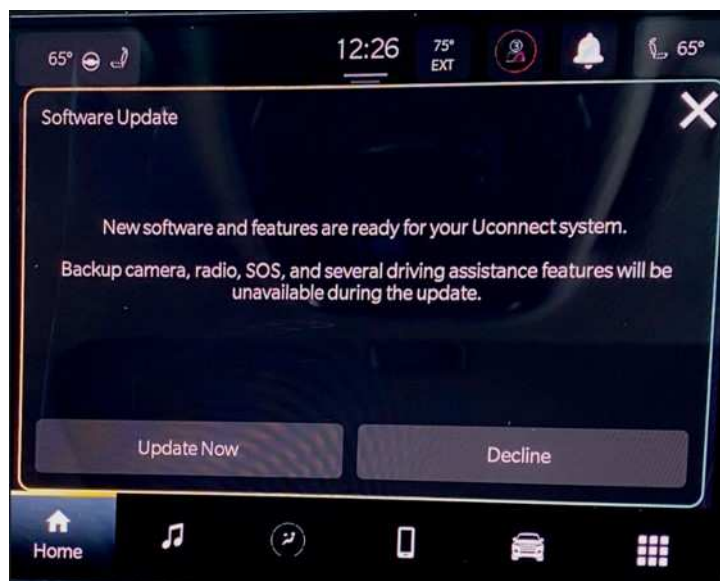
16. The radio will prompt you if you want to update to the newest software version (Fig. 8) .

Fig. 8
Software Update Screen

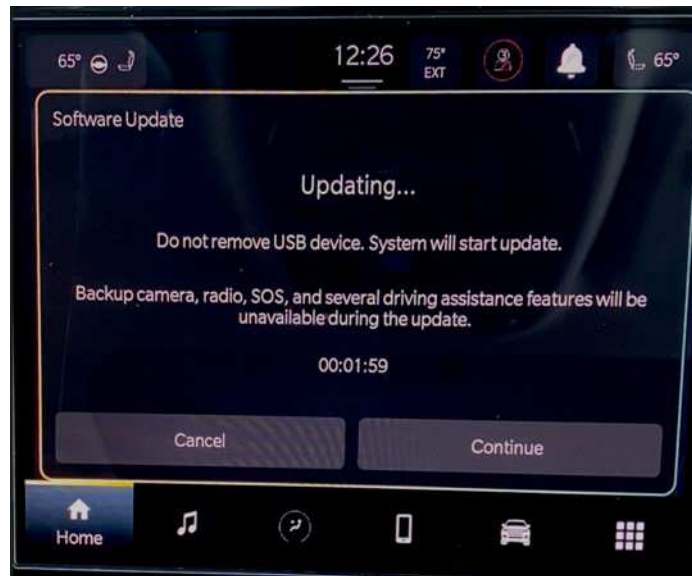
18. The radio will prompt you if you want to continue updating to the newer software (Fig. 9) .

Fig. 9
Software Updating Screen

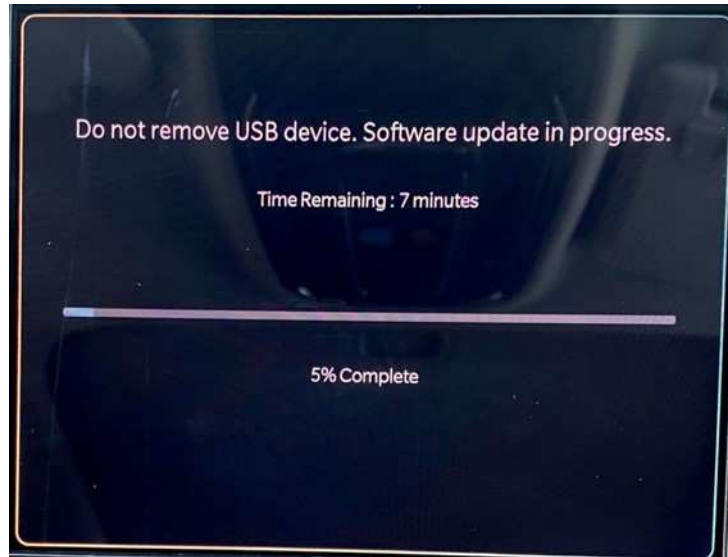
20. The update will take approximately 15-20 minutes (Fig. 11) .

Fig. 11
Update In Progress Screen

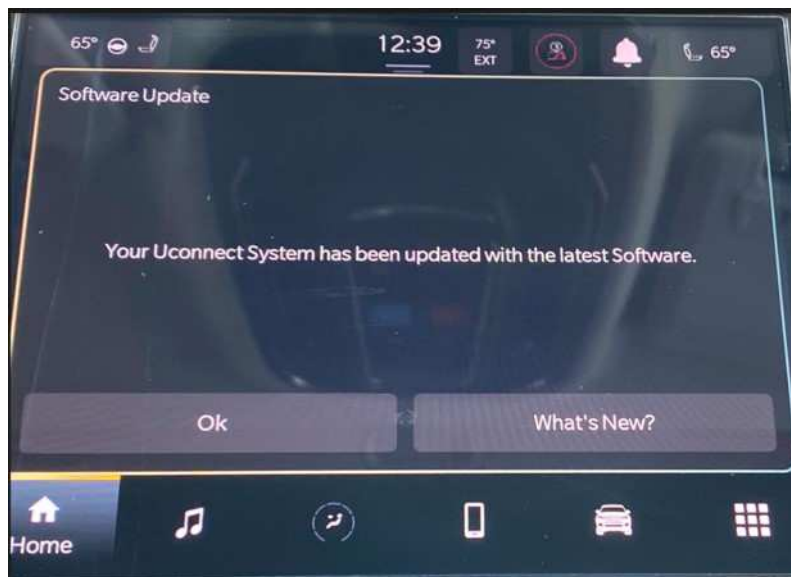
21. The radio will reboot and you will observe the update screen after the splash screen once the update has been successful (Fig. 12) .

Fig. 12
Software Updated Screen

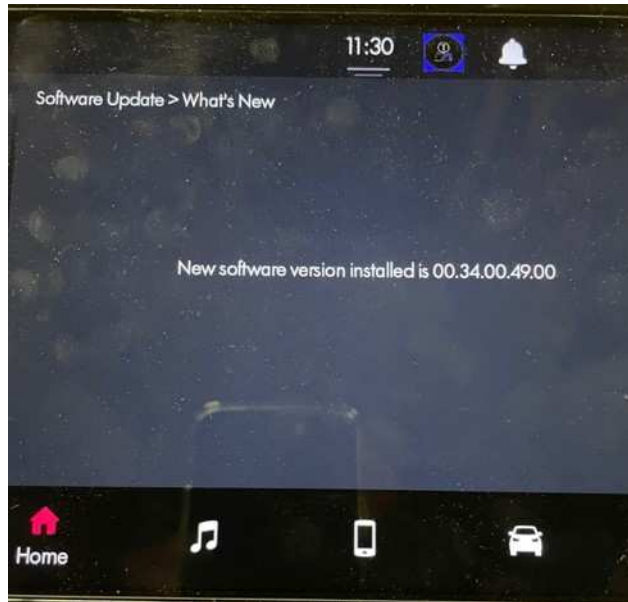
22. Select “What’s new” to confirm the software has been updated to 34.00.49 (Fig. 13) .

Fig. 13
What's New Screen
