TECHNICAL SERVICE BULLETIN

**SERVICE ACTION: MIL ON DTC P0605 AND/OR P2181
ECM LOGIC IMPROVEMENT (SA463)**

This bulletin provides the procedure to improve the logic of the Engine Control Module (ECM) on some 2020-2021MY Soul (SK3) vehicles produced from November 24, 2018 through January 4, 2021 and 2021MY Seltos (SP2) vehicles produced from November 20, 2019 through January 8, 2021, equipped with NU 2.0L ATK engines, which may exhibit engine starting related DTC P0605 and/or thermostat related DTC P2181. To correct this concern. Follow the flowchart on page 2, then perform the Coolant Discharge procedure using KDS (for DTC P2181) if applicable, and/or apply the improved logic to the Engine system using the KDS ECU Upgrade function as described in this bulletin. For confirmation that the latest reflash has been applied to a vehicle you are working on, verify the ROM ID using the table on page 8 of this bulletin. Before conducting the procedure, verify that the vehicle is included in the list of affected VINs.

DTC P0605: Internal Control Module Read Only Memory (ROM) Error
DTC P2181: Thermostat Continuous Monitor Error

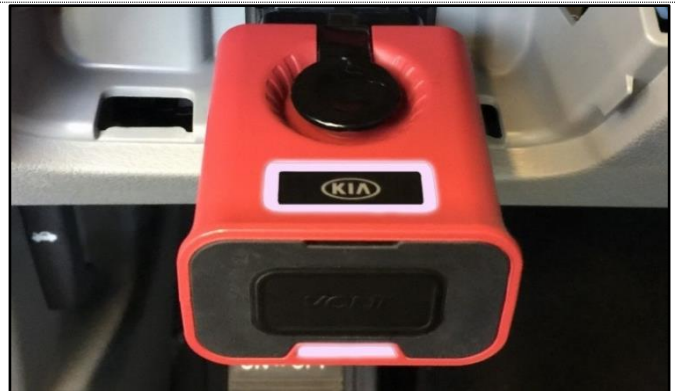
1. Connect the VCI-II to the OBD-II connector, located under the driver's side of the instrument panel.

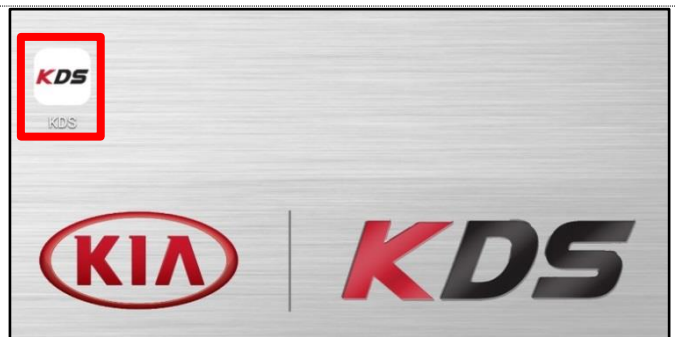
2. With the ignition ON, turn ON the KDS tablet. Select **KDS** from the home screen.

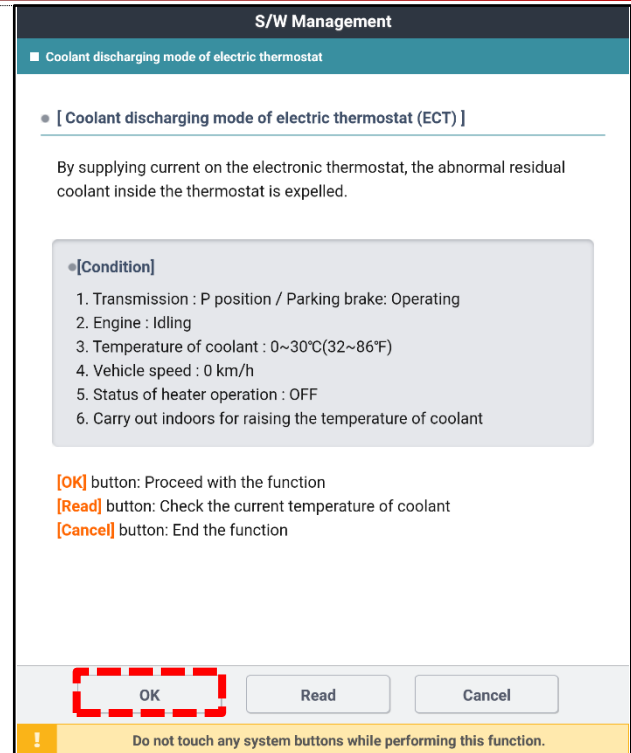
4. Confirm the following conditions listed below are present, then select 'OK'.

1.	Transmission: Park (P) position / Parking Brake: ON
2.	Engine: Idling
3.	Coolant temperature: 32 - 78°F
4.	Vehicle speed: 0 mph
5.	Heater: OFF
6.	Conduct procedure indoors to raise temperature of coolant

By supplying current on the electronic thermostat, the abnormal residual coolant inside the thermostat is expelled.

1. Transmission : P position / Parking brake: Operating
2. Engine : Idling
3. Temperature of coolant : 0~30°C(32~86°F)
4. Vehicle speed : 0 km/h
5. Status of heater operation : OFF
6. Carry out indoors for raising the temperature of coolant

[OK] button: Proceed with the function
[Read] button: Check the current temperature of coolant
[Cancel] button: End the function

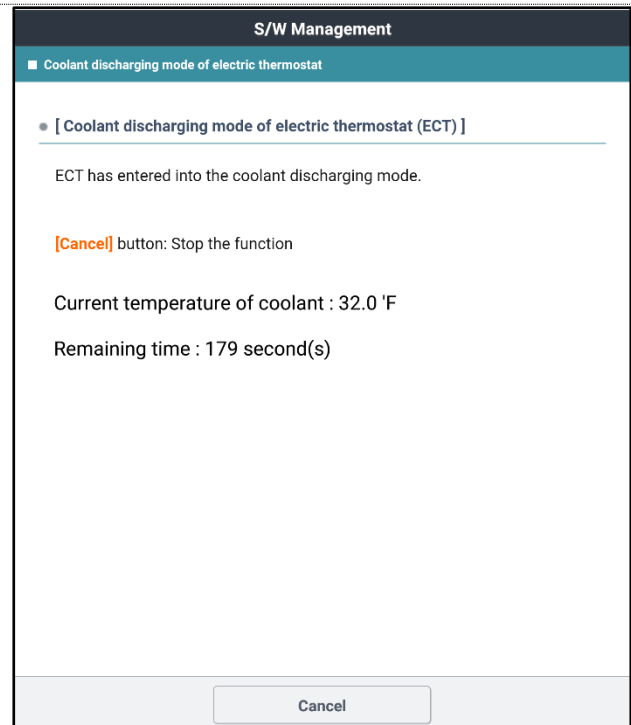
5. Wait for 180 seconds (3 minutes).

ECT has entered into the coolant discharging mode.

Current temperature of coolant : 32.0 'F

Remaining time : 179 second(s)

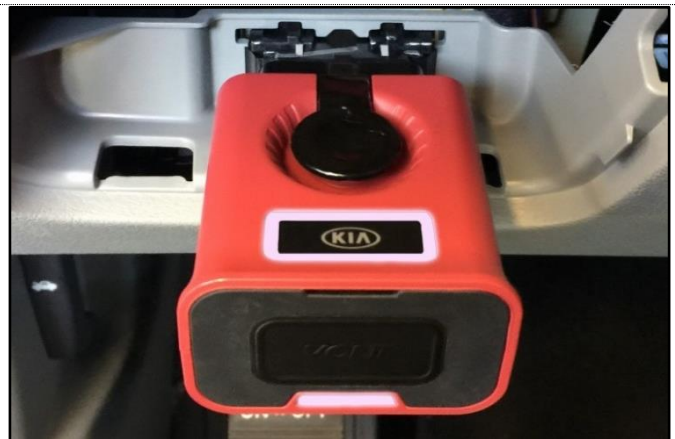
1. Connect the VCI-II to the OBD-II connector, located under the driver's side of the instrument panel.

The ECU upgrade function on KDS operates wirelessly. It is not necessary to perform the upgrade via USB cable.
