Service Action

Code: 91CD

Subject 3G Cellular Network Sunset

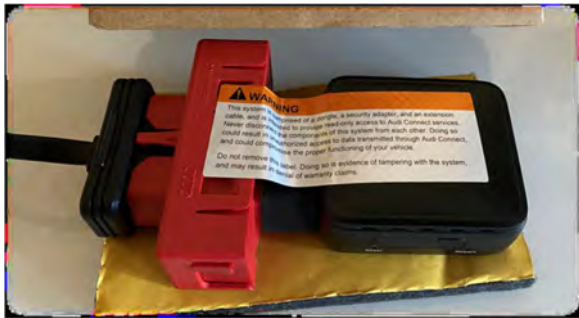
- For the A4 and A5 variants, the insulation material must be placed on the bar code side. The warning label will be exposed.

! NOTE	
The warning label on the LTE Retrofit Telematics Device must be point upwards because of the position of GNSS antenna.

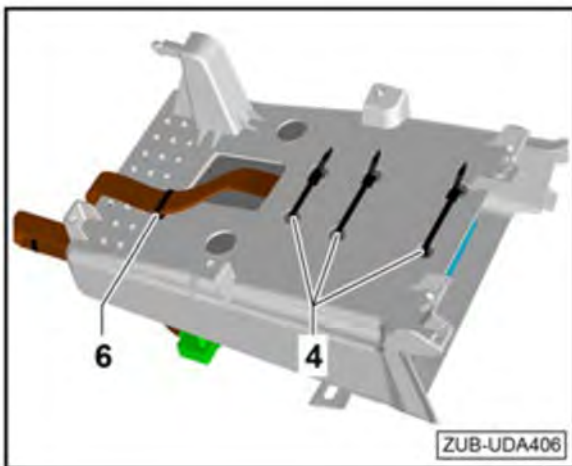
- Position the LTE Retrofit Telematics Device with the insulation material attached in the storage compartment in the installation position and secure with cable ties -4-.
- Route the OBDII extension cable towards the position of the OBDII slot in the vehicle and secure it in a suitable place using a cable tie with adhesive pad -6- to prevent noise from occurring.

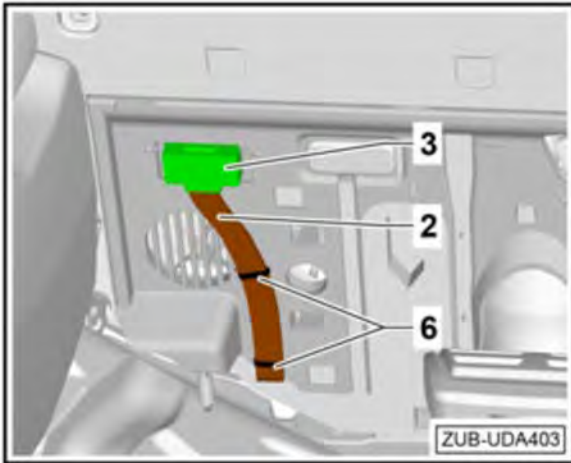
- Connect the OBDII extension cable -2- on the vehicle to the OBDII slot -3-.
- Secure the OBDII extension cable -2- in a suitable place using cable ties with adhesive pad -6- to prevent noise from occurring.

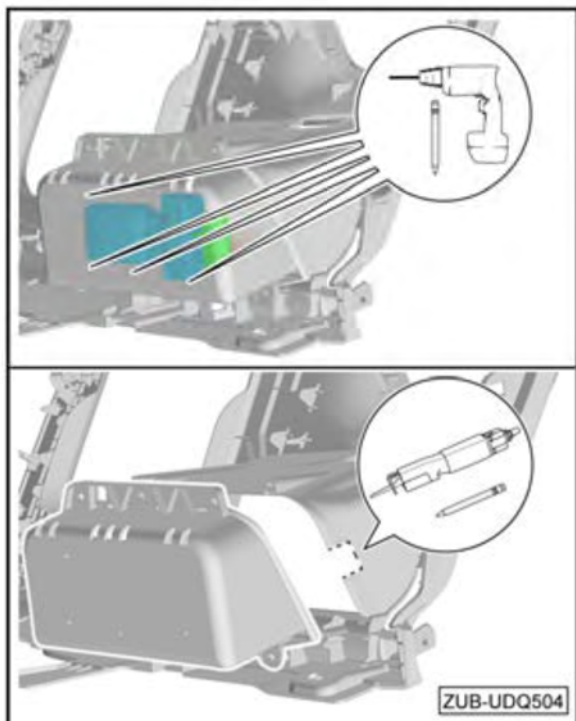
- Position the LTE Retrofit Telematics Device -1- on the cover of the storage compartment in the installation position and mark the holes for the cable ties.
- Drill M5 holes for the cable ties.
- Drill an opening measuring -18 mm x 18 mm- on the dash panel cover in the area of the cable feed-through using suitable workshop equipment and deburr the opening.

Drilling pilot holes at the corners of the cutout will make cutting easier.

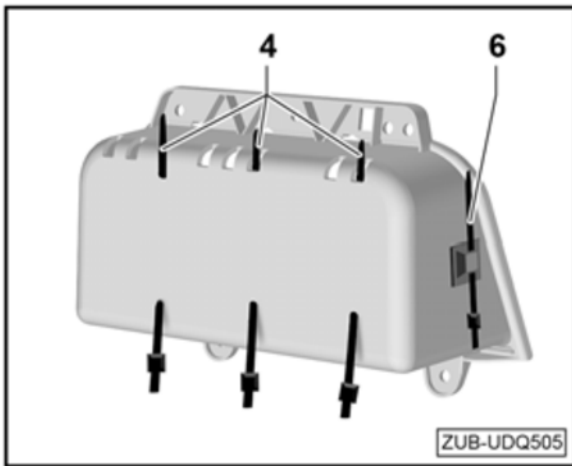
- Position the LTE Retrofit Telematics Device - 1- with the insulation material attached on the storage compartment in the installation position and secure with cable ties -4-.
- Attach a cable tie with adhesive pad -6- to the side.

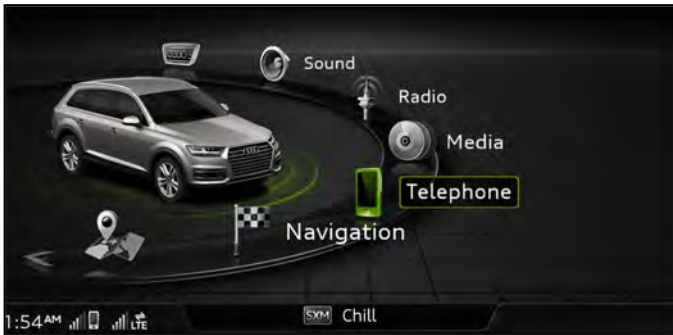
- Select “Telephone”

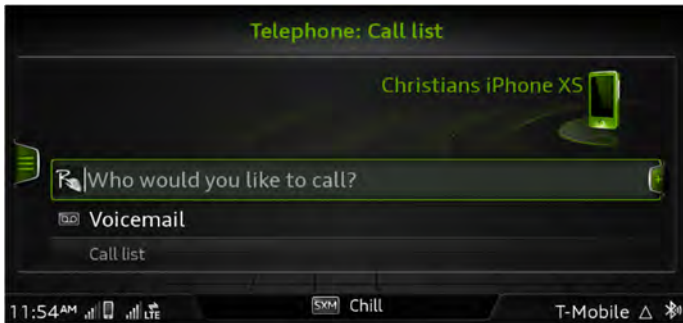
- Example: Customer phone shown as connected device.

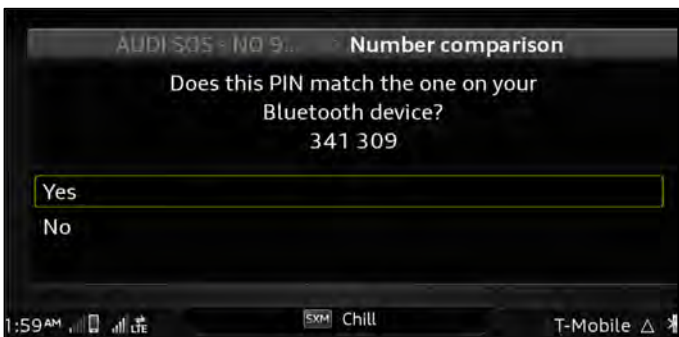
- Confirm the PIN by selecting “Yes”

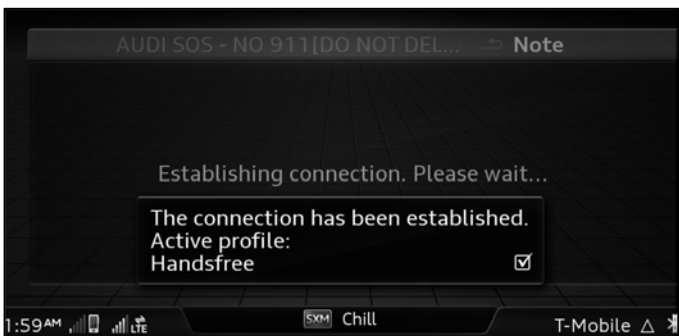
- The Bluetooth connection will be established.

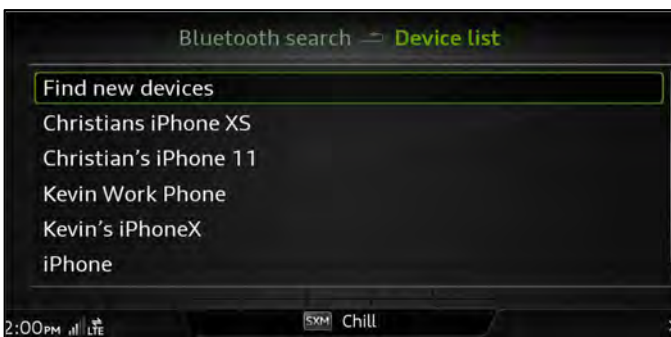
- Select "Find new devices"

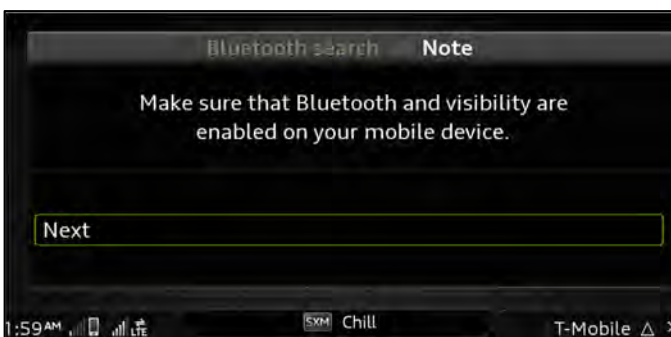
- Select "Next"

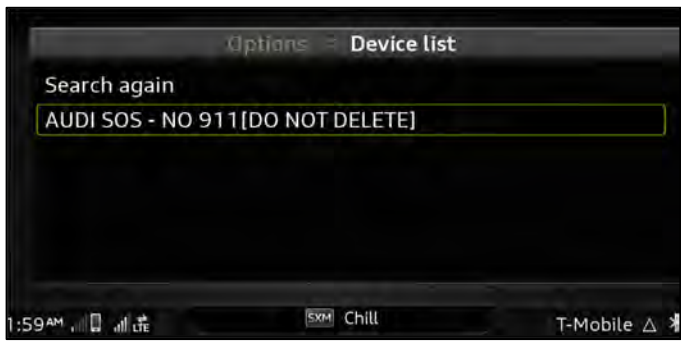
- Select “AUDI SOS – NO 911 [DO NOT DELETE]” from the device list.

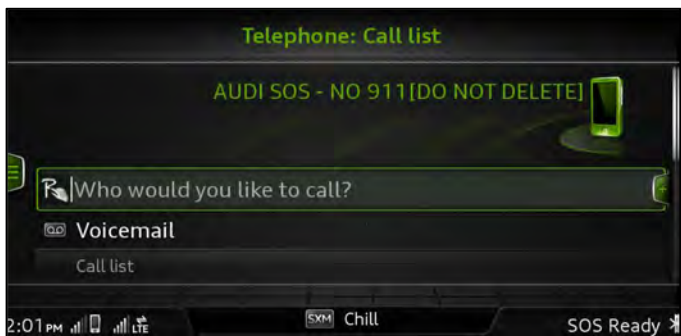
- “AUDI SOS – NO 911 [DO NOT DELETE]” shown as connected device.

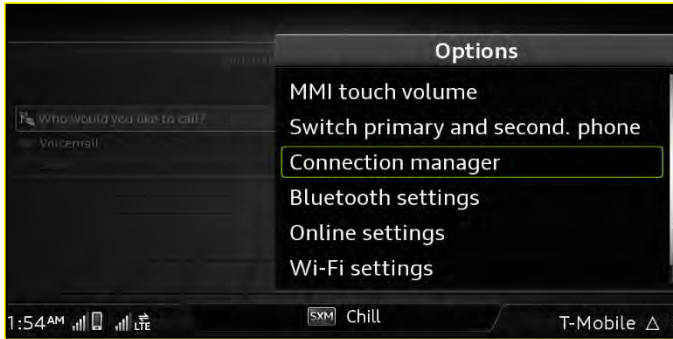
- Select "Connection manager"

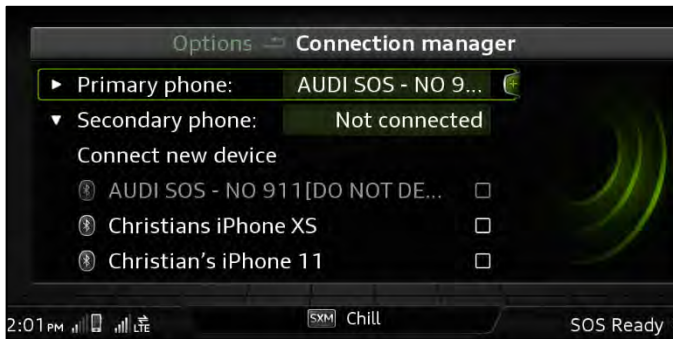
- Select "Primary phone"

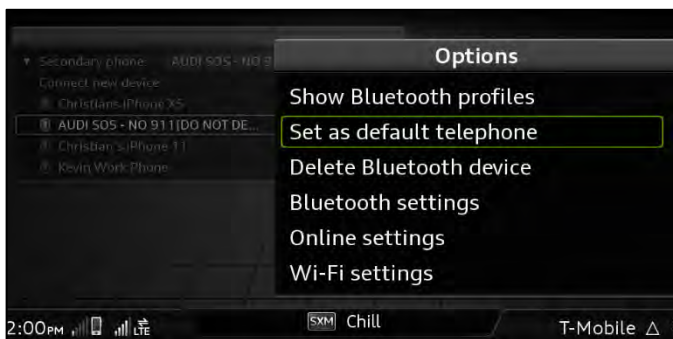
- Select "Set as default telephone"
