Service Action

Code: 91CD

Subject 3G Cellular Network Sunset

REVISION SUMMARY Updated instructions for activating Motion for Audi Connect services

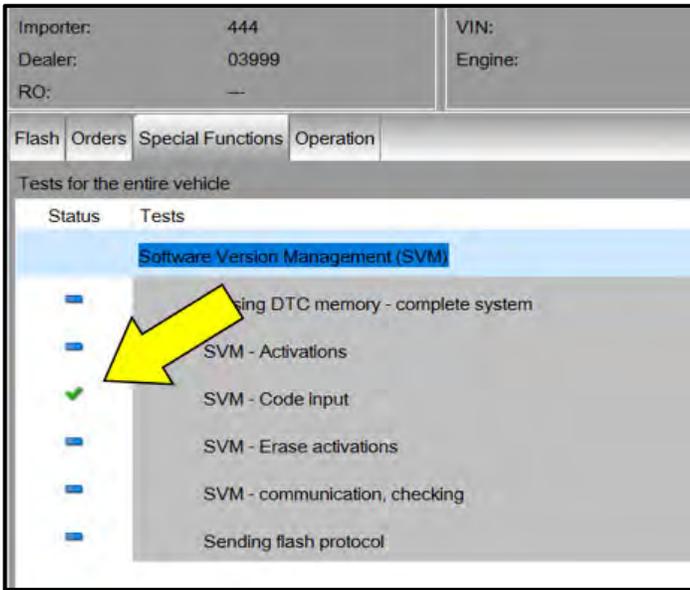
- Enter the corrective action code (SVM code) as listed below.

SVM code
91CDA108

- Select “Accept”.
- Follow the on-screen prompts.

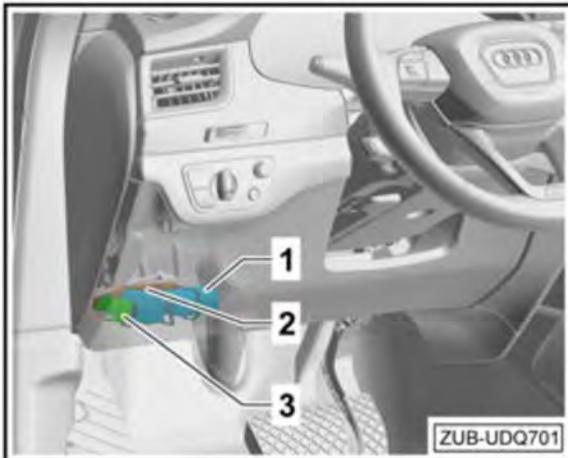
Make sure that all routed wires are long enough to reach the installation positions.

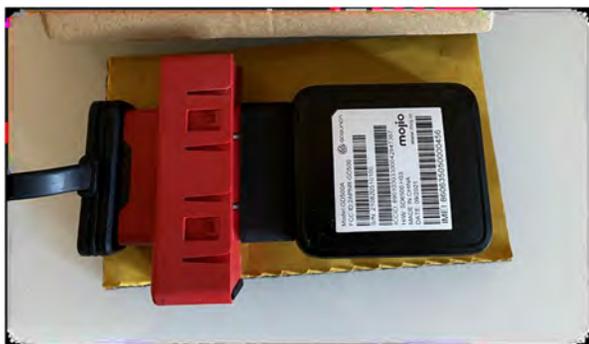
Installing and routing the LTE Retrofit Telematics Device in the vehicle

- Cover the surface of the LTE Retrofit Telematics Device -1- with insulation material -5-.

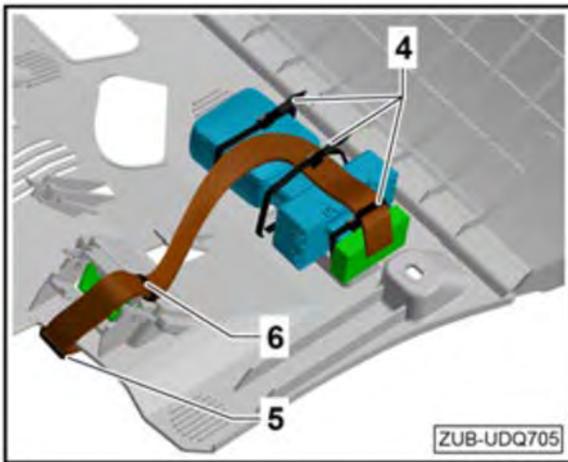
- To secure the LTE Retrofit Telematics Device using the cable ties -4-, use the mounting holes and the grille for the removed emergency loudspeaker.
- Attach a cable tie with adhesive pad -6- to the opening for the OBDII connector
- Attach a cable tie with an edge clip -5- to the edge of the footwell cover

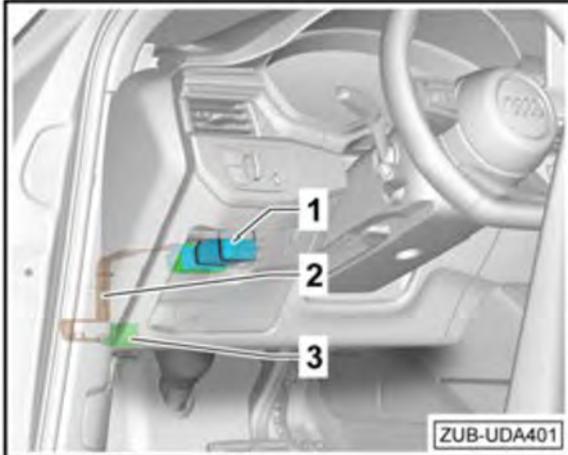
Make sure that all routed wires are long enough to reach the installation positions.

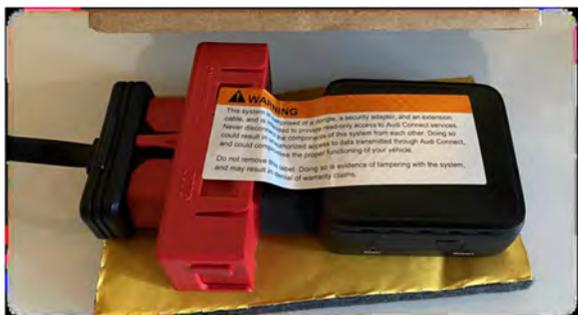
Installing and routing the LTE Retrofit Telematics Device in the vehicle

- The insulation material must cover the barcode on the LTE Retrofit Telematics Device.
- Cover the surface on one side of the LTE Retrofit Telematics Device -1- with insulation material -5-.

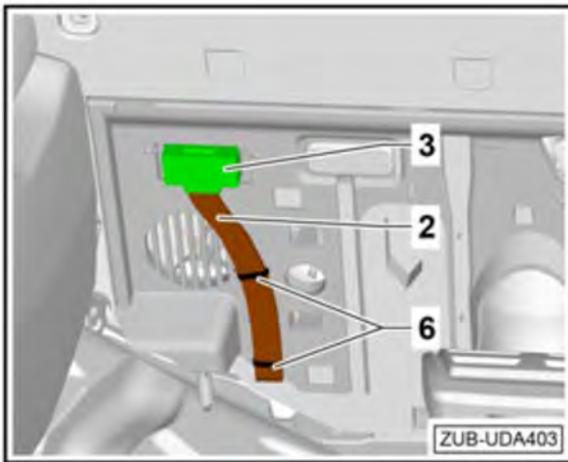
- Install the storage compartment with footwell cover.

- Connect the OBDII extension cable -2- on the vehicle to the OBDII slot -3-.
- Secure the OBDII extension cable -2- in a suitable place using cable ties with adhesive pad -6- to prevent noise from occurring.

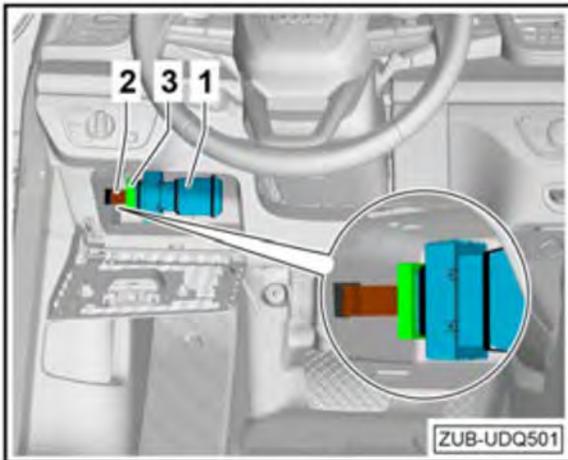
Make sure that all routed wires are long enough to reach the installation positions.

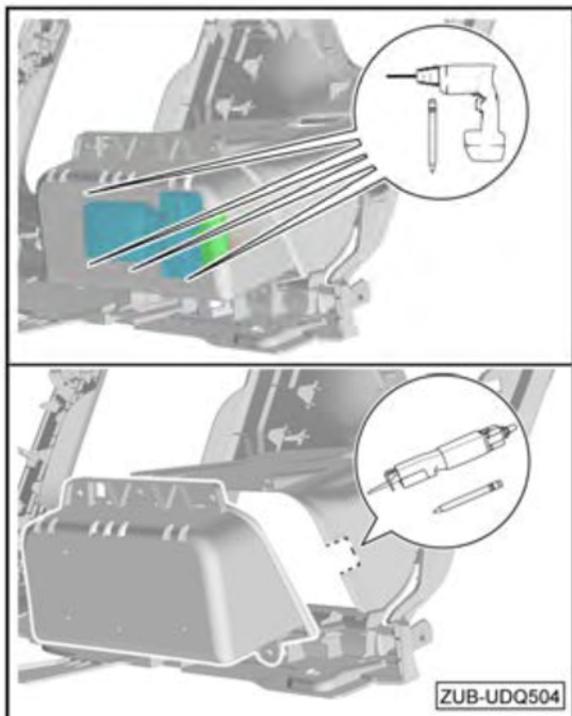
The barcode on the LTE Retrofit Telematics Device must be point upwards because of the position of GNSS antenna.

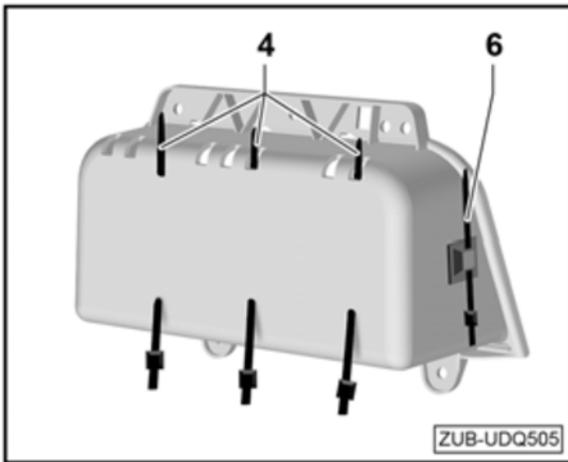
- Position the LTE Retrofit Telematics Device -1- on the cover of the storage compartment in the installation position and mark the holes for the cable ties.
- Drill M5 holes for the cable ties.
- Drill an opening measuring -18 mm x 18 mm- on the dash panel cover in the area of the cable feed-through using suitable workshop equipment and deburr the opening.

Drilling pilot holes at the corners of the cutout will make cutting easier.

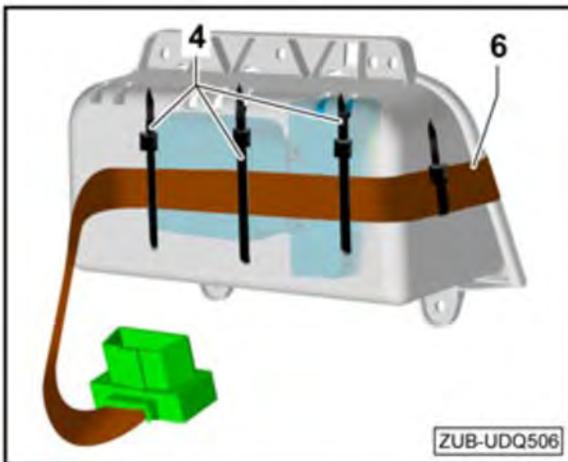
- Position the LTE Retrofit Telematics Device - 1- with the insulation material attached on the storage compartment in the installation position and secure with cable ties -4-.
- Attach a cable tie with adhesive pad -6- to the side.

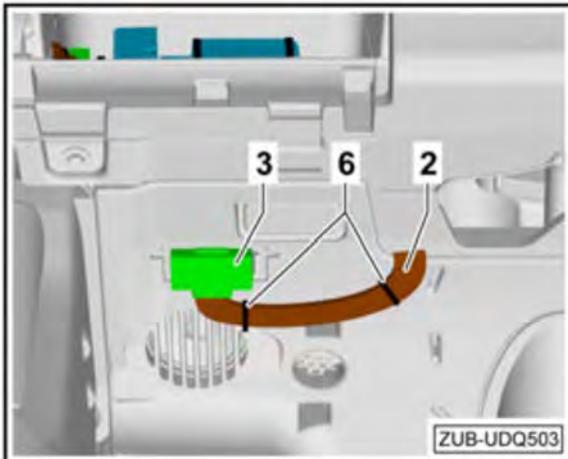
- Route the OBDII extension cable towards the position of the OBDII slot in the vehicle and secure it in a suitable place using a cable tie with adhesive pad -6- to prevent noise from occurring.
- Leave the end of the OBDII extension cable loose.

- Connect the OBDII extension cable -2- on the vehicle to the OBDII slot -3-.
- Secure the OBDII extension cable -2- in a suitable place using cable ties with adhesive pad -6- to prevent noise from occurring.

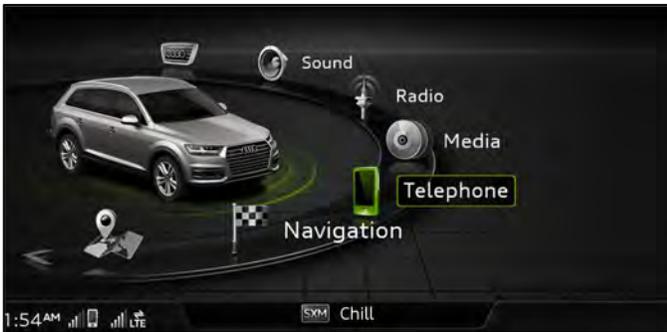
- The vehicle is stationary and the ignition is switched on.
- LTE Retrofit Telematics Device connected to OBD2 and ready for operation.

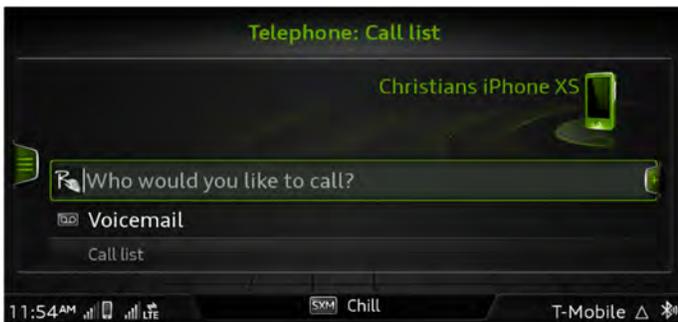
- Select “Telephone”

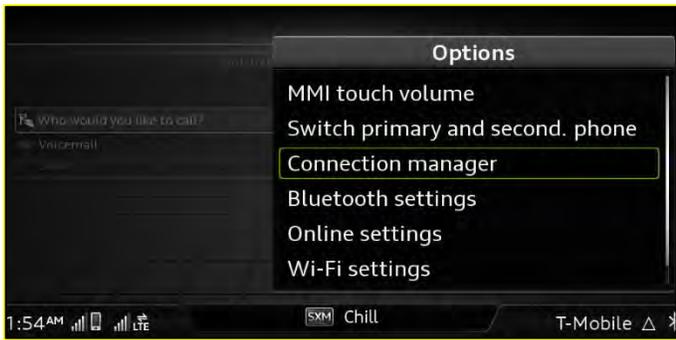
- Press right control button on the MMI control pad to bring up Options menu.

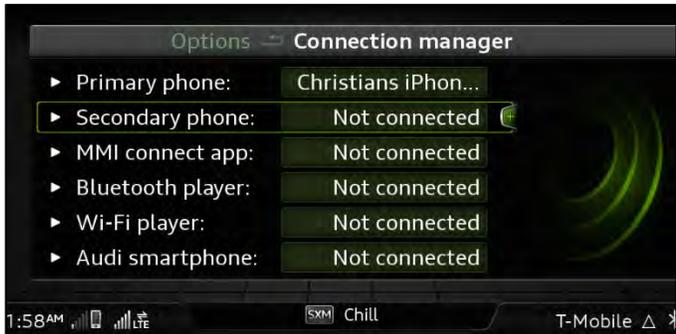
- Select “Connection manager”

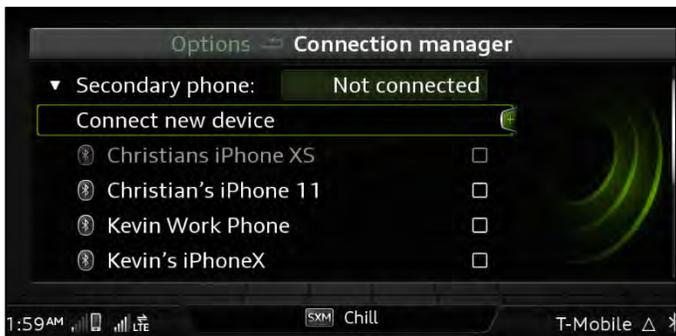
- Select “Secondary phone”

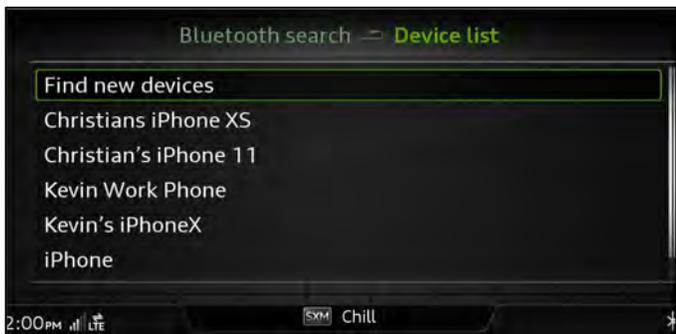
- Select “Connect new device”

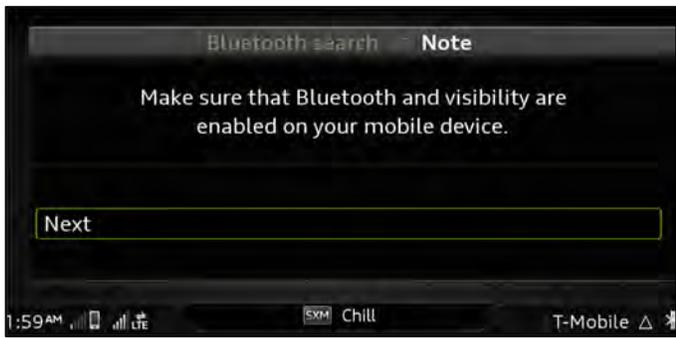
- Select “Find new devices”

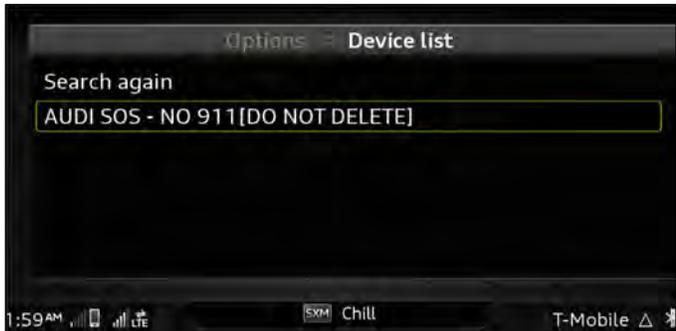
- Select “Next”

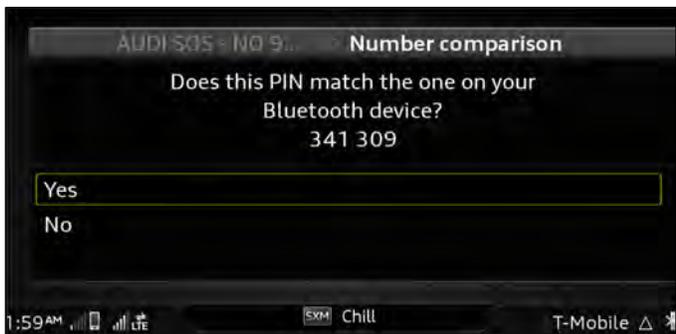
- Select “AUDI SOS – NO 911 [DO NOT DELETE]” from the device list.

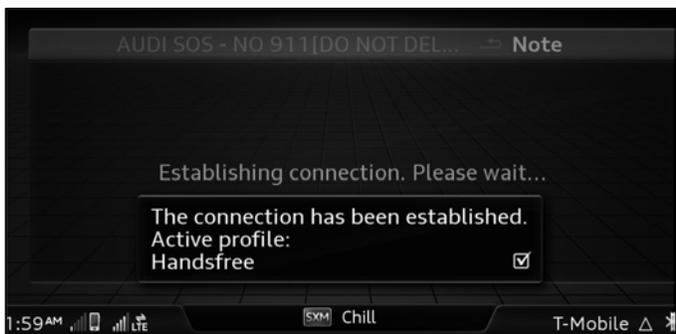
- Confirm the PIN by selecting “Yes”

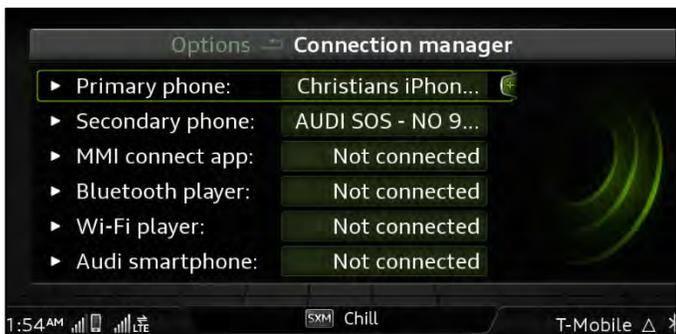
- The Bluetooth connection will be established.

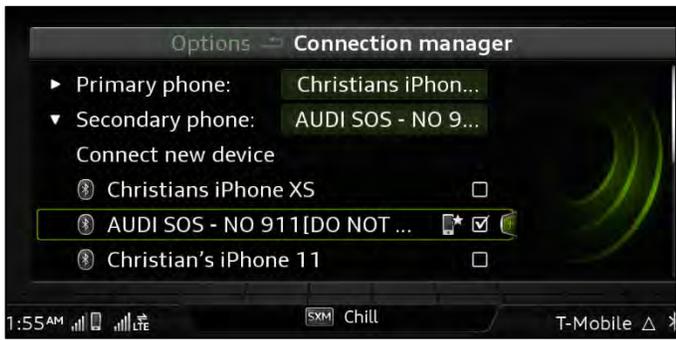
- LTE Retrofit device is now a secondary connected device.

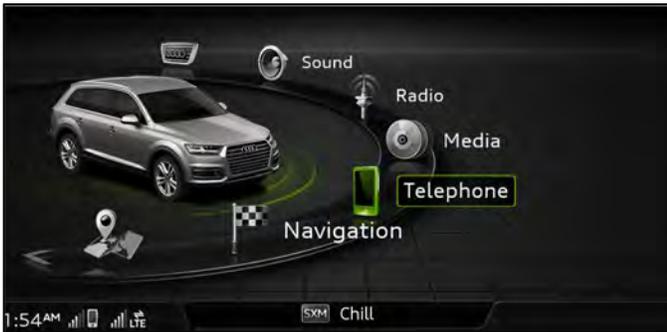
- The vehicle is stationary and the ignition is switched on.
- LTE Retrofit Telematics Device connected to OBD2 and ready for operation.
- The MMI is not connected to any mobile phone.

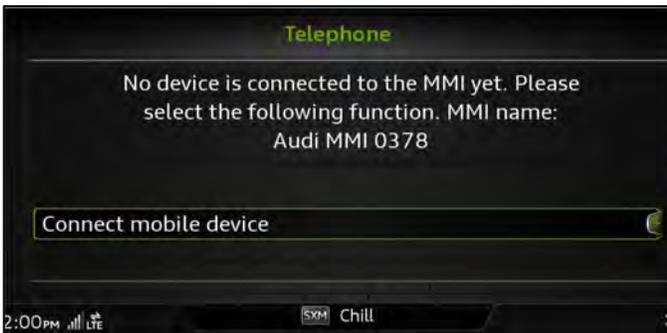
- Select "Telephone"

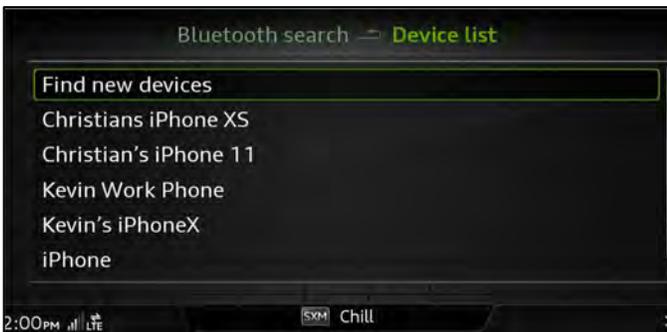
- Select "Connect mobile device"

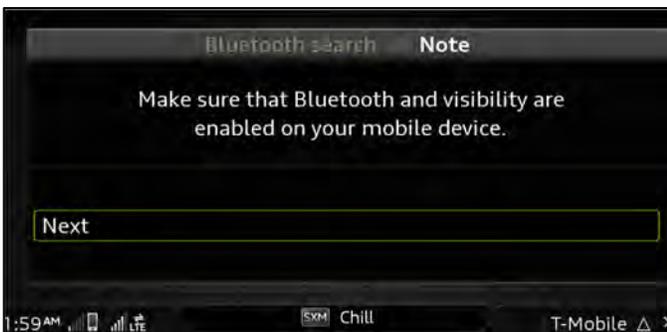
- Select "Find new devices"

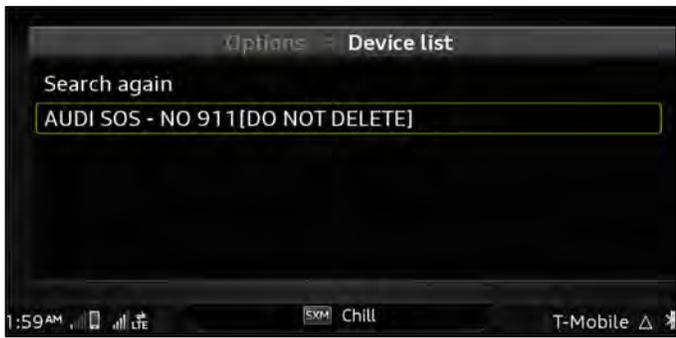
- Select "Next"

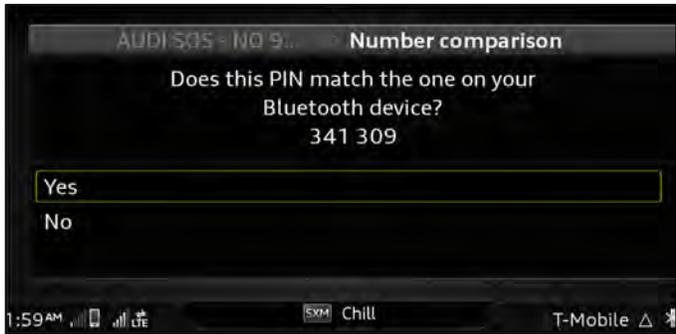
- Select “AUDI SOS – NO 911 [DO NOT DELETE]” from the device list.

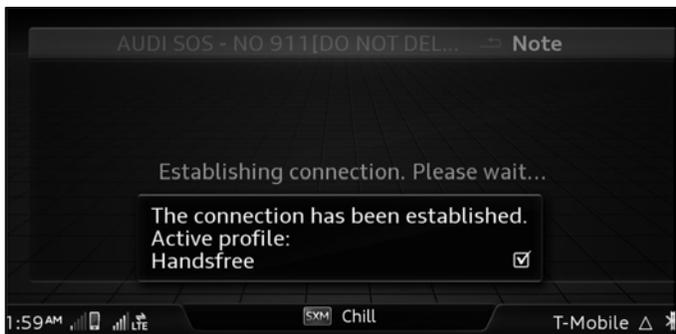
- Confirm the PIN by selecting “Yes”
- *NOTE: there is no need to confirm PIN on telematics device*

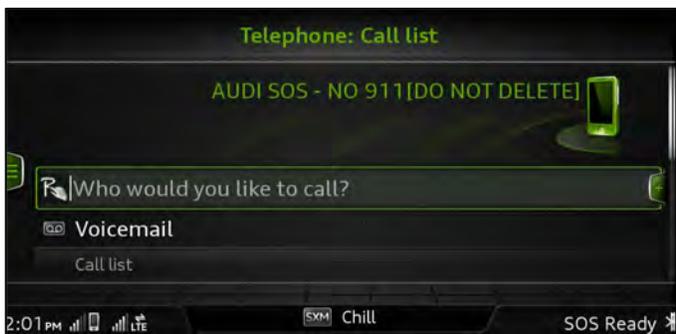
- The Bluetooth connection will be established.

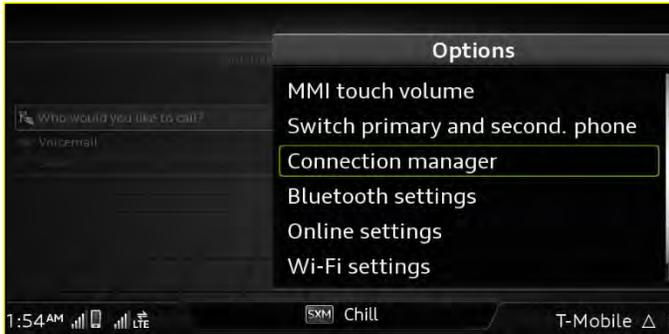
- Press right control button on the MMI control pad to bring up Options menu.

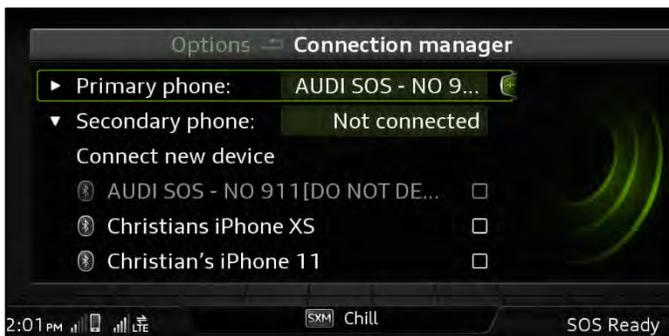
- Select "Connection manager"

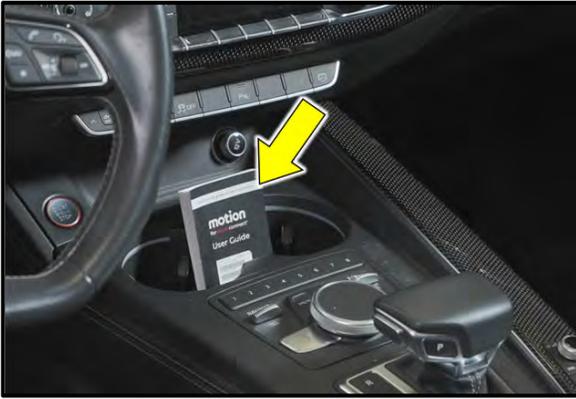
- The User Guide <arrow> from the retrofit kit must remain with the vehicle.
- The User Guide from the retrofit kit contains registration data unique to the retrofit kit that was installed in the vehicle.

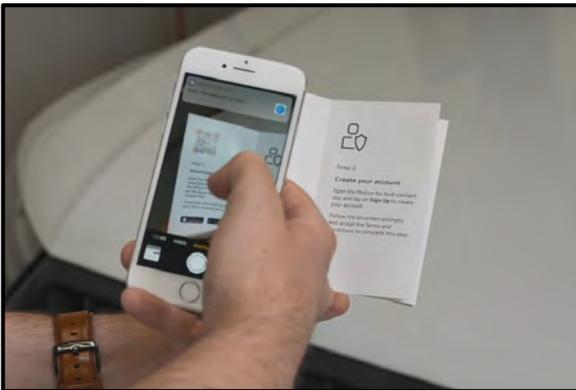
- In order for the customer to use the Motion for Audi Connect app, they must first download the app by scanning the QR code found in the User Guide

- Once the app is downloaded, and the customer creates an account, they must scan the unique barcode on the front of the User Guide in order to activate their services.
