WME9 - Re-Programming PDK Control Unit (Workshop Campaign)

Model Line: **911 (992)**

Concerns: **PDK control unit**

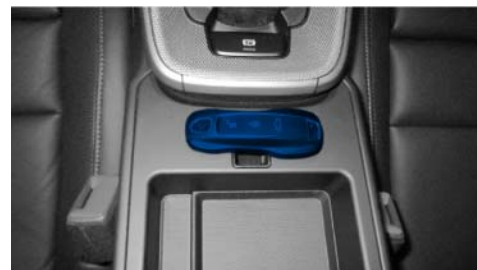
Emergency start tray

2 Place the driver's key with the back facing down in the area in front of the storage compartment under the armrest (emergency start tray) in order to guarantee a permanent radio link between the vehicle and driver's key ⇒ *Emergency start tray*.

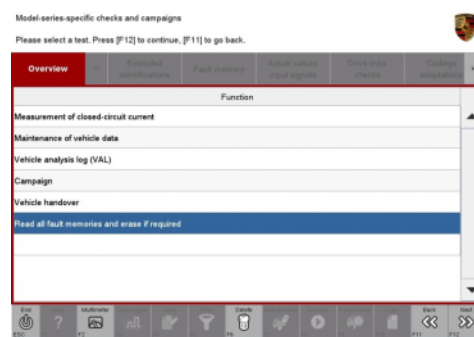
Erasing fault memories

- 1.1 Press •F7" in the control unit selection screen ('Overview' menu) to call up the Additional menu.
 - 1.2 Select the function "Read all fault memories and erase if required" and press •F12" ('Next') to confirm ⇒ *Erasing fault memories*.
- The fault memories of the control units are read out.
- 1.3 Once you have read out the fault memories, check the fault memory entries.

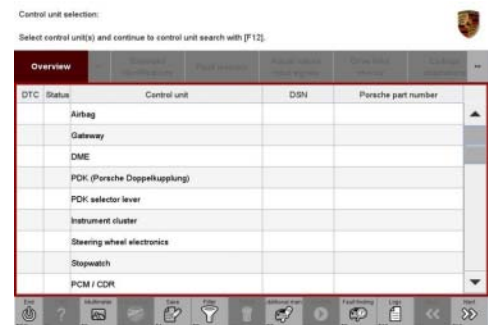
Control unit selection

- Switch off ignition.
 - Disconnect the PIWIS Tester diagnostic connector from the diagnostic socket.
 - Lock the vehicle using the driver's key.
 - Wait approx. 1 minute before unlocking the vehicle again.
 - Start the engine, leave it running for a short time and then stop it again.
 - Switch off the ignition and wait approx. 10 seconds before switching it back on again.
 - Plug the PIWIS Tester diagnostic connector into the diagnostic socket again and restore communication with the vehicle.
 - Read out the fault memory again and delete any fault memory entries that are stored.
- 1.6 Once you have erased the fault memories, select the **'Overview'** menu to return to the control unit selection screen ⇒ *Control unit selection*.
