Technical Service Bulletin

SUBJECT:			No: TSB-22-13-001
CHECK ENGINE LIGHT ILLUMINATES OR ENGINE MALFUNCTION POWER REDUCED SERVICE NOW WARNING MESSAGE APPEARS WHILE IDLING OR DRIVING			DATE: January 2022
			MODEL: 2022 Outlander
CIRCULATE TO:	<input type="checkbox"/> GENERAL MANAGER	<input checked="" type="checkbox"/> PARTS MANAGER	<input checked="" type="checkbox"/> TECHNICIAN
<input checked="" type="checkbox"/> SERVICE ADVISOR	<input checked="" type="checkbox"/> SERVICE MANAGER	<input checked="" type="checkbox"/> WARRANTY PROCESSOR	<input checked="" type="checkbox"/> SALES MANAGER

This reflash is to correct the ECU software. The check engine light illuminates or an engine malfunction power reduced service now warning may appear while idling or driving. DTC P0401, P0404 or others may be set. Please perform this reflash first, then proceed to diagnosing other codes if they persist.

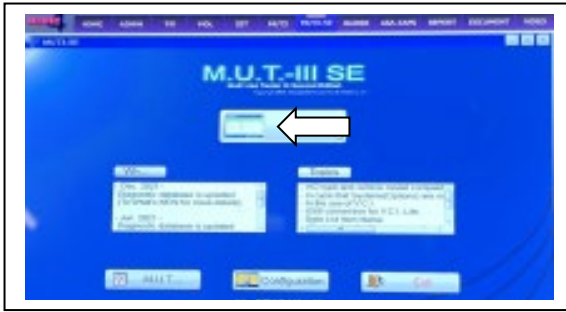
a. Click "STV".

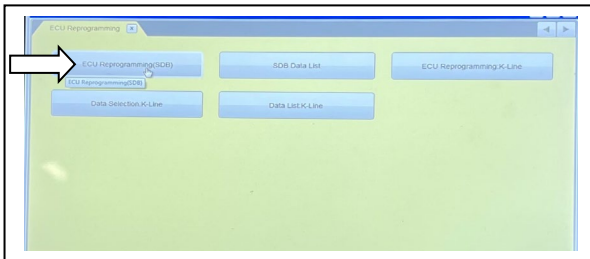
c. Click "SDB Data List, select the reprogramming data system and press the OK button".

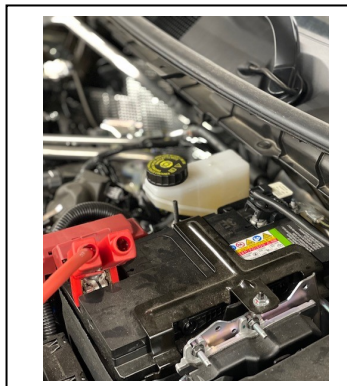
NOTE: Due to limited space it may be easiest to connect cable onto negative ground post and ground strap as shown below.

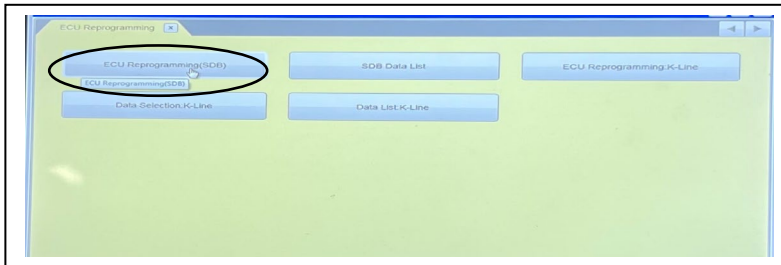
5. Verify that the ECU has not already been updated to the latest S/W number shown in the "ECU Reprogramming Chart" in this TSB. If the ECU is at the latest level, reprogramming **is not** necessary. If reprogramming **is** necessary, proceed with the following steps.

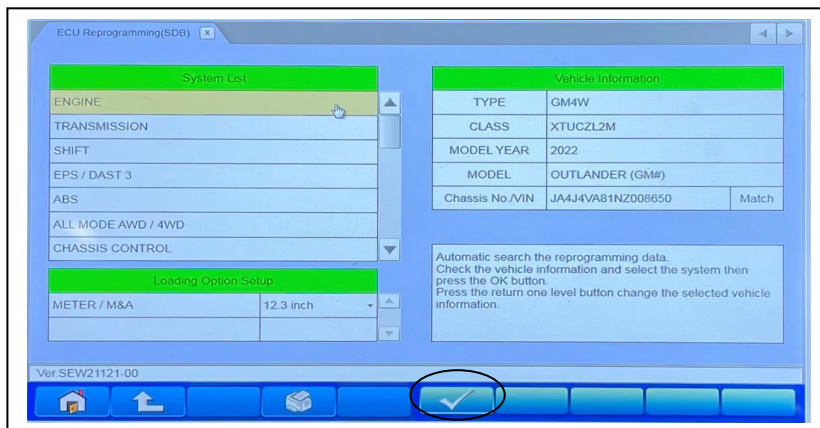
a. Select ECU Reprogramming (SDB).

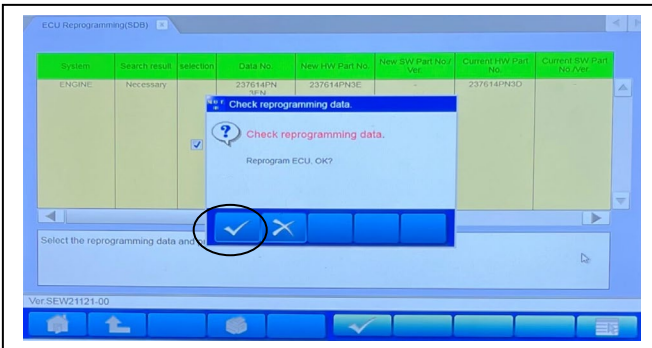
c. Click the Selection box and the OK button.

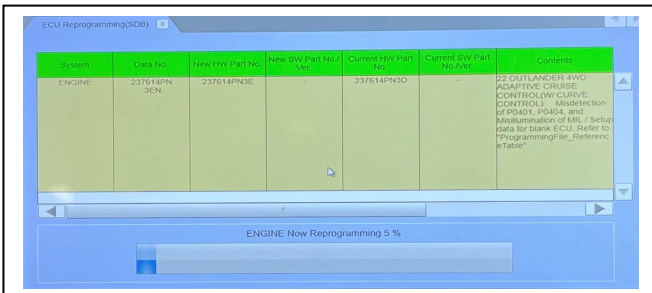
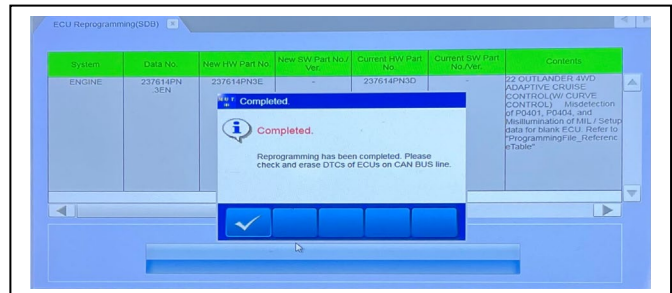
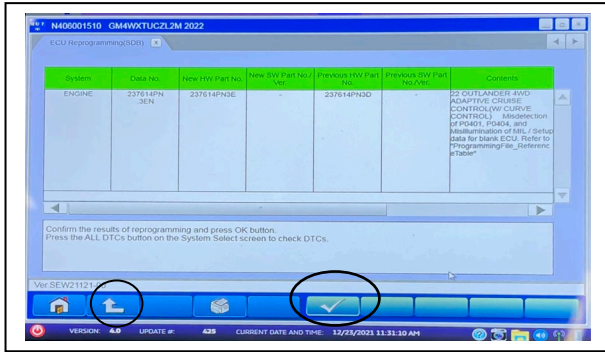
f. Reprogramming will begin and a progress bar will appear followed by a notification upon successful completion.

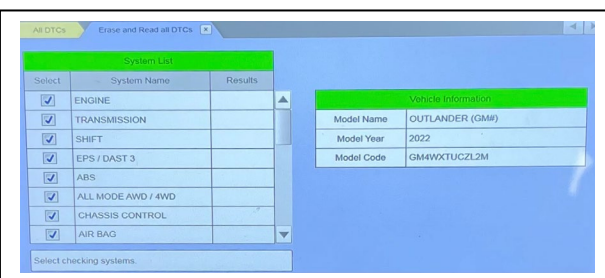
c. Press the Erase and Read all DTCs button.

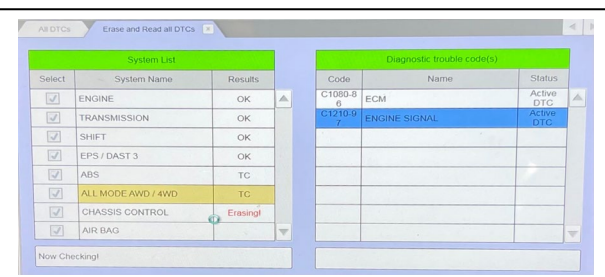
d. Select all systems.

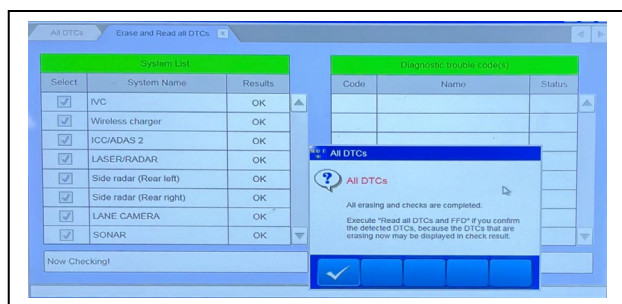
e. The results are displayed during the erase and read process.

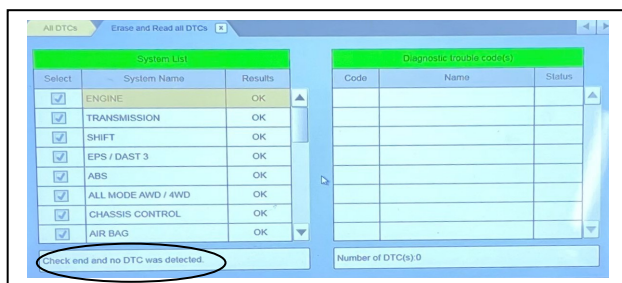
f. Confirm that the erasing and checks have been completed and that no DTCs were detected.

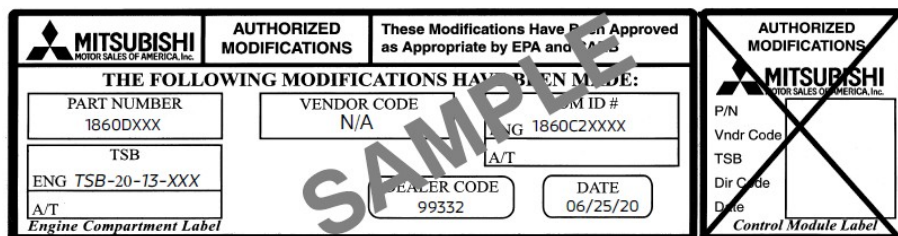
7. Using a ball-point pen, enter the appropriate ECU part number, Software Part Number (ROM ID#), this Technical Service Bulletin number, your dealer code, and the current date on the Engine Compartment/Control Module Label (p/n MSSF024G00). The Vendor Code is not applicable. The label is available from your facing PDC.
